Service Bulletin

Subject: Musty Odor from HVAC Vents on Startup

Models: 2013-2016 Cadillac ATS
2014-2016 Cadillac CTS Sedan (VIN A)

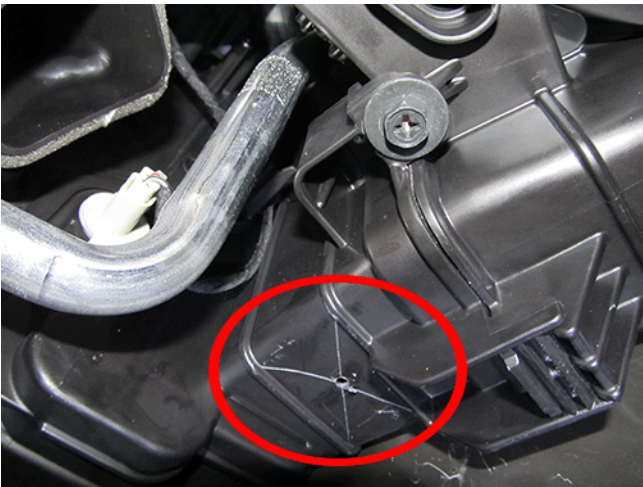
9. On the lower HVAC case, scribe an "X" in the area shown.

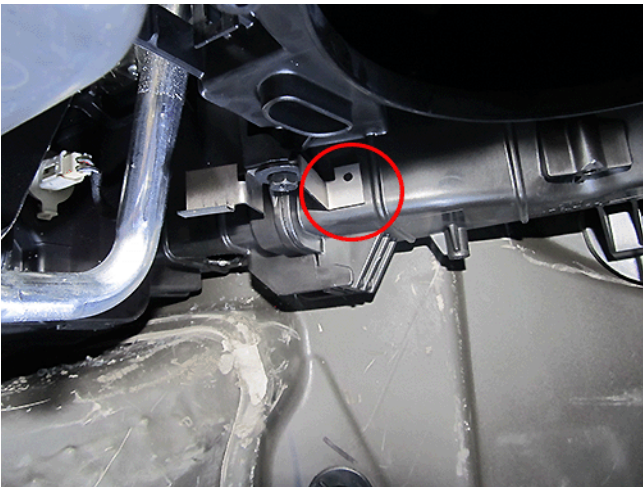
11. Drill a 19 mm (3/4") hole in the center of the air duct between the blower motor and the air distribution box. The use of a Uni-bit style bit works well. The use of a spade bit will produce excessive plastic chips and may cause the drain to get plugged.

Note: Use a vacuum to collect as many of the plastic chips inside and outside the HVAC case as possible. The blower motor removed helps gain access to the inside of the HVAC case.

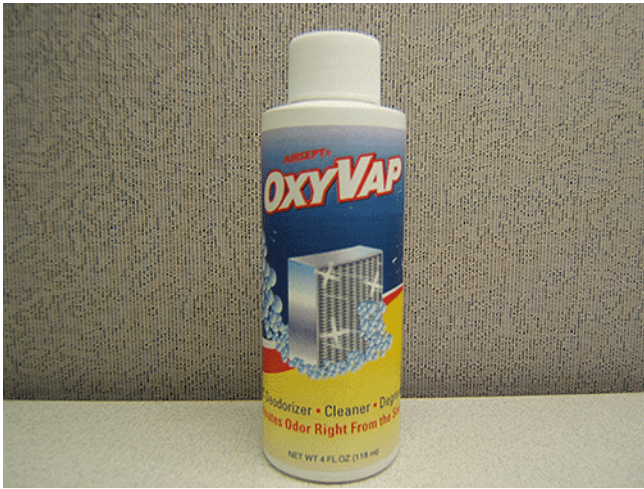
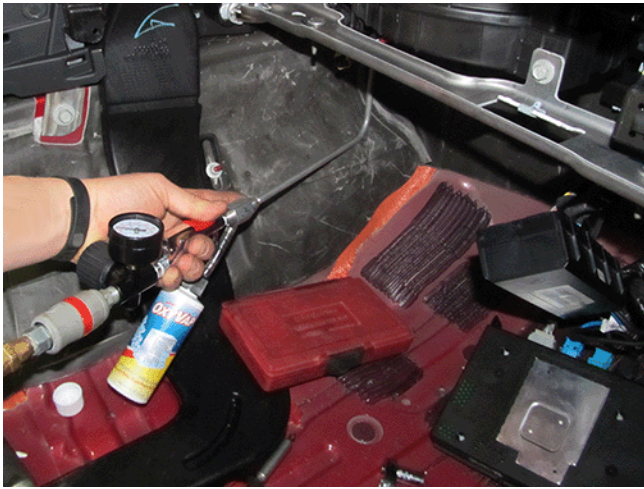
17. Insert the application tool into the drilled hole. Apply OxyVap™ at 65 psi (448 kPa).

- Apply the OxyVap to the evaporator core using applicator tool P/N 23372329. Move the wand up and down to obtain good coverage to the fin area. Turn the HVAC system to off.
- Allow the core to soak for 5 minutes.
- Rinse the empty bottle of OxyVap and fill with clean water. Rinse the evaporator core moving the applicator tool up and down with clean water until the bottle is empty with the blower turned on "High."
 - Using the applicator tool, blow compressed air on the evaporator core for one minute moving the applicator tool up and down to help remove excess water.

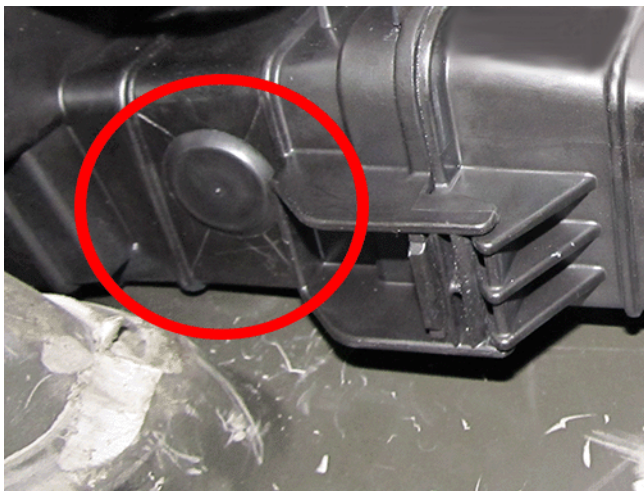
- Install the body plug, P/N 15632415, into the 19 mm (3/4") hole with a thin coating of RTV.

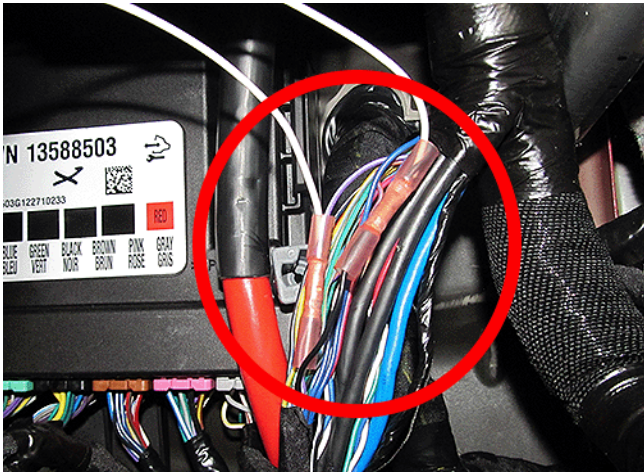
7. Using the supplied splice sleeves, crimp wire 2 from the supplied wire harness to the black I/P harness and connect the other end of the black wire to the connector.
8. Apply heat to the splice sleeves to seal them.
9. Rewrap the I/P harness with the friction tape and seal with electrical tape.

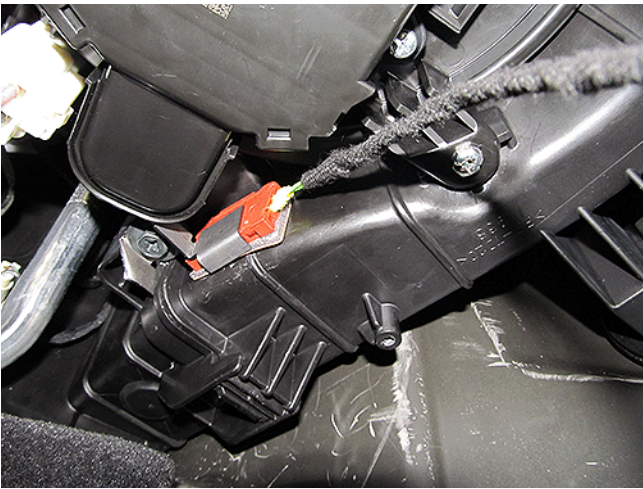
22. Install the ionizer emitter bracket to the HVAC case with the supplied or existing screw.

Tighten: Tighten the screw to 9 Y (79 lb in).
