# Service Bulletin

File in Section: -  
Bulletin No.: 17-NA-330  
Date: October, 2017

**Subject:** Normal Characteristic – Push to Talk Button on Steering Wheel Control is Inoperative

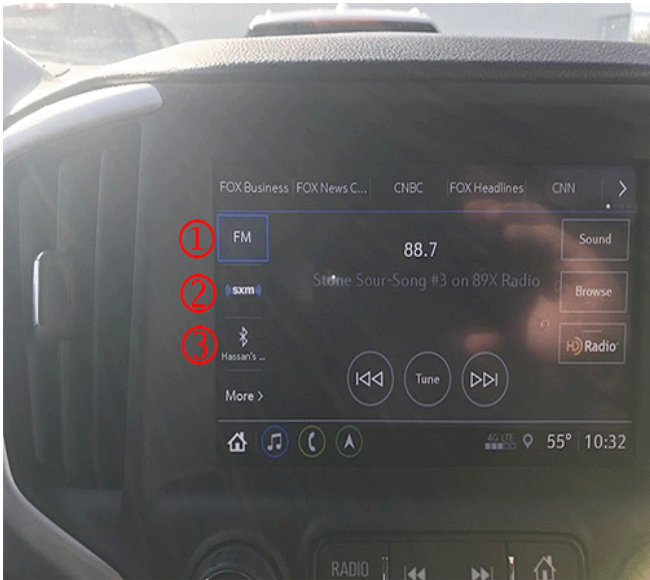
4875408

| <b>Cause</b> | <p>This condition may be due to one of the following:</p> <p>Condition 1, no action is required. It is normal operation if you do not have a phone device paired with the vehicle via Bluetooth.</p> <p>Condition 2, the radio displays the last 3 sources used for the radio like AM, FM, XM, Bluetooth device streaming music or USB drive. The sources are highlighted/actively listed even after the source is removed from the system.</p> <p>To delete the name of the USB from the radio display, push the more button on the display and select another radio sources like AM, FM or XM.</p> |

| | <b>Note:</b> The radio will show the last 3 audio sources after removed, as shown in the illustration above. |

| <b>Correction</b> | <b>DO NOT</b> replace the radio assembly as this is a normal design characteristic for the infotainment system. |
