Service Update

17345 Front Damper Rod Fractured

Reference Number: N172106700

Models: 2017 Chevrolet Colorado
Equipped with High Wider Performance Chassis Package (RPO ZR2)

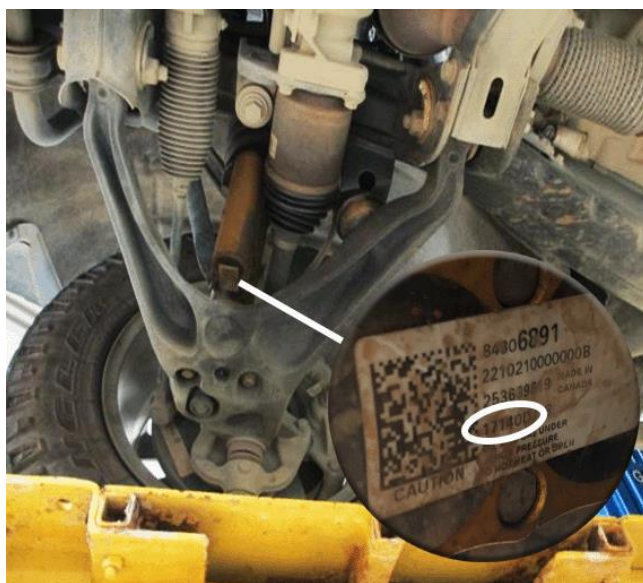
4875793

2. Inspect the label on the bottom of the left front shock absorber.

- If the first 6 digits of the date code are NOT 17089A, 17091D, or 17093D, no further action is required.
 - If the first 6 digits of the date code are 17089A, 17091D, or 17093D, proceed to the next step.
3. Replace the left front shock absorber. Refer to *Shock Absorber and Spring Removal and Installation (With ZR2)* in SI.
