Special Coverage Adjustment

17336 Combi-Cooler Air Conditioner Refrigerant Leak

Reference Number: N162080780

Release Date: November 2017
Revision: 02

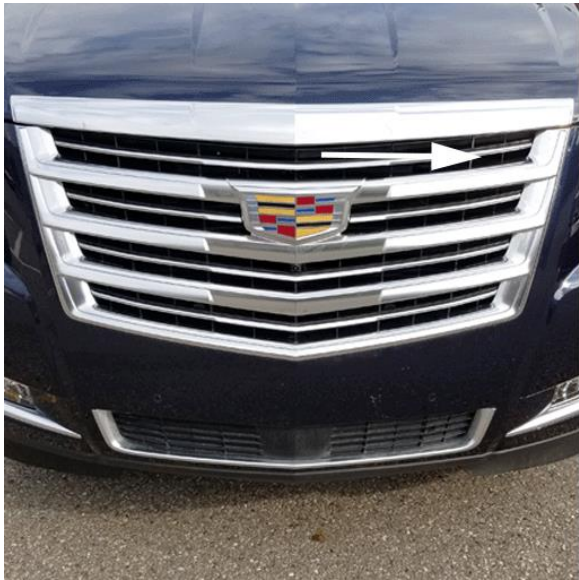
4873592

Cadillac Escalade shown. Other models are similar.

1. Locate the coupler (1) on the air conditioning condenser by looking through the identified area of the radiator grille.

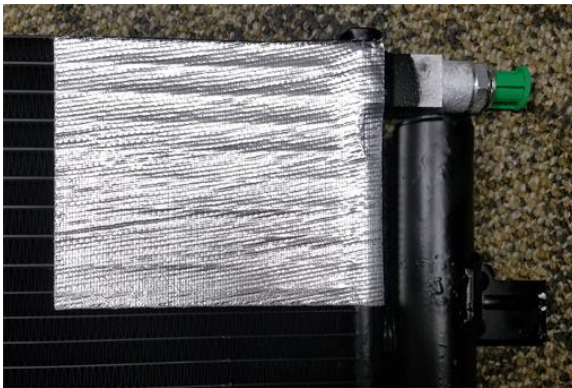
4892397

- If an air conditioning condenser shield assembly is NOT installed, install the air conditioning condenser shield assembly as shown in the picture above.
5. Remove one of the plugs from the transmission fluid auxiliary cooler fitting.
 6. Fill the transmission fluid auxiliary cooler full of transmission fluid.
 7. Install the plug back into the transmission fluid auxiliary cooler fitting.
 8. Install the NEW air conditioning condenser. Refer to *Air Conditioning Condenser Replacement* or *Air Conditioning Condenser Replacement (L83 L86)* in SI.
