## R231 center console stowage compartment retractable cover

| Topic number | LI68.20-P-054630 |
| Design group | 68.20 Center console |

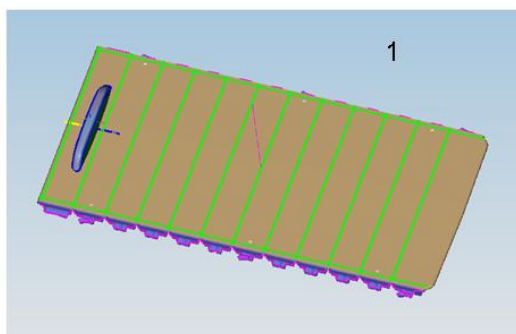
Retractable cover with wide slats has excessive resistance, - jams , - catches

Up to WDD 231 XXX XX 003486 (approx. 01.04.2012) retractable covers with wide slats were installed. (Figure 1 up to VIN / Figure 2 as of VIN)

In vehicles up to WDD 231 XXX XX 003486 (prior to 01.04.2012) with wide slats, the complete stowage compartment assembly of the center console must be replaced.
