Service Bulletin

Subject: Incorrect Display of Fuel Economy Units Displayed on Driver Information Center (DIC)

Brand:	Model:	Model Year:		VIN:		Engine:	Transmission:
		from	to	from	to		
Cadillac	CT6	2016	2017				
	CTS	2016	2016				
	Escalade Models

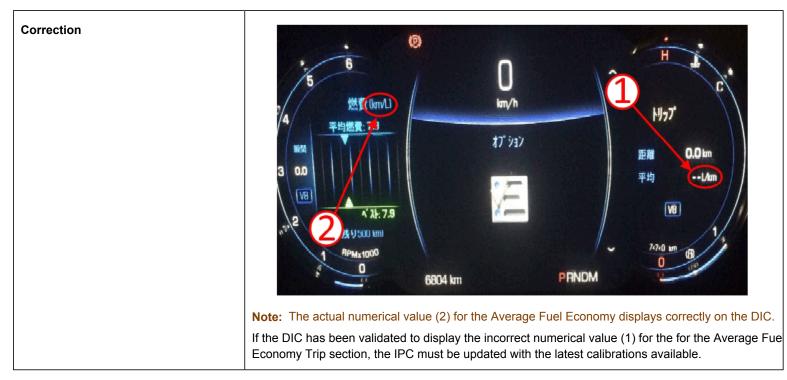
Involved Region or Country	Japan
Additional Options (RPOs)	UDV, UHS
Condition	Some customers may comment that the display for fuel economy units in the Driver Information Center may be displayed in L/KM .
Cause	This condition may be caused by a software anomaly in the Instrument Panel Cluster (IPC).

Refer to Instrument Cluster Programming and Setup in SI.
