Service Bulletin

Subject: Information on Installation of Stage One and Two Rear Wicker Bills on Spoiler

Brand:	Model:	Model Year:		VIN:		Engine:	Transmission:
		from	to	from	to		
Chevrolet	Corvette	2015	2018			All	All

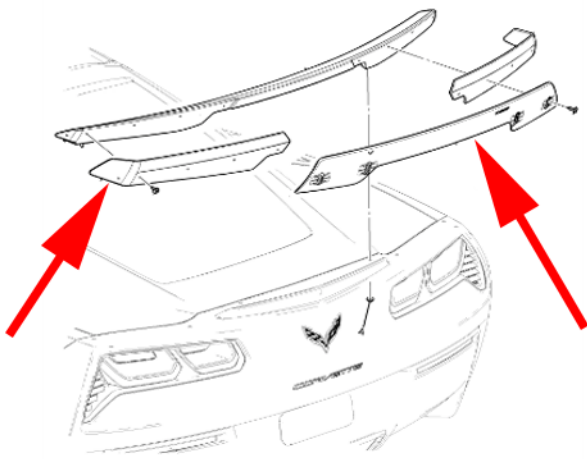
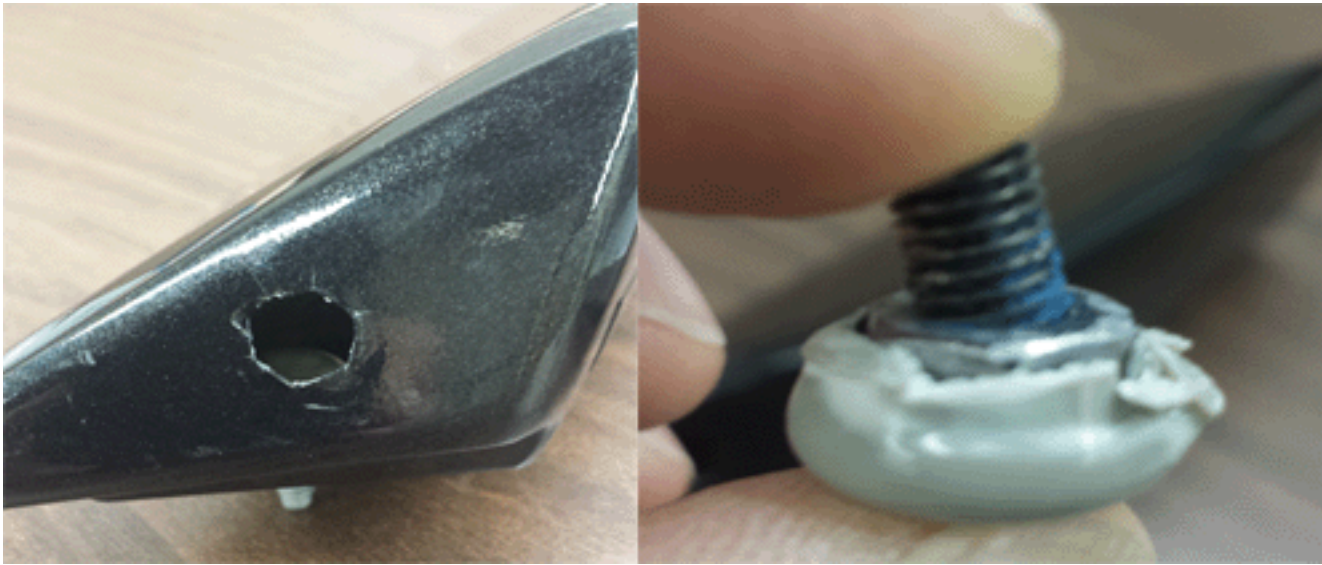
During the installation of the rear wicker bills that are fastened on the rear spoiler, some technicians may revert to the use of power tools to tighten the fasteners.

The use of power tools should not be used due to the fact that this could lead to damage to the fasteners and/or the spoiler.

When installing the wicker bills onto the vehicle, it is recommended to hand start the fasteners before using the correct hand tools to torque the fasteners to the proper torque specifications.
