# Service Bulletin

**Subject:** Rattle Noise from 2nd Row Outboard Seat Belt Retractor Latch Plate

Brand:	Model:	Model Year:		VIN:		Engine:	Transmission:
		from	to	from	to		
GMC	Acadia (VIN N)	2017	2017			All	All

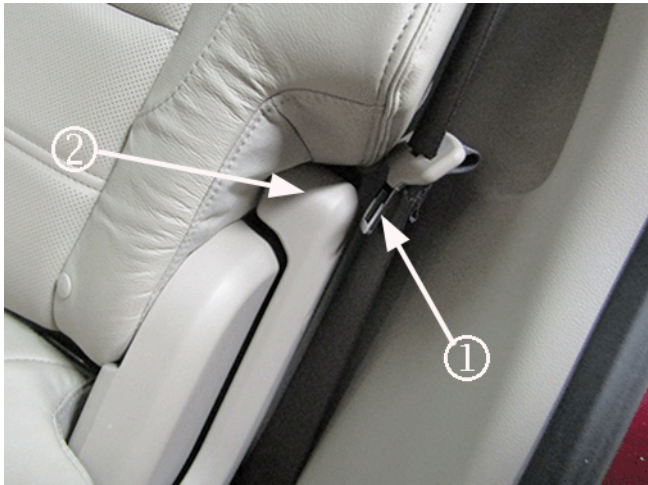
<b>Involved Region or Country</b>	North America, Middle East
<b>Condition</b>	Some customers may comment on hearing a rattle noise coming from the driver and/or passenger side 2nd row outboard seat belt retractor latch plate.
<b>Cause</b>

<p>The cause of the condition may be that the latch plate (1) of the rear seat belt retractor is contacting the rear seat outer hinge finish cover (2).</p>
<b>Correction</b>	Apply flocking tape to both the driver and passenger side rear seat outer hinge finish covers, following the Service Procedure below.
