Service Bulletin

Bulletin No.: 16-NA-341

Subject: Waiting for Update Media Message Displayed Under Various Conditions

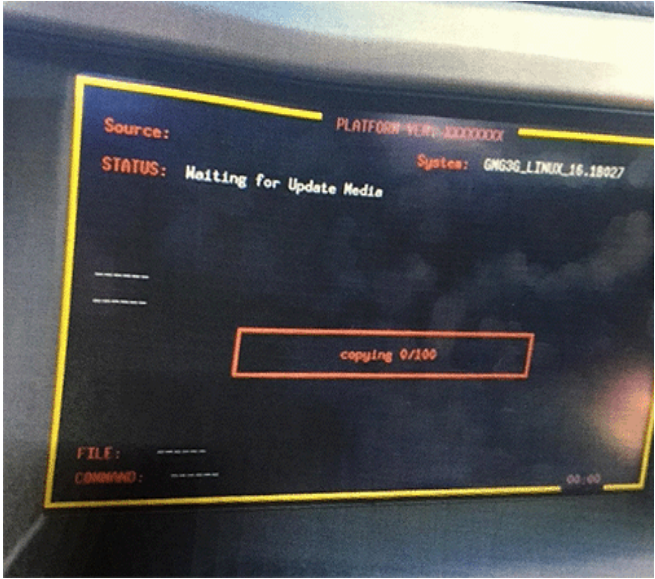
Involved Region or Country	North America and N.A. Export Regions
Additional Options (RPO)	Equipped with Radio RPO IO5, IO6 or UY4
Condition	Some customers may comment that the "waiting for update media" screen below appears/appeared while driving. They may also advise that it disappears within 80 minutes of being displayed.

<p style="text-align: right;">4593363</p> <p>Some technicians may also notice this message during HMI module programming.</p>
Cause	Depending on when this screen is displayed, this may be the result of an HMI module concern, normal HMI programming procedures, or the HMI software concern described in bulletin 17-NA-025. Follow the instructions below to determine which direction to take based on the details of the concern.

If the screen above is only noticed by a technician who is programming the HMI module for something else but not present once programming is complete, no repairs are required as it is normal for this screen to be momentarily displayed during HMI module programming. If the screen is still displayed after HMI module programming, the technician should try to program the HMI module again and re-evaluate the concern. Refer to *Human Machine Interface Control Module Programming and Setup* in SI.

If the vehicle comes in with the screen above displayed or if it is still displayed after HMI module programming, the technician should remove the HMI module fuse for at least 5 minutes, reinsert the fuse, and re-evaluate the concern.

If the screen above is still present after the technician has power cycled the fuse or after the screen has been displayed for more than 80 minutes, replace the HMI module. Refer to *Human Machine Interface Control Module Replacement* in SI.

If the screen disappears after the technician has power cycled the fuse or if it is reported that it disappears within 80 minutes of initially being displayed and there are no DTCs setting, please do not replace any parts. If this is encountered and no DTCs are setting, follow the instruction outlined in bulletin 17-NA-025 to determine if the HMI module needs to be programmed with updated calibrations.
