# Service Bulletin

Bulletin No.: 17-NA-238

**Subject:** Wi-Fi Hotspot and/or Data Sharing Feature Not Working Once it is Turned On

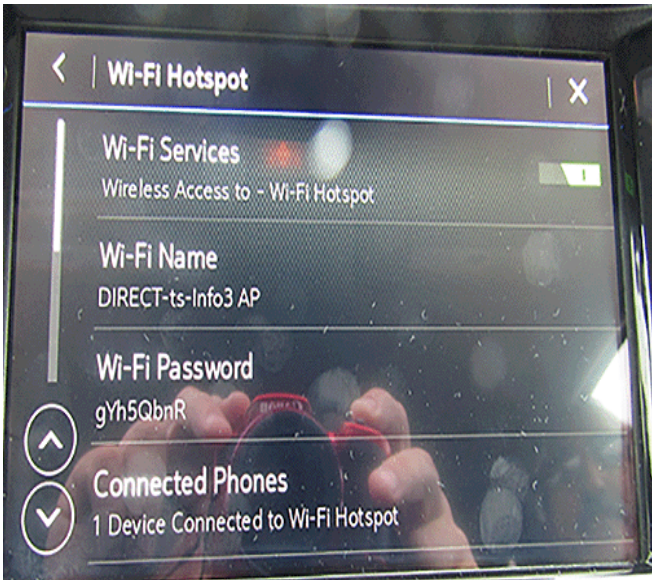
4846535

There are two settings icons that have to be toggled (switched) "on" to "green" to enable Wi-Fi: hotspot and share hotspot data.

| <b>Correction</b> | Need to toggle <b>BOTH</b> switches on, the Wi-Fi hotspot and hotspot data on the display. |
