**November 2017  
SF545AB**

## **Subject: Freightliner Cascadia Combined ESC/AAVA Bracket**

**Models Affected: Freightliner Cascadia vehicles manufactured  
May 3, 2016, through June 6, 2017.**

## Work Instructions

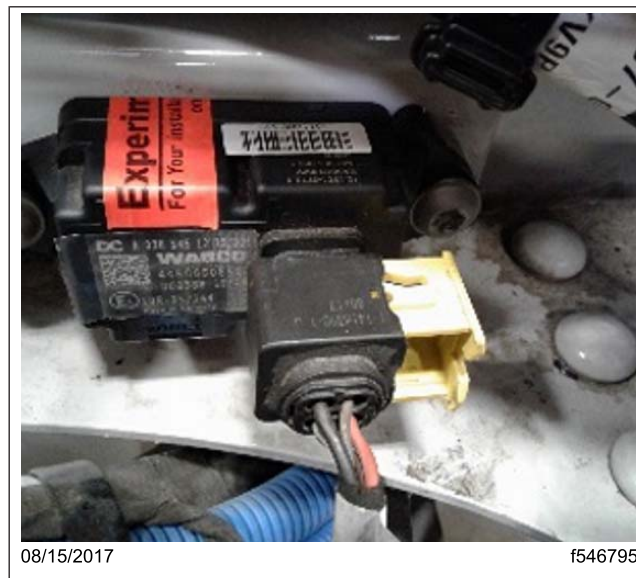
**Fig. 1, ESC Connector**

3. Locate the ESC Module on the crossmember, aft of the transmission, and disconnect the electrical connector. See [Fig. 1](#).

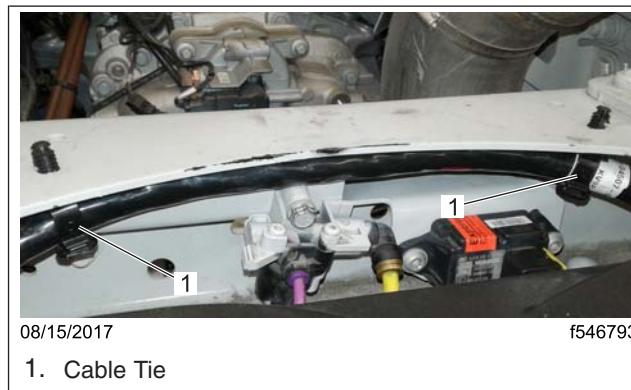
**Fig. 2, Rail-to-Rail Ground**

4. Remove the cable ties that secure the rail-to-rail ground to the inside top of the cross member. See [Fig. 2](#).

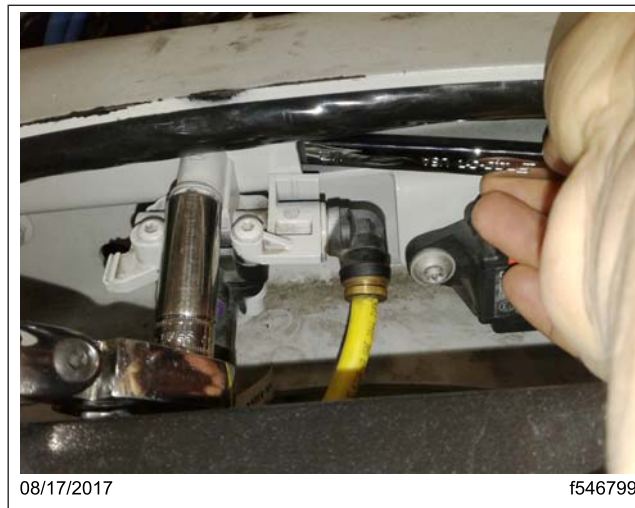
**Fig. 3, Wrench Holding the Nut in Place**

5. If equipped, remove all AAVA valves from the bracket. Inside the bracket, hold the nut in place with a boxed-end wrench to keep it from spinning while removing the bolt. See [Fig. 3](#).

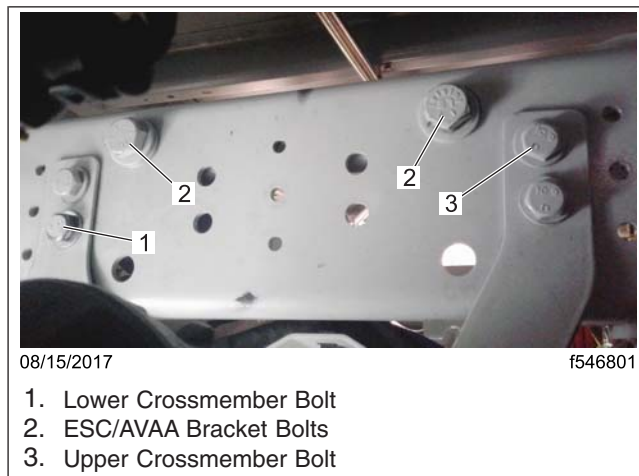
**Fig. 4, Crossmember Backside, with the Old Bracket Installed**

NOTE: It is not necessary to secure the nuts when removing the ESC/AVAA bracket. The nuts are welded to the bracket.

6. Remove the two bolts securing the ESC/AVAA bracket to the crossmember, then remove the bracket. See [Fig. 4](#).

9. Remove the lower crossmember fastener shown in [Fig. 4](#). This fastener will be reused to mount the new ESC bracket.
10. If installing the new AAVA bracket, remove the upper crossmember fastener. See [Fig. 4](#).

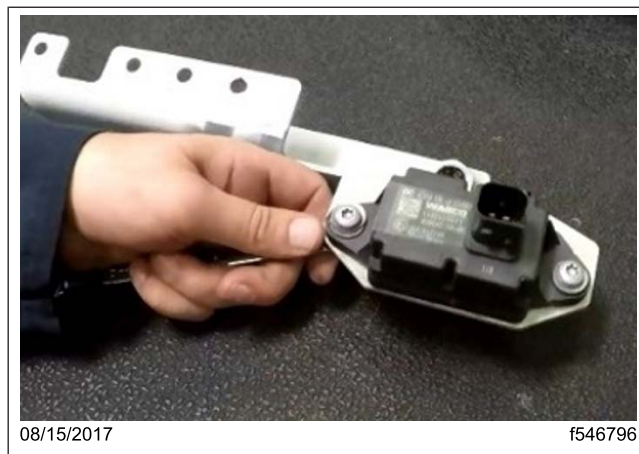
**Fig. 5, Removing the ESC Module from the Old Bracket**

7. Remove the ESC module from the bracket. See [Fig. 5](#).

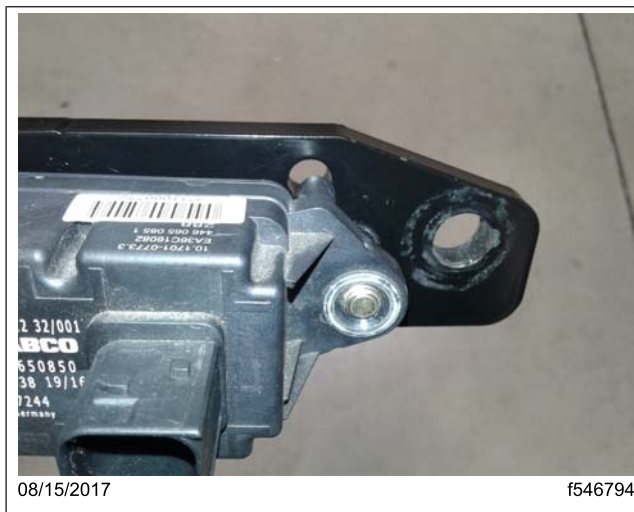
**Fig. 6, Installing the ESC on the New Bracket**

8. Secure the ESC Module to the new bracket, as shown in [Fig. 6](#). The text on the bracket should be facing up, and the connector on the ESC should be on the tapered side of the bracket. Torque the nuts to 15 lb·ft ft ± 1 (20 N·m ± 1.5).

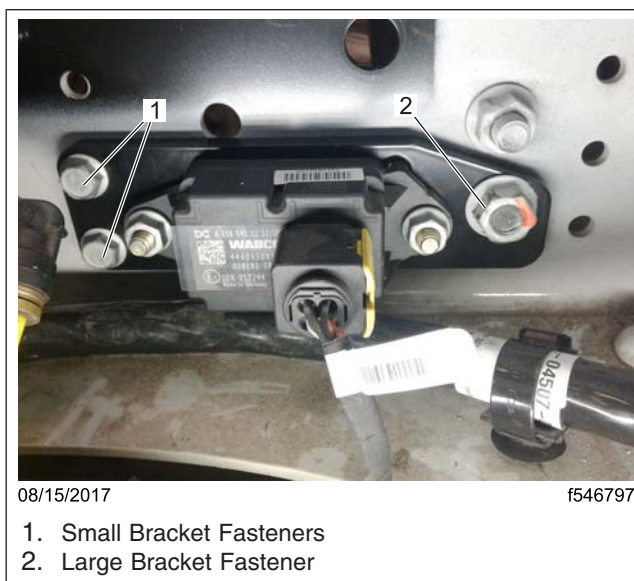
**Fig. 7, New ESC Bracket Fasteners**

**IMPORTANT:** The text on the ESC Module label should be facing up when the bracket is installed on the cross-member.

11. Install the new ESC bracket as shown. Torque the smaller fasteners to 11 lb·ft ft ± 15% (15 N·m ± 15%) and the larger fastener to 60 lb·ft ft ± 15% (81 N·m ± 15%). See [Fig. 7](#).

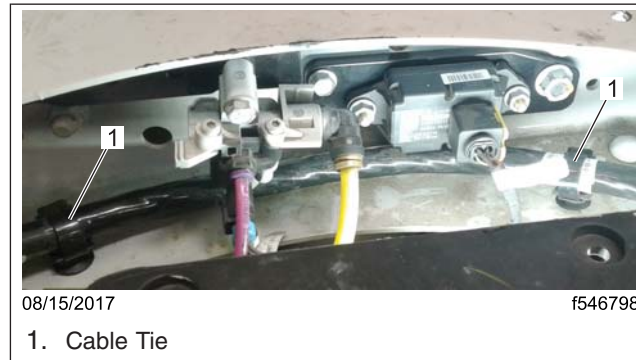
**Fig. 8, Ground Cable Secured to the Bottom of the Frame Rail**

12. Secure the rail-to-rail ground cable to the inside bottom of the crossmember with cable ties, as shown in [Fig. 8](#).

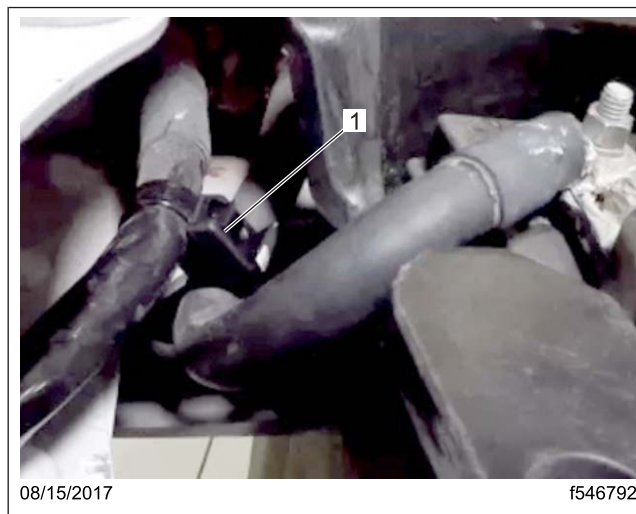
**Fig. 9, Butterfly Cable**

13. On Daycabs, add a butterfly cable tie to the rail-to-rail ground cable and the battery ground cable to prevent rubbing. See [Fig. 9](#).

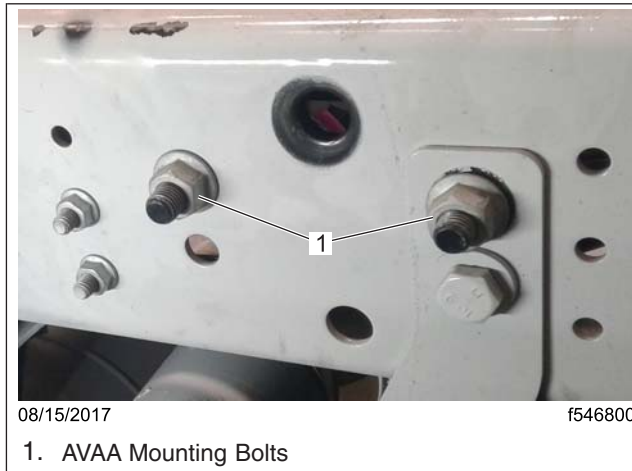
**Fig. 10, Crossmember with AVAA Bracket Installed**

14. If equipped with AAVA valve(s), install the new AAVA bracket. Torque the nuts to 60 lb·ft  $\pm$  15% (81 N·m  $\pm$  15%). See [Fig. 10](#).

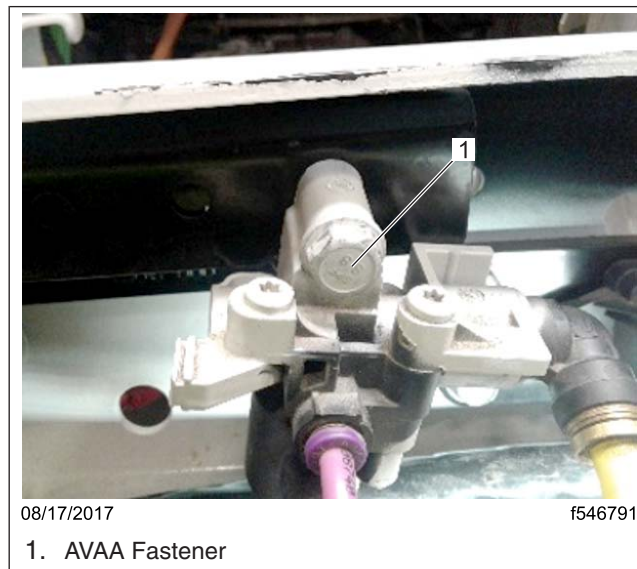
**Fig. 11, AVAA Valves**

15. Install the AAVA valves as they were configured on the old bracket. Torque fastener to 11 lb·ft  $\pm$  15% (15 N·m  $\pm$  15%). See [Fig. 11](#).
