Navigation Micro SD Card Error

2016-17 Land Cruiser

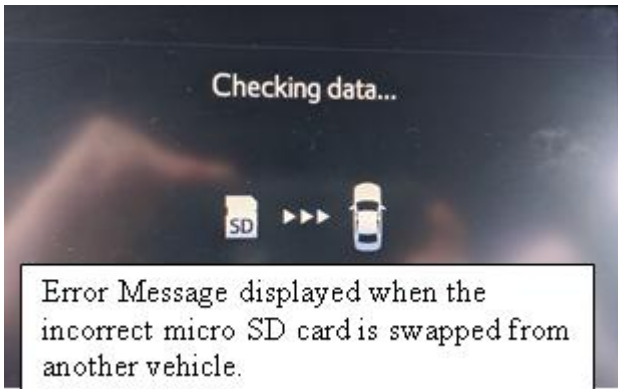
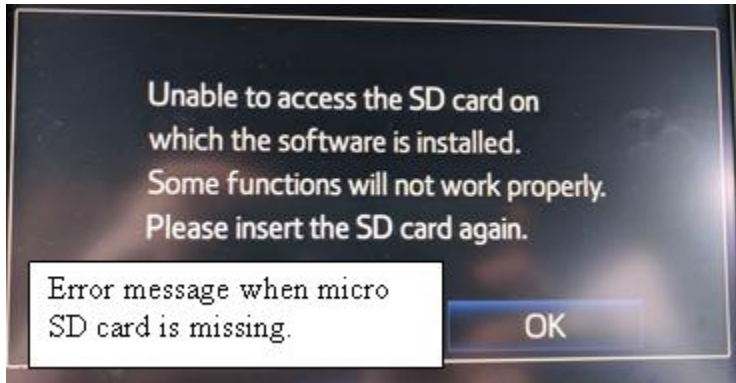
Navigation microSD (mSD) card reads an error when missing or swapped from another vehicle.

- Do not interchange mSD cards. Each mSD card is “paired” with the head unit.
- Once a mSD is “paired” with a vehicle, it may not be swapped into a different vehicle.
- A new mSD is “unpaired” and becomes “paired” when inserted into the vehicle.
- Service exchange radios come in “unpaired” service mode and accept used mSD cards.
- If a mSD card is swapped, returning it to the original vehicle will remedy the concern.
