SI B51 18 17
Body Equipment

April 2017
Technical Service

EXTERIOR BMW ROUNDEL EMBLEMS SEPARATE AND FALL OFF

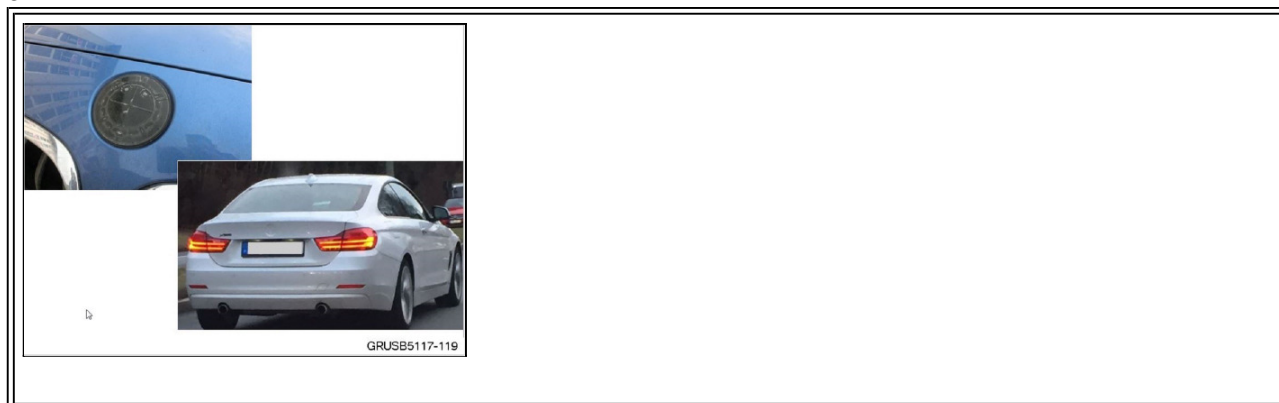
The exterior BMW Roundel Emblem (front and/or rear) separates from the mounting base and falls off.

Delamination of the Roundel Emblem.

Replace the affected BMW Roundel Emblem(s).

1. Remove remaining elements of the delaminated roundel from the vehicle as per repair manual "51 14 001 Replacing the front BMW badge" or "51 14 010 Removing and replacing rear badge"

2. Install a new roundel and grommets.
