## FUEL LEVEL LED INDICATOR – INCOMPLETE

F60 (Cooper, Cooper S Countryman)			
-----------------------------------	--	--	--

Produced from 11/1/16 through 12/12/16

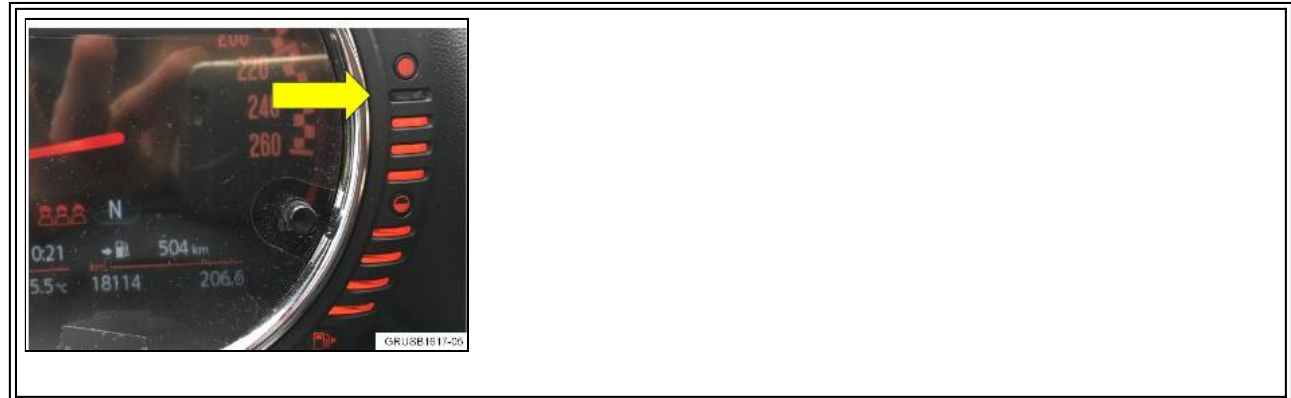
Fuel level indicator upper LED does not illuminate even though tank has been filled until auto-shutoff.

Pressure relief valve in fuel tank closes too early.

Replace fuel tank.

1. Drain the fuel tank according to REP11 00 005
2. Remove the fuel delivery unit following repair instruction REP 16 14 090.
3. Remove and replace the fuel tank according to repair instruction REP16 00 XXX
4. Reinstall the fuel delivery unit following repair instructions.
