SI B51 46 16  
Body Equipment

## CREAKING NOISE FROM TAILGATE LOCK.

F34 (3 Series Gran Turismo)	F36 (4 Series Gran Coupe)
-----------------------------	---------------------------

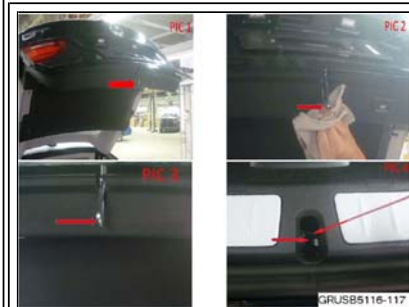
1. Using a soft cloth, remove any build-up of grease or dirt on the tailgate lock and striker mechanism (PIC1 and PIC 2).

2. Lubricate the striker (PIC3) and tailgate lock (PIC4), with specified grease, brushing on where shown.

Clean and lubricate the tailgate lock and striker.
