# Service Campaign Bulletin

Campaign No. 2017020001, August 2017

SUBJECT: **Model 166 and 292, Model Year 2016**  
**Check Expansion Reservoir for Coolant, Replace if Necessary**

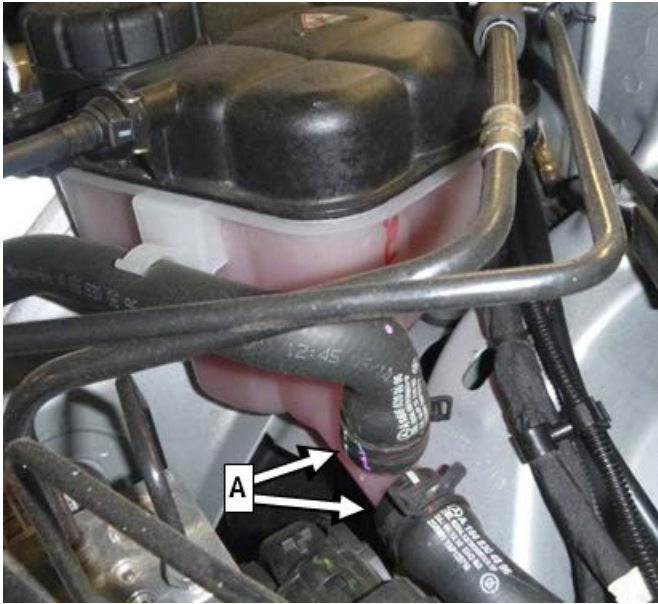
Figure 1

Daimler AG ('DAG'), the manufacturer of Mercedes-Benz vehicles, has determined that in certain MY16 166, 292 (GLE-Class, GLE-Coupe Class) vehicles, the hose for the coolant may not make proper contact with the expansion reservoir. This may result in gradual coolant loss, leading to warning lamp indicators to be displayed in the instrument cluster. An authorized Mercedes-Benz dealership will check the expansion reservoir for coolant, and replace if necessary.

Check lower hose connections (A, figure 1) at coolant expansion reservoir for leaks:
  - If hose connections at coolant expansion reservoir are **not** leaking **(OK)**: Procedure is complete.
  - If hose connections at coolant expansion reservoir **are** leaking **(NOT OK)**: Proceed to

2. Replace expansion reservoir for coolant
