## Creaking noises from ABC suspension strut spring control arm joint

| Topic number | LI32.50-P-063003 |
| Design group | 32.50 Active Body Control (ABC) |
| Validity | Model 222, 217<br>With code 487 ABC |

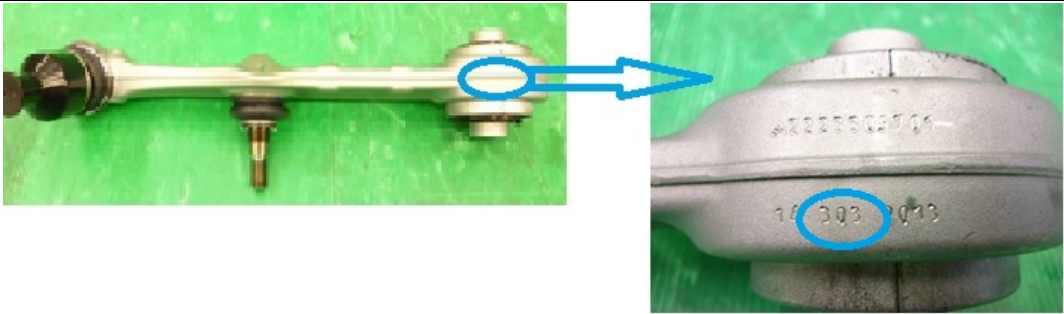
Federlenker links.jpg:

The production date (day stamp) can only be checked on the left spring control arm when installed; the production day stamp is imprinted on the rubber bearing eye.

| Federlenker links.jpg | The left spring control arm can only be checked for the day stamp when installed. The day stamp is on the bottom of the rubber bearing eye. The production day is the middle number; the year is mentioned before it (e.g. XX 303 XXXX) |

Possible lack of lubrication in the 30-mm pedal joint after long runtime, series conversion to optimized 32-mm pedal joint was carried out on June 17, 2014 (production day 168 in 2014).

Replace both spring control arms.
