Noise complaints from backrest locks (2nd seat row)

Topic number	LI91.12-P-064631
Version	2
Function group	91.12 Rear seats
Date	07-20-2017
Validity	117,156,176,246, 242 S205
Reason for change	BR 242 added.
Reason for block

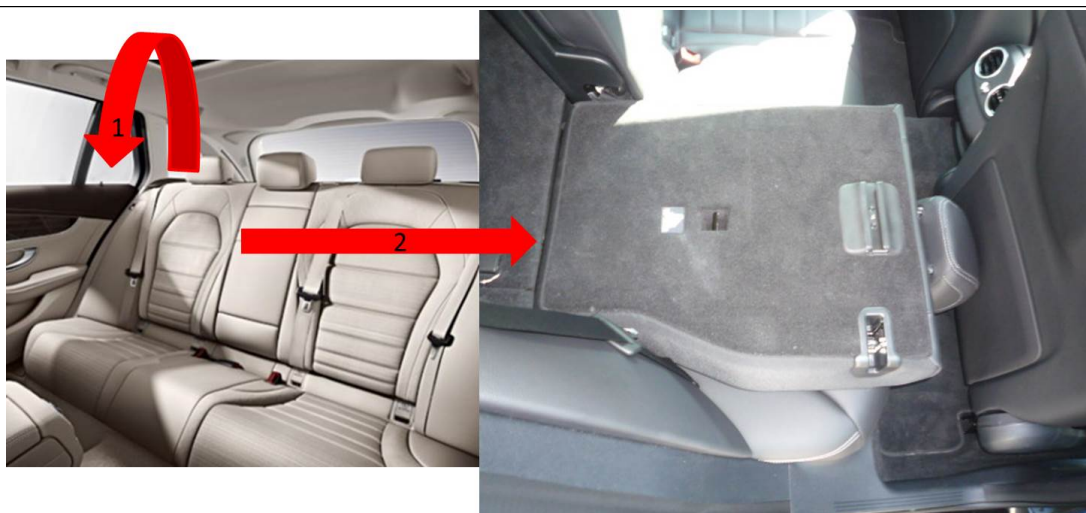
Pic1.jpg:

1. Fold down the rear seat backrest (Pic1).
2. Apply a thin coat of special lubricant to the marked surfaces on the backrest lock using a brush:
 - Lower area of locking unit (Pic2).
 - Upper area of locking unit (Pic3).

Attachments	
File	Description
Pic1.jpg	Fold down rear seat backrest
Pic2.jpg	Application of special lubricant to locking unit of folded rear backrest (brush or pipette)
Pic3.jpg	Application of special lubricant to locking unit of folded rear backrest (brush or pipette)

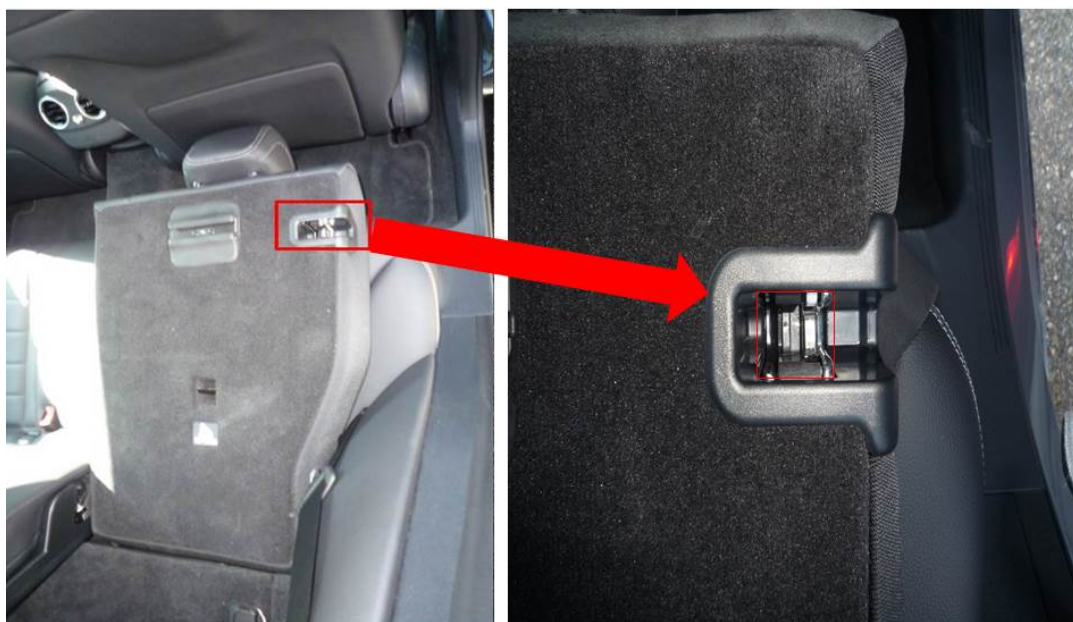
Pic2.jpg:

Material pairing in locking mechanism.

Important: The special lubricant must not be applied to the outer surfaces (danger of staining).
