Bulletin No.: 17-NA-304

# Service Bulletin

**Subject:** Ticking, Rattle and/or Buzzing Noise Heard from inside Passenger Compartment,  
Possible Fuel Leak

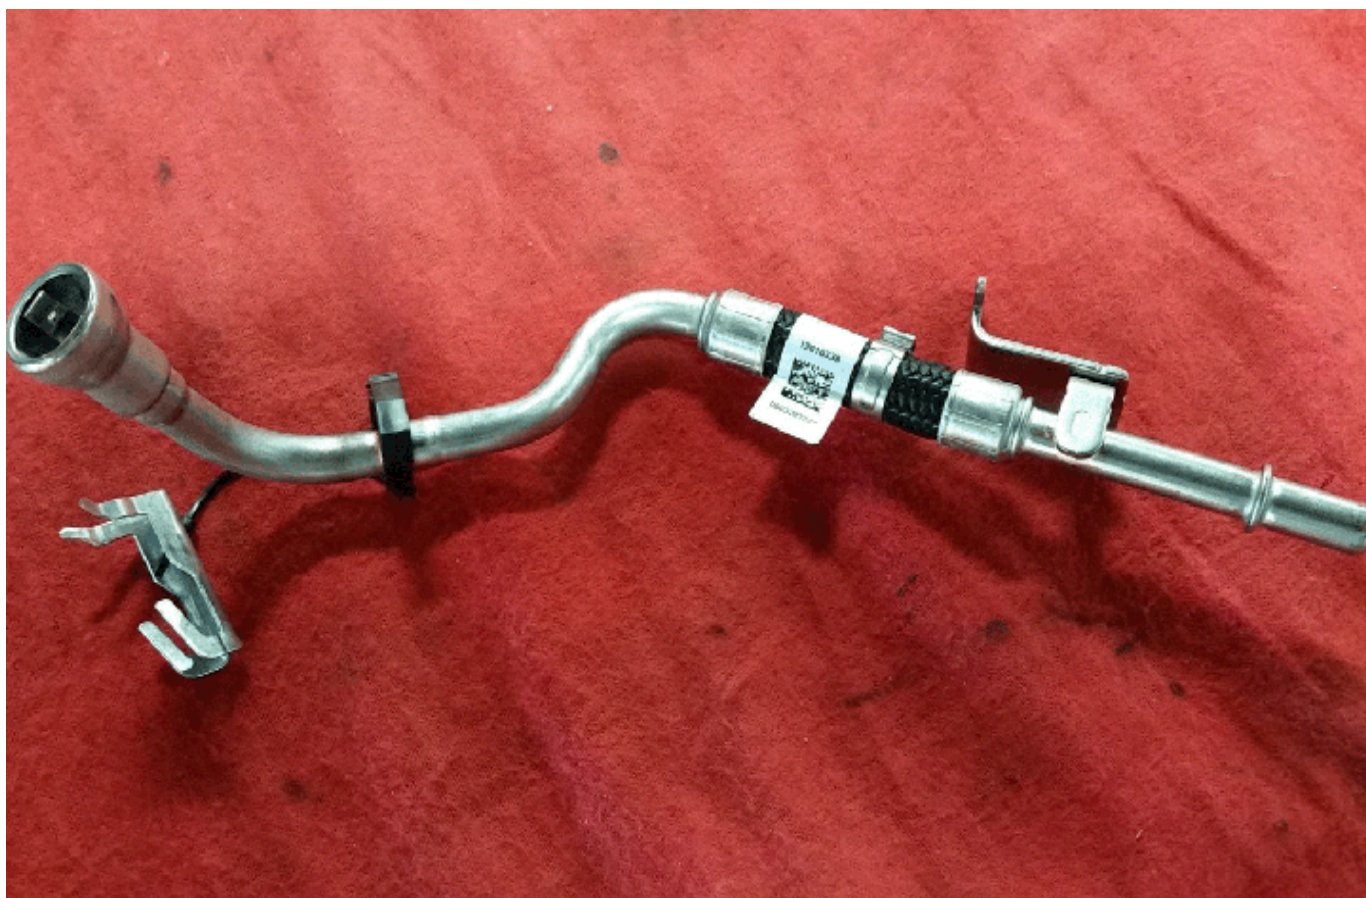
4863828

**Low pressure fuel feed jumper pipe at engine**

Install a new low pressure fuel feed jumper line at the engine, and replace the original design fuel feed line at the tank with the appropriate updated design PN listed in the Parts table, following the procedure below.

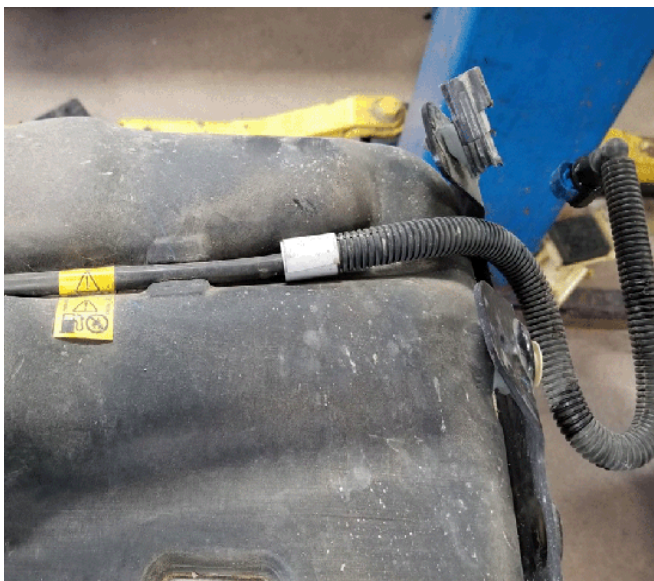
4870639

**Original design fuel feed line at tank**

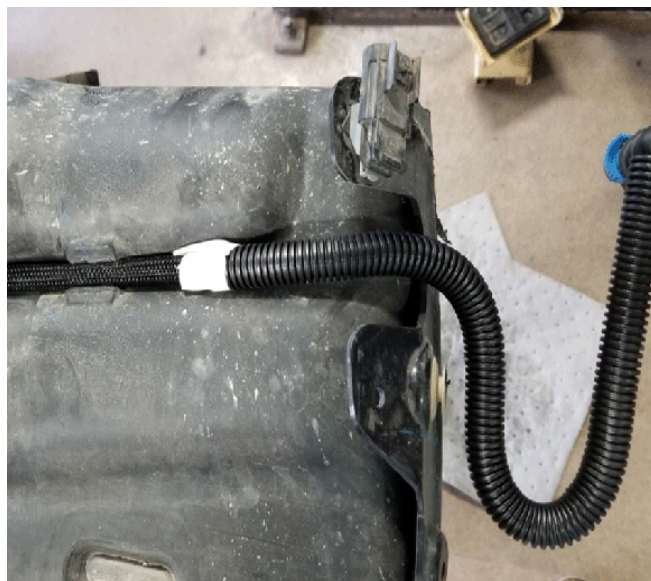
4863840

**Updated design fuel feed line at tank**
