Technical Journal

Protective caps for wheel screws, falling off

REF NO: TJ 32163.1.0	ISSUING DEPARTMENT: Technical Service	CAR MARKET: United States and Canada	
PARTNER: 3 US 7510 Volvo Car USA		ISSUE DATE: 2017-03-21	STATUS DATE: 2017-03-21
FUNC GROUP: 7716	FUNC DESC: wheel nut	Page 1 of 5

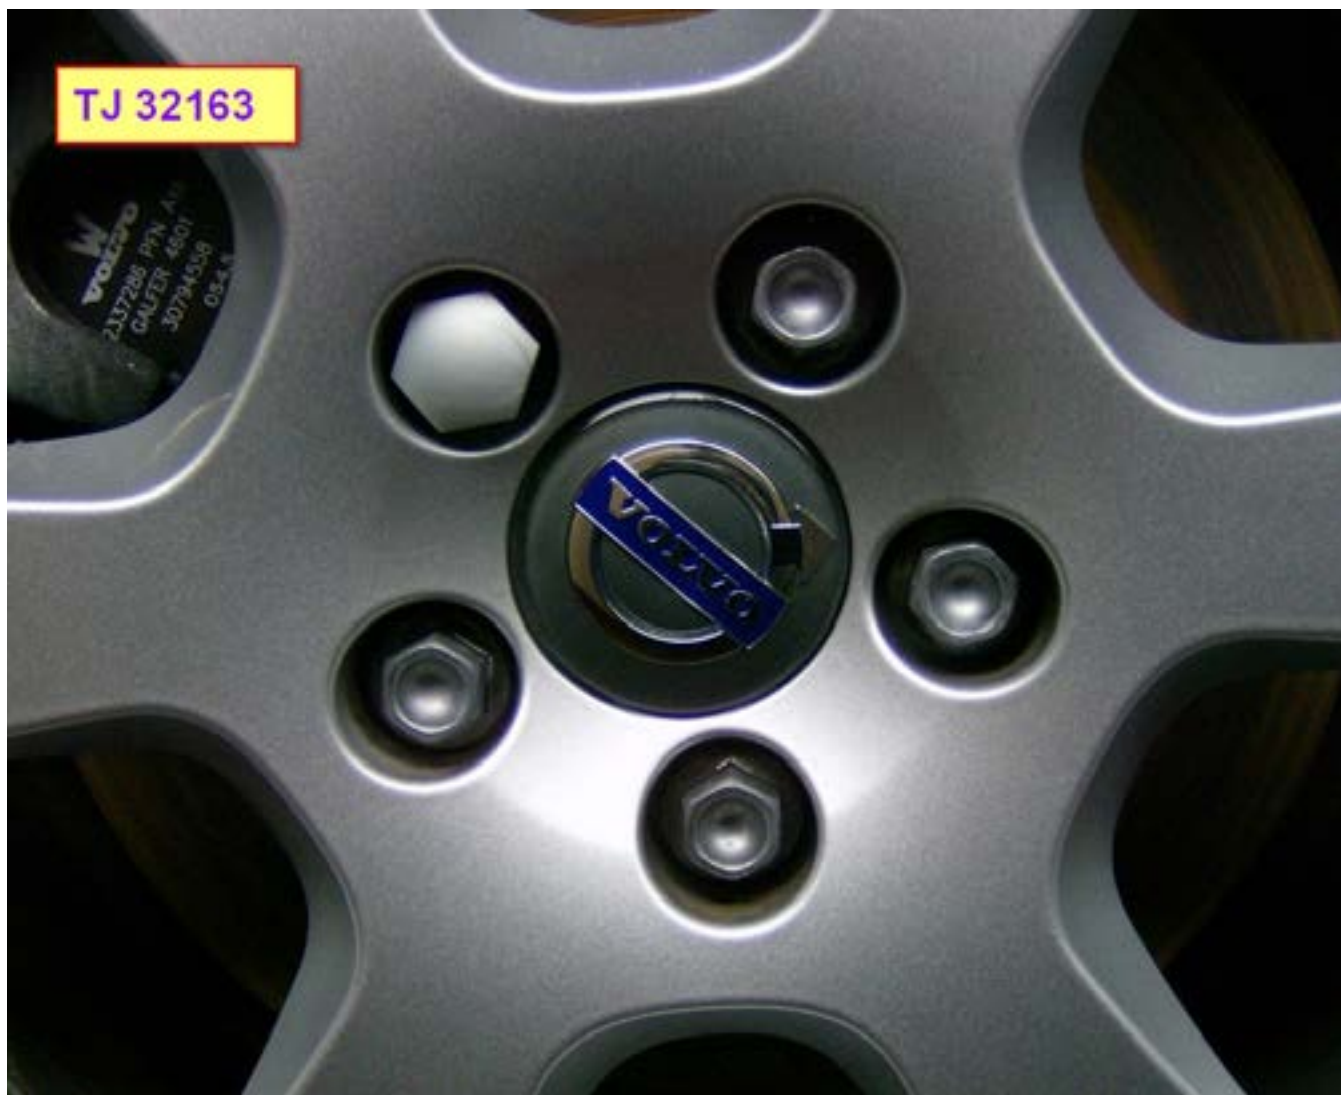
TJ 32163

If protective caps over wheel screws are missing / falling off (refer to example [TJ 32163 - 1.jpg](#)) then follow advice under Service.

If protective caps are missing and the vehicle is within the chassis number range in TJ header, then remove all remaining caps and install new protective caps on all wheel screws.

Note: Also replace the protective caps for the 4 lockable wheel screws if car is equipped with this accessory.

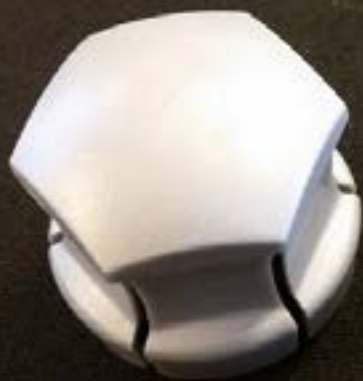
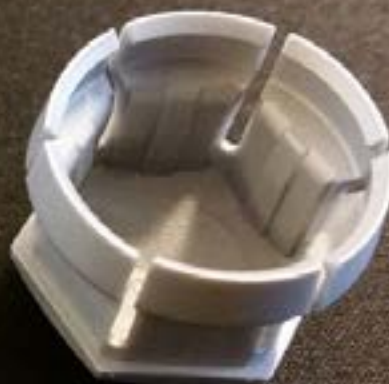
TJ 32163

New protective caps in silver and dark grey colors has been introduced from 2017 week 09 that are snapped on over the wheel screw flange, see [TJ 32163 - 2.jpg](#)

Silver (VDN code 6F03): kit 20 pcs P/N 31660917, kit 4 pcs for lockable screw P/N 31650000

Dark grey (VDN code 6F01): kit 20 pcs P/N 31660916, kit 4 pcs for lockable screw P/N 31650002
