P5-XC90 Front license plate screws

REF NO: TJ 31218.1.2	ISSUING DEPARTMENT: Technical Service	CAR MARKET: United States and Canada	
PARTNER: 3 US 7510 Volvo Car USA		ISSUE DATE: 2017-01-24	STATUS DATE: 2017-01-30
FUNC GROUP: 8611	FUNC DESC: Bumper, front	Page 1 of 3

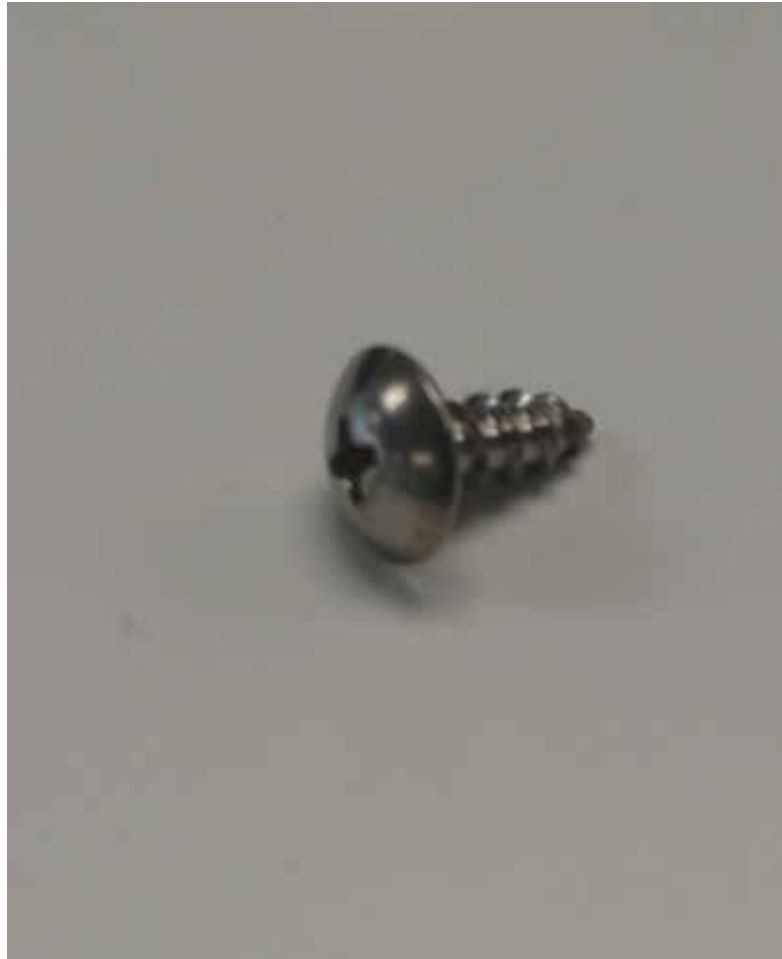
File Name	File Size
Wurth 02151012.jpg	2.4353 MB

A new front license plate frame was introduced on MY16 XC90 2015w45. The H frame P/N (part number) 31391625 is no longer needed.

Install front license plate using four (4) Wurth screws P/N 02151012. (For claiming use P/N 2151012)

*Canadian market use Wurth screw P/N 119.48.13
