Technical Journal

Leather dashboard, leather comes loose

REF NO: TJ 29012.5.0	ISSUING DEPARTMENT: Technical Service	CAR MARKET: United States and Canada		
3 US 7	PARTNER: '510 Volvo Car USA	ISSUE DATE: 2017-02-15	STATUS DATE: 2017-02-28	
FUNC GROUP: 8811	FUNC DESC: Instrument panel	Page	1 of 3

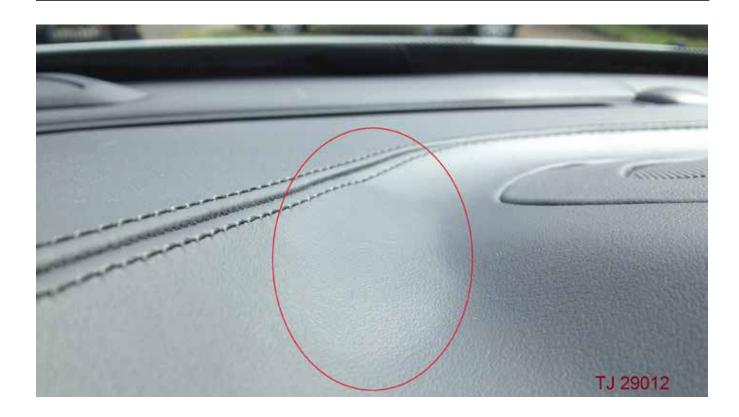
File Name	File Size
Leather dashboard.jpg	1.2691 MB

Leather on dashboard may come loose on small areas.

The amount of glue used for fastening the leather has been increased and finetuned. Process has been optimized and more measurements introduced.

In case of customer complaints regarding leather coming loose from the dashboard, complete dashboard must be replaced.
