Service Action S89807: Exterior door handle tape

REF NO: TJ 32183.1.2	ISSUING DEPARTMENT: Technical Service	CAR MARKET: United States and Canada	
PARTNER: 3 US 7510 Volvo Car USA		ISSUE DATE: 2017-01-11	STATUS DATE: 2017-01-18
FUNC GROUP: 8300	FUNC DESC: Doors, lids and convertible top	Page 1 of 8

QB Instruction VCC-496312-1

Title	Exterior Door Handle	Page	1 (5)
Action	Adjustment	Operation number:	97173-2

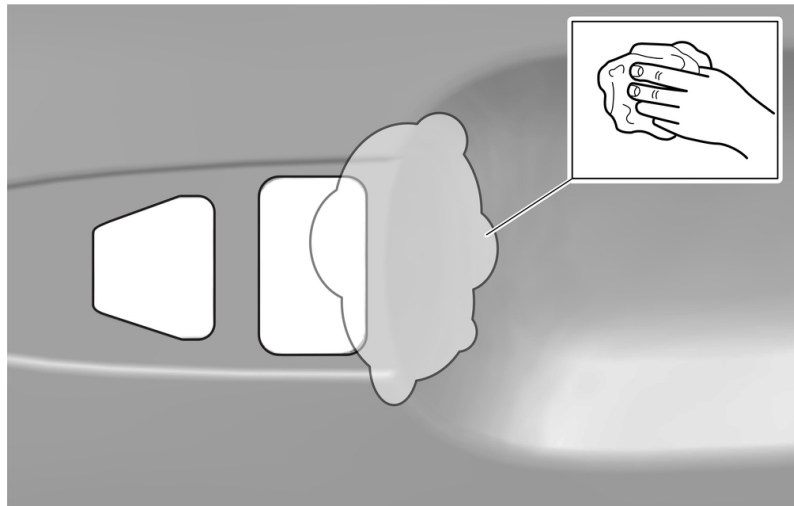
Use: Cleaning agent

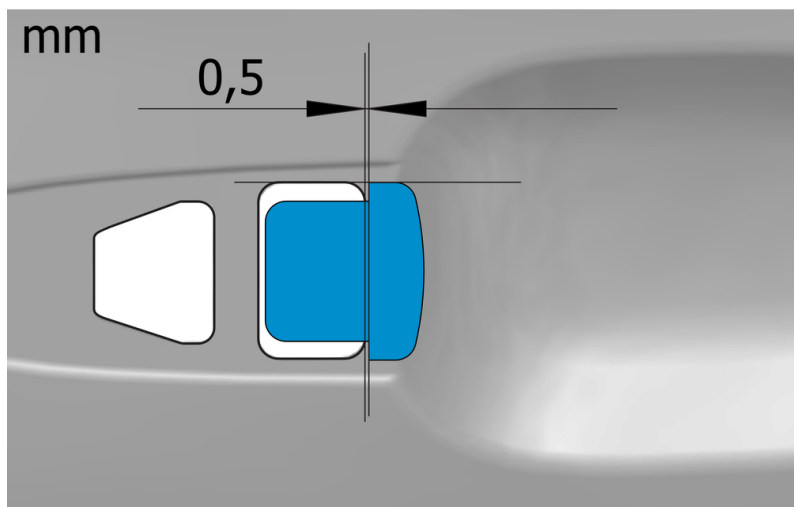
On both sides.

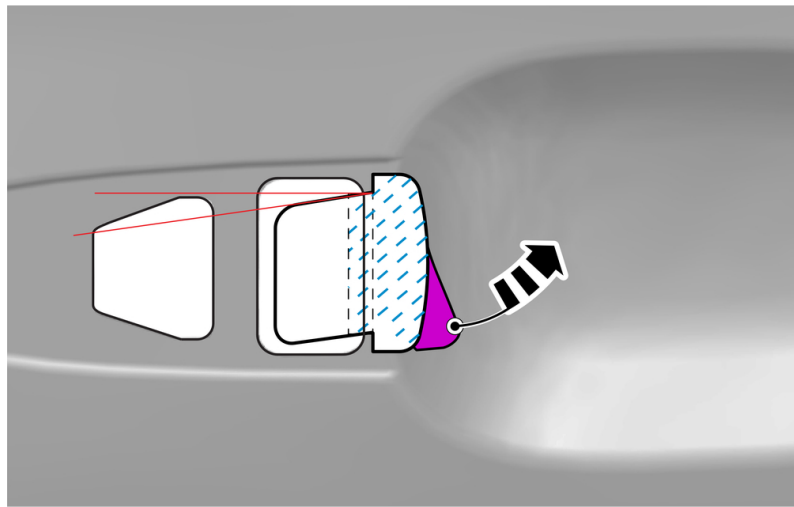
Press the marked component.

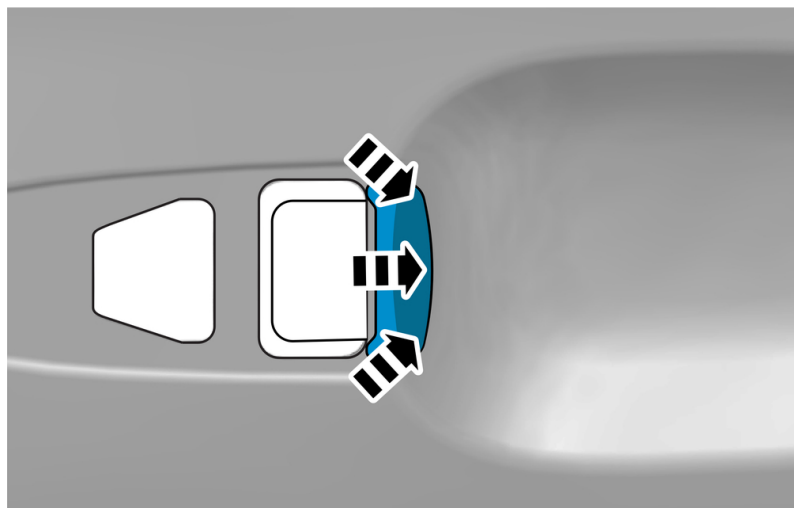
Press the marked component.

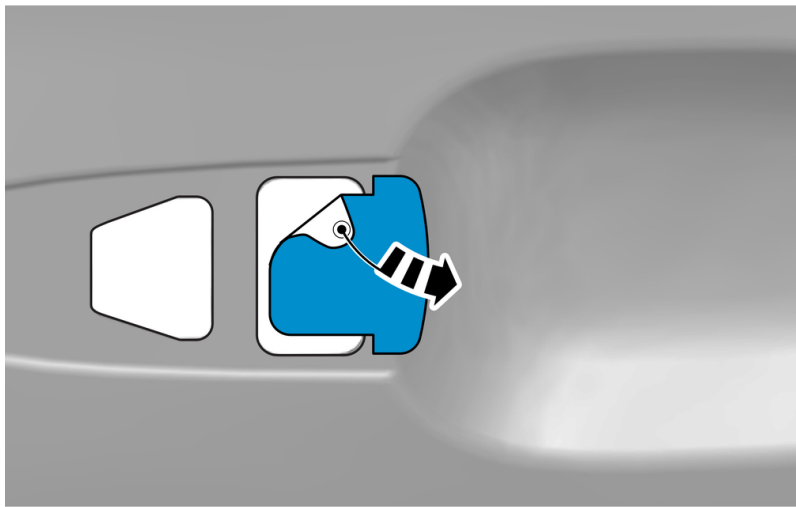
Remove the marked part.

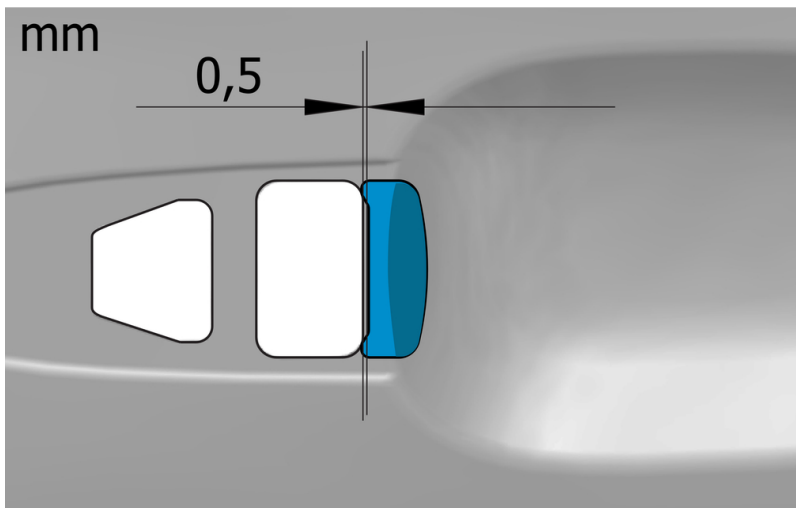
Check the value.
