## Campaign Update CA#8641

Subject: 15 Amp Fuse instead of 30 Amp Fuse  
Affects certain 2017 Unity models

# QAAR 8641 400W Solar Panel Fuse replacement.

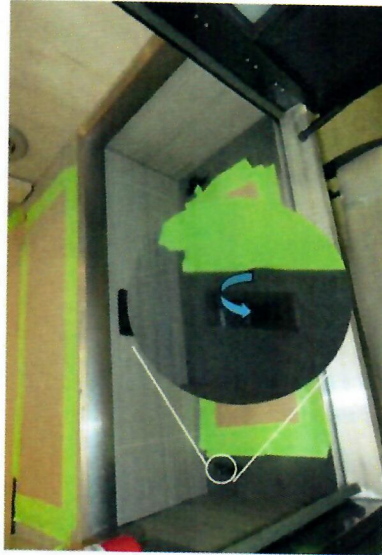
1

At entrance  
step flip up grip  
tabs

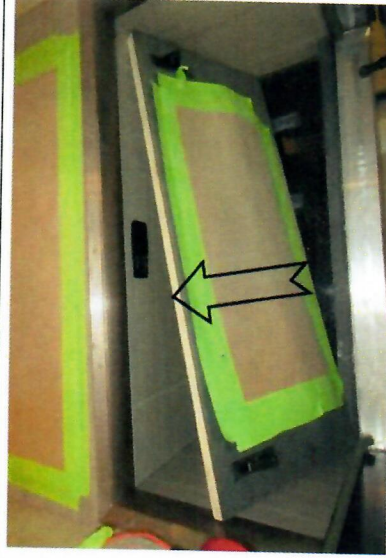
2

Pull up on tabs  
and rotate step  
base to fit  
crosswise in  
step well. Pull  
straight up.

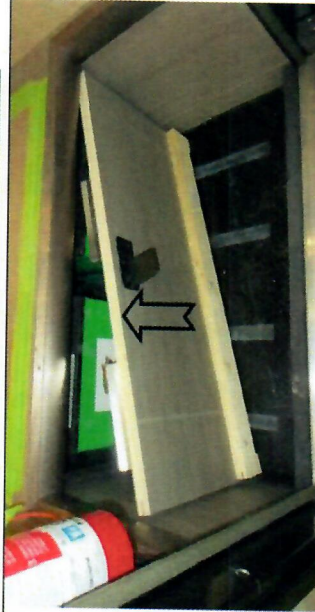
3

Open battery compartment latch and shift door so it fits crosswise in step well lift door upwards.

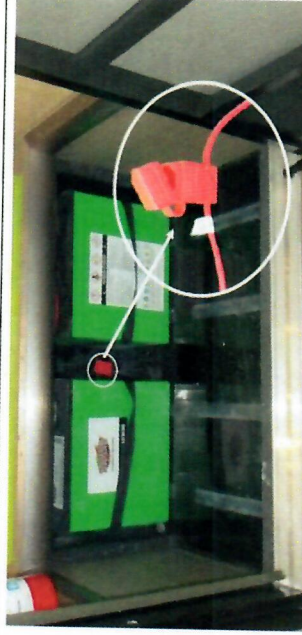
4

The red fuse mounted at the back of the compartment between the batteries must hold a 30 amp fuse for the 400W option.  
Replace as needed and remove the 15amp sticker
