## Campaign Update CA#8674

Subject: Pantry Door Hinge  
Affects certain 2017 Wonder models

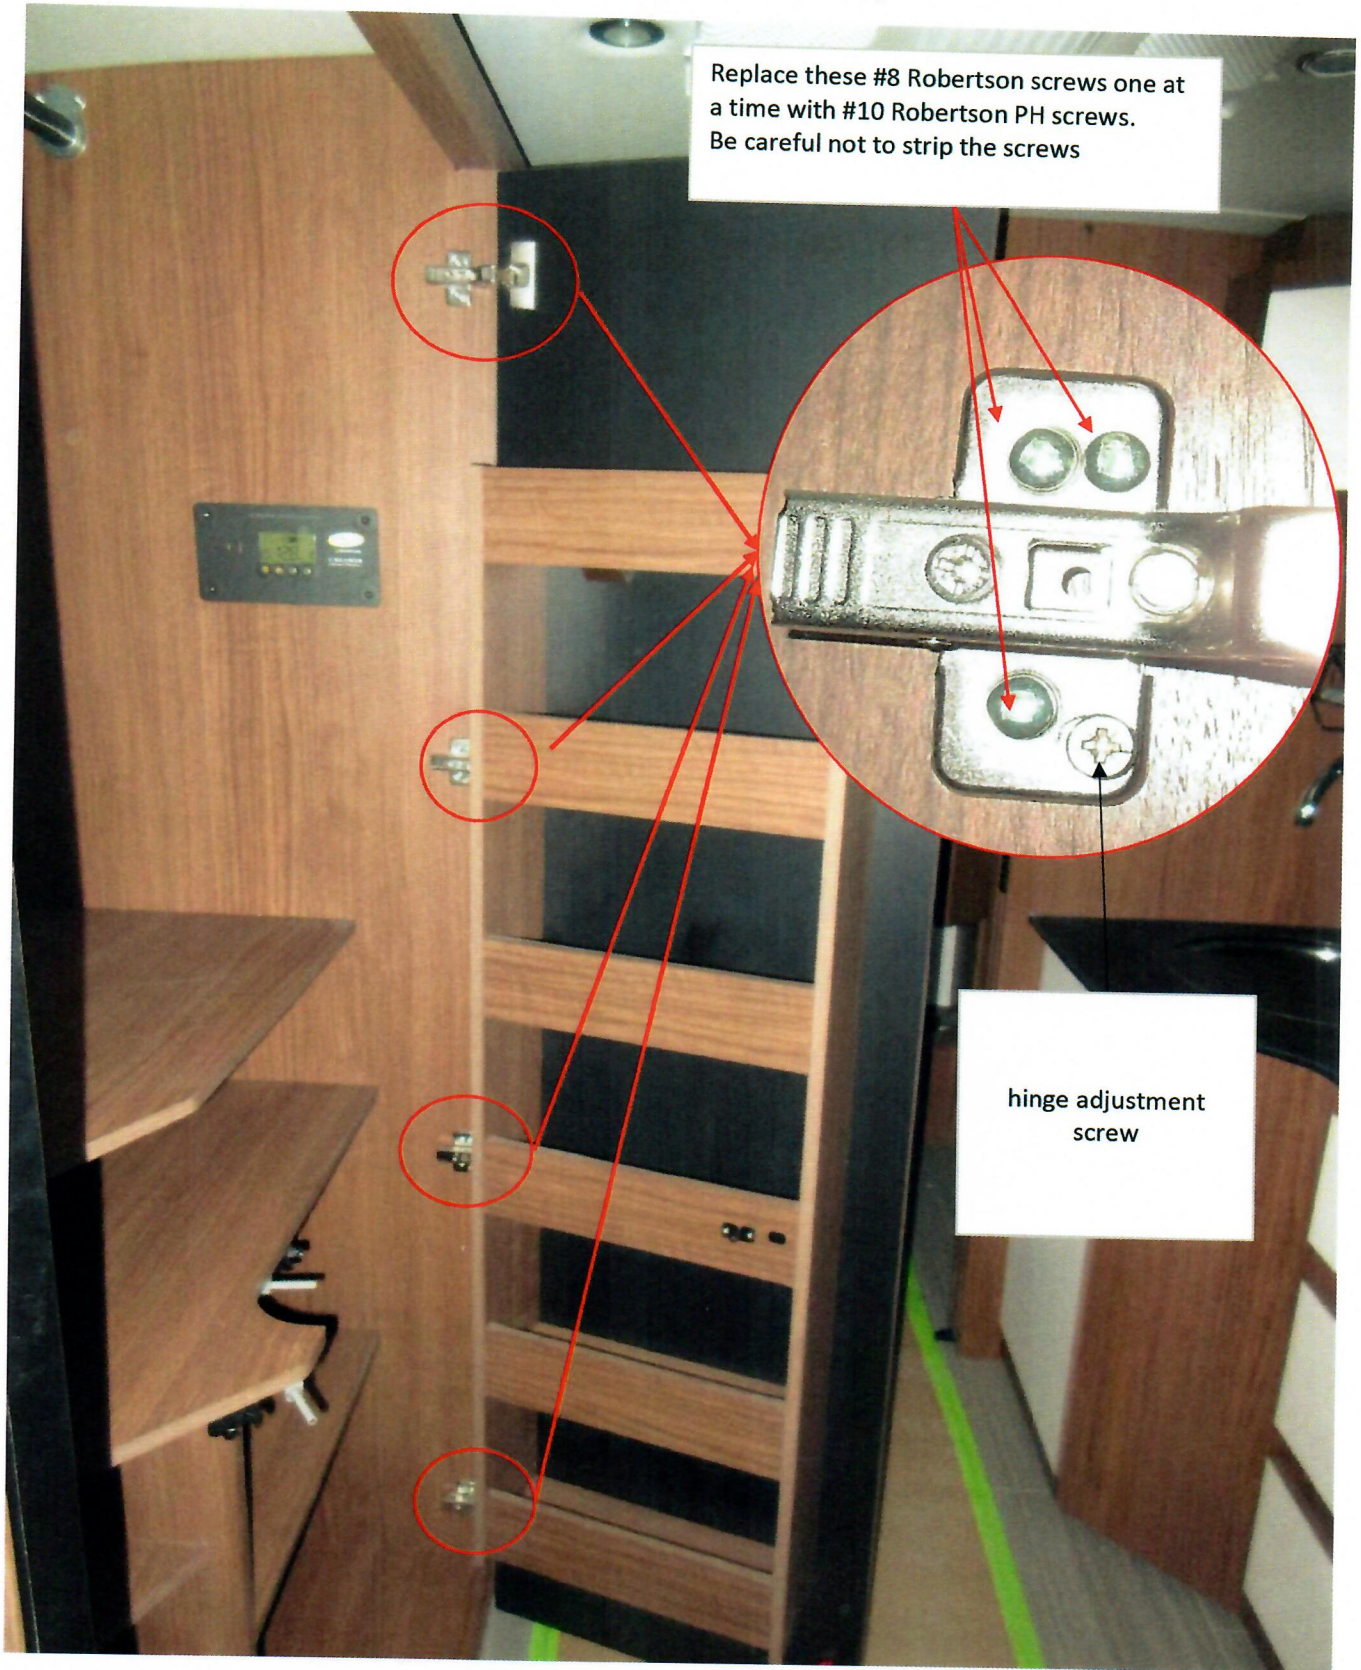
Our in-house inspections have confirmed the screws installed on the pantry door hinge may fail when significant weight of tins and common grocery items are placed on the shelves.

Replace these #8 Robertson screws one at a time with #10 Robertson PH screws. Be careful not to strip the screws

hinge adjustment  
screw

To correct this situation, please follow the enclosed instructions to install 12 - #10 screws included in this mailing.
