# Team Tips

ARTICLE: I-17-01-01

**SUBJECT: Indian Scout – Transmission Service Parts Information****MODELS: 2015-2016 Indian Scout 1200 Models****NOTE: Scout Sixty models are not affected by this change.**

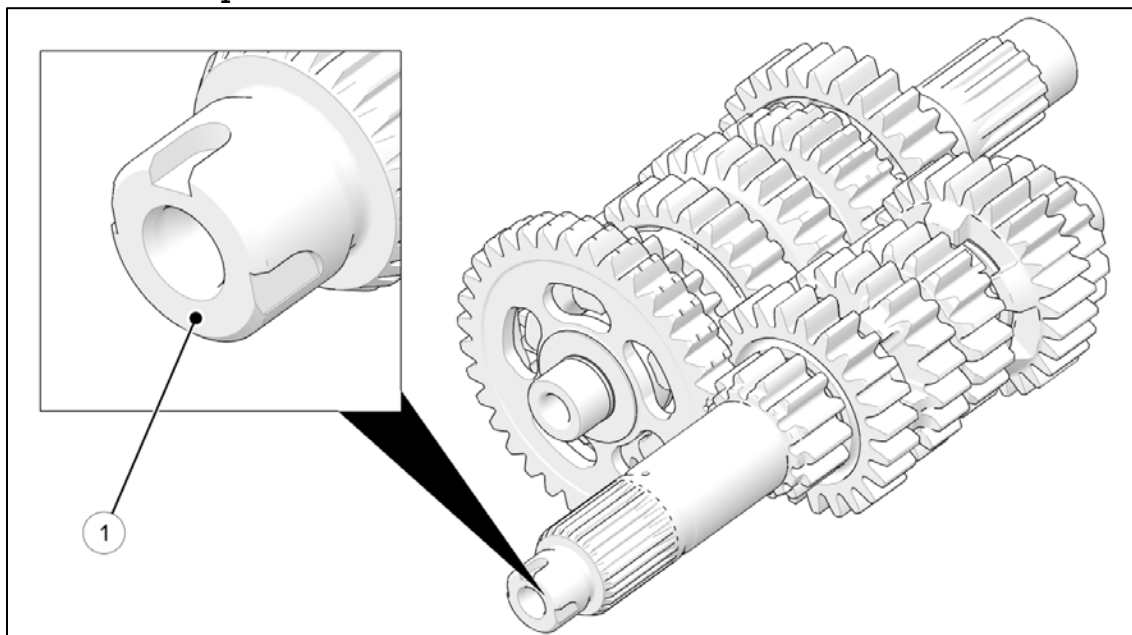
**TRANSMISSION IDENTIFICATION:** The end of the new output shaft assembly has a stamped “Dot” ① as shown below. The “Dot” indicates components of transmission can be replaced and kit replacement is not required.

**PARTS INFORMATION:** Indian Motorcycle is no longer able to offer individual transmission components as service parts for 2015 - 2016 Indian Scout 1200 motorcycles. In the event that any transmission parts require replacement, they will now be sold as a Service Kit ONLY. Affected service parts from the original transmission will automatically supersede to the new transmission kit (PN: 2206256)
