PREVOST

WARRANTY BULLETIN

WB16-02D

DATE :	MAY 2016	SECTION :	06 - Electrical
EXPIRATION:	MAY 2018		
SUBJECT :	CHARGING SYSTEM IMPROVEMENT

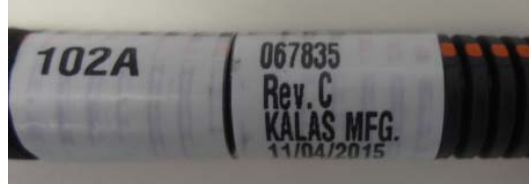
FIGURE 5

Rev.C lug terminal through hole dia.= 5/16" **CORRECT**

Rev.B lug terminal through hole dia.= 13/32" **INCORRECT**

Rev.B diameter of the through hole is too large, reducing contact surface with the stud and the nut thus reducing electrical conductivity between the lug and the alternator stud (FIGURE 7).

6. Reinstall the jumper cable **#067835 revision C** included in kit #7770176 (FIGURE 5, FIGURE 6).

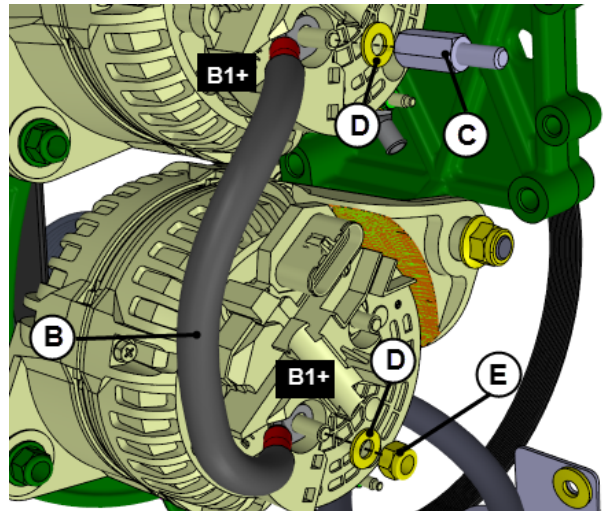
FIGURE 8

B : JUMPER CABLE #067835 revision C

C : STUD ADAPTER #060297 torque: 10 lbf-ft

D: FLAT WASHER #5001341

E: NUT M8 #5001787 torque: 10 lbf-ft

REVISION D: THIS WARRANTY BULLETIN SUPERSEDES PREVIOUS VERSION.
 Released: Jan.2017 Stud adapter #564590 canceled. New improved stud adapter is #060297. Stud adapter and M8 nut torque was 10 lbf-ft, increased to 11 lbf-ft.

7. Reinstall appropriate jumper cable **B** (i.e. rev.C) with appropriate stud adapter. Refer to FIGURE 8.

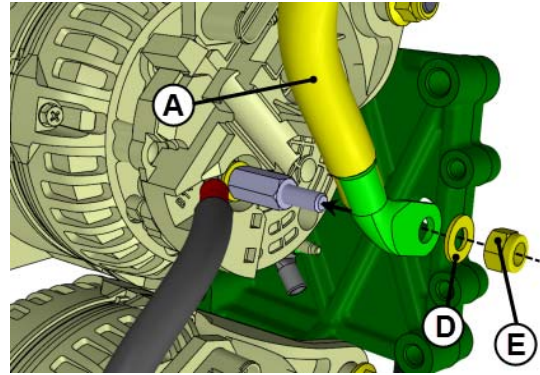
FIGURE 9

A : POWER CABLE

D: FLAT WASHER #5001341

E: NUT M8 #5001787 *torque: 10 lbf-ft*

-
8. Reinstall power cable **A**. To do so, connect power cable **A** to the upper alternator **B1+** stud terminal. Refer to **FIGURE 9**.

-
9. **Protect the alternator studs against corrosion.** Apply anti-corrosion compound or **Color Guard Rubber Coating** on alternator terminals, cable lugs and nuts.
-

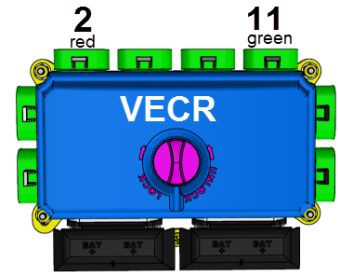
FIGURE 10 : VECR

1. Inside rear electrical compartment (rear junction box), locate VECR module (FIGURE 10).

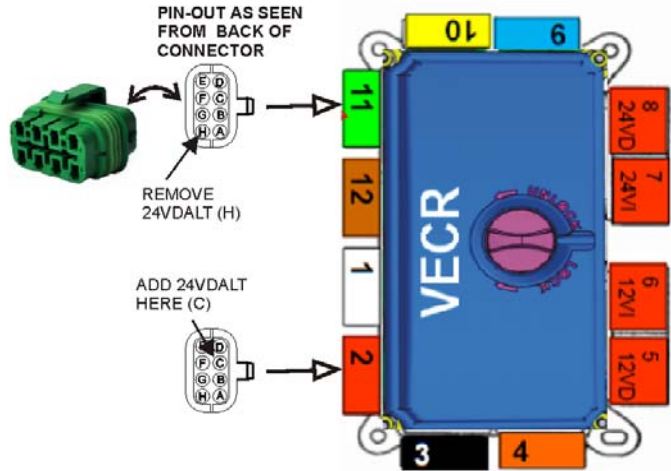
FIGURE 14

Cut and discard existing terminal. Extend wire 24VDALT by doing **one** soldered joint. Use the included piece of heat shrinking sleeve to protect the soldered joint. Crimp the terminal included with the kit to the end of wire and the seal (see FIGURE 15).

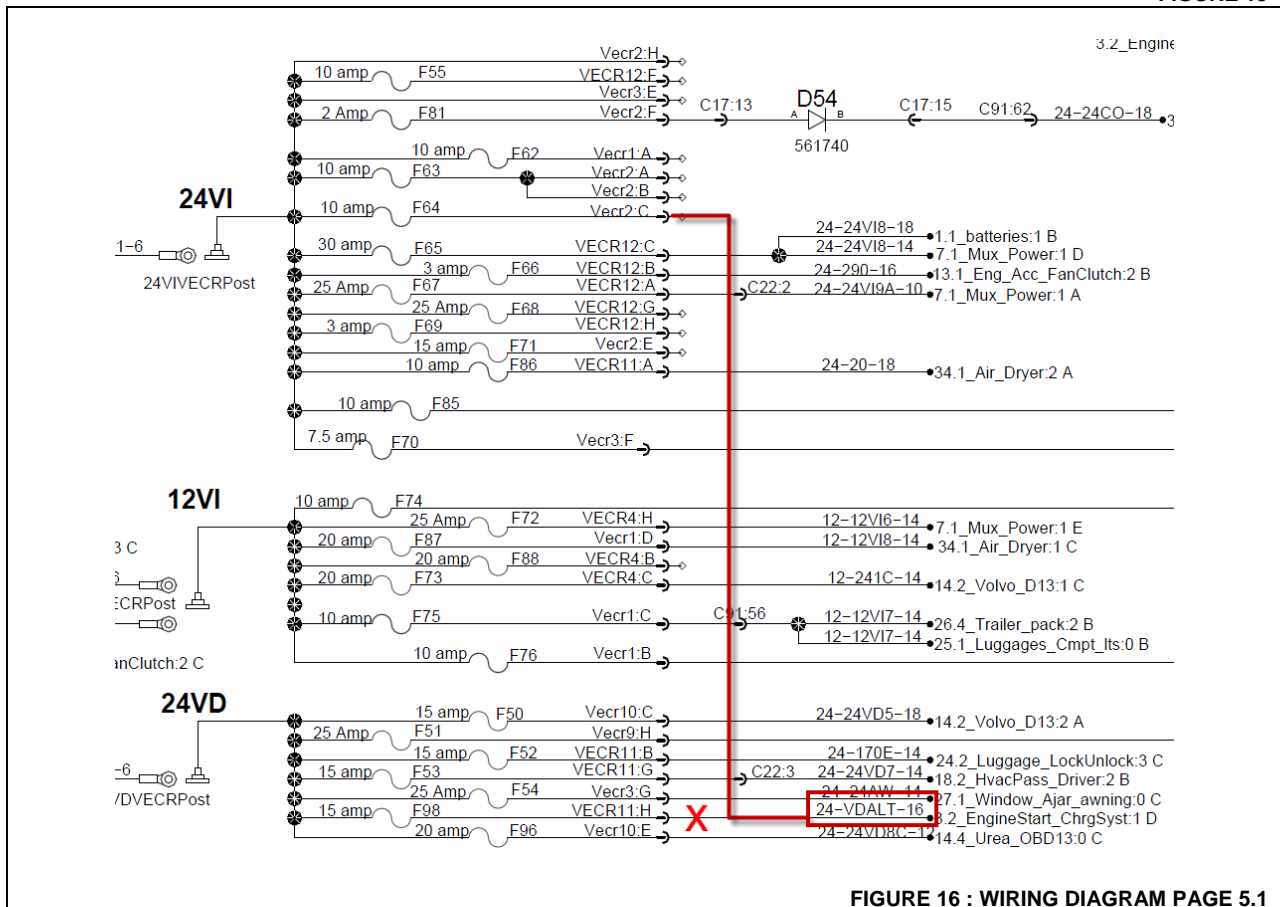
FIGURE 16 : WIRING DIAGRAM PAGE 5.1

Cavity **C** of connector no.2 should be available. This branch of the circuit will be protected by 10A fuse F64 (see FIGURE 16 below).

Should cavity C not be available, refer to your vehicle wiring diagram page 5.1 to select another free cavity protected by a 10A or 15A fuse (see FIGURE 16 for reference).

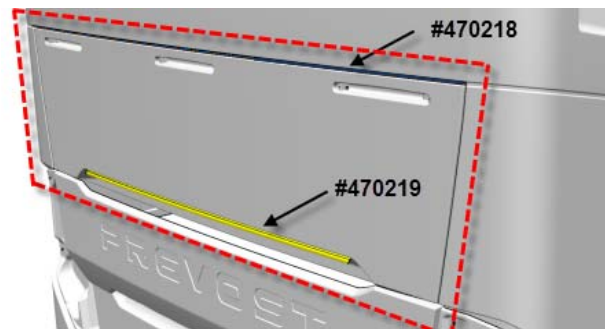
2. Clean dirt on the lower part of the **exhaust aftertreatment system ATS** access hatch as well as the area located right above the ATS access hatch (FIGURE 20). It is very important to install the drip edge on a clean surface to assure water tightness.

NOTE: FIGURE 20 shows where the drip edges will be installed.

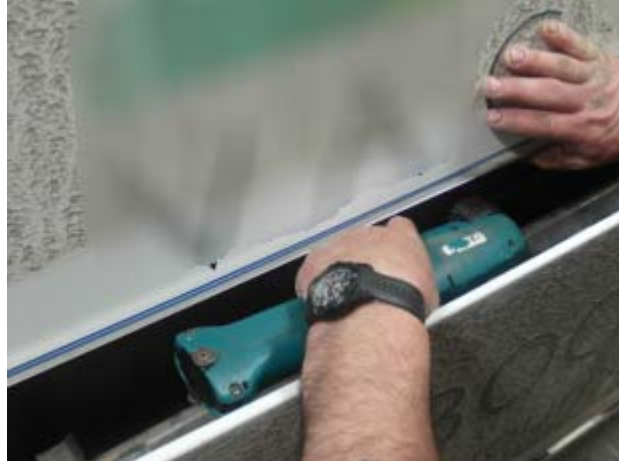
Drill using a 9/64 bit. FIGURE 34 shows how to drill holes with the access hatch in place using a right angle drill.

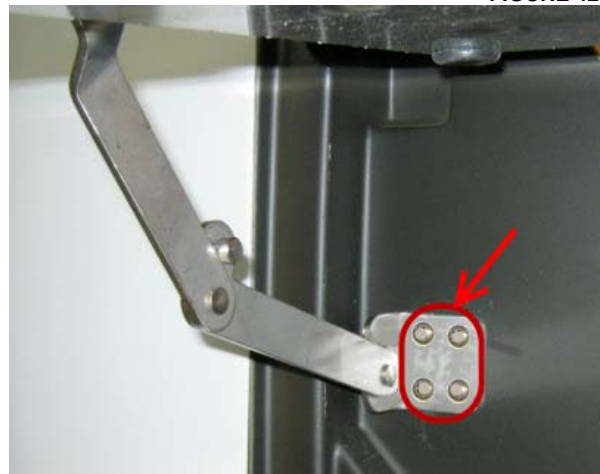
- a) To do so, drill through the folding arm rivets (4 rivets) shown on FIGURE 43
- b) Disconnect the “high mounted stop lights” cable harness.
- c) Unscrew the hinges mounting bolts (2 bolts per hinge). Spacers may be found behind the hinges. Make sure you identify the spacers in order to reinstall the access hatch using the proper spacer at the correct location (FIGURE 44).

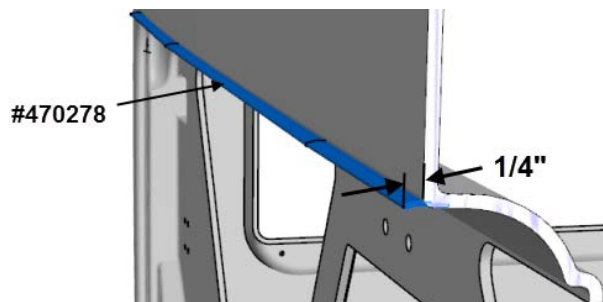
FIGURE 48

The drip edge should extend past the panel surface by **1/4"**. The goal is to prevent water/rain from dripping on the inner side of the SCR access hatch.

9. Place drip edge #470278 in proper position. Use reference lines marked on the drip edge and vehicle body to center properly.

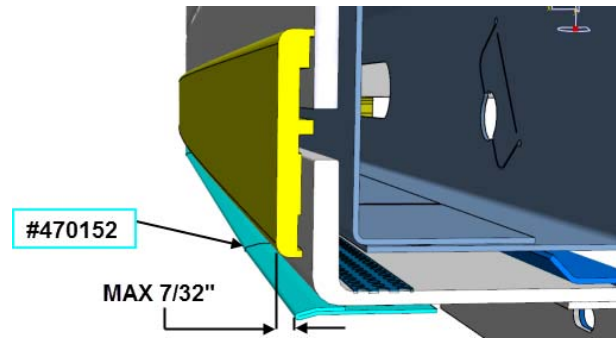
FIGURE 52

The drip edge should be shifted not more than 7/32" from the surface of the molding located above it (FIGURE 52). The goal is to prevent water from dripping on the inner side of the engine compartment door.

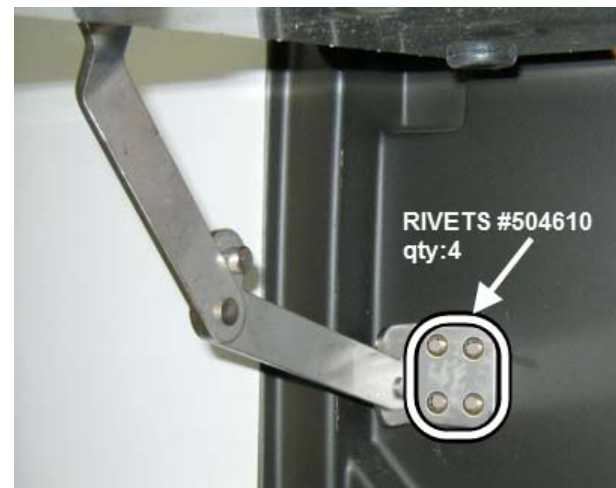
17. Reinstall the folding arm. Secure the folding arm as shown on FIGURE 54 using four 1/4" x 5/8 stainless steel rivets #504610.
