ONRD – 0003302017 - 0014  
**TECHNICAL SERVICE BULLETIN**

**Title:** Reyco Granning Suspension Safety Recall

**Problem:** Potential Improper Securement of Central Steering Ball Joints Recall No. 17E013

| <b>SUBJECT</b> | IFS BALL JOINTS – RECALL NHTSA ID: 17E013 |

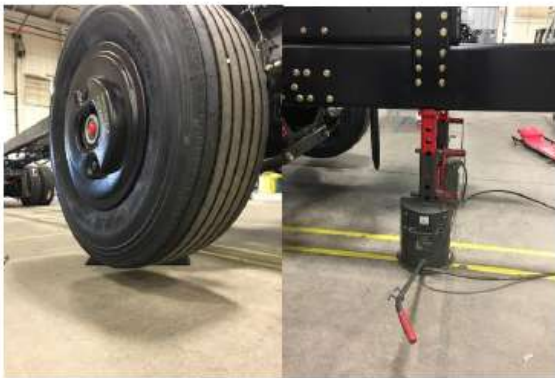
| Step | Instruction | Illustration |
|---|---|---|
| 1 | Safely lift vehicle until the wheels are off the ground. Properly support vehicle with 10t to 12t jack stands. | |

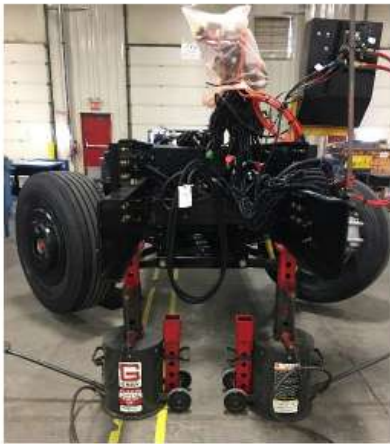
| Step | Instruction | Illustration |
|---|---|---|
| 2 | Steer wheels all the way to the left | |

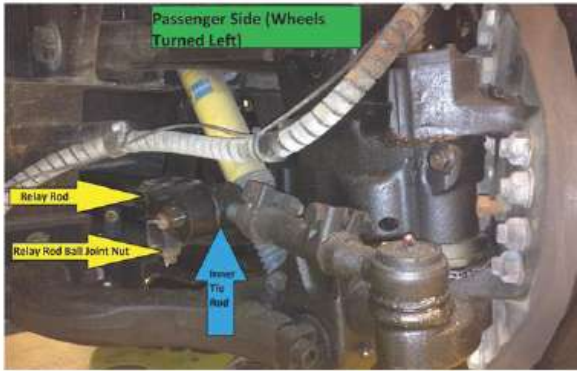
| Step | Instruction | Illustration |
|---|---|---|
| 3 | Starting on the right hand side (passenger), remove cotter pin and castle nut from tie rod end that is connected to the relay rod. | |

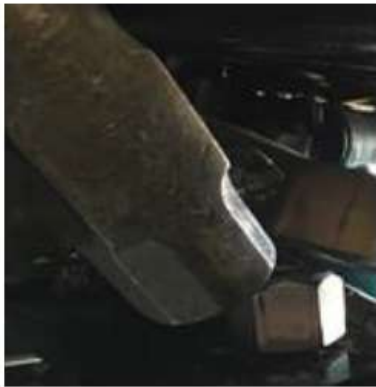
| 4 | Place sacrificial 7/8"-14 nut on rod end stud and strike with hammer to un-seat tapered connection. | |

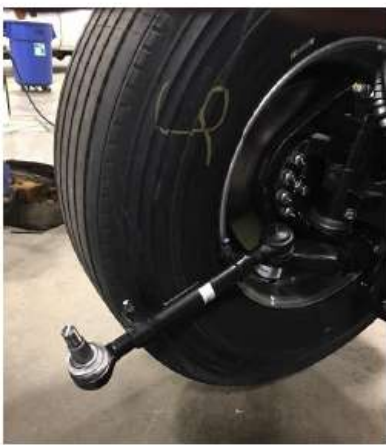
| 5 | Remove tie rod end from relay rod assembly and position tie rod against wheel | |

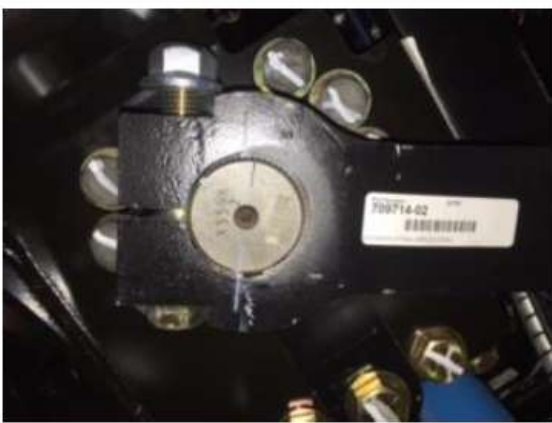
| 6 | Mark the pitman arm to steering box output shaft as shown, to ensure correct alignment when re-assembling. Remove pinch bolt nut from right pitman arm (leaving pinch bolt in pitman arm to prevent pitman arm from falling from steering box output shaft) | |

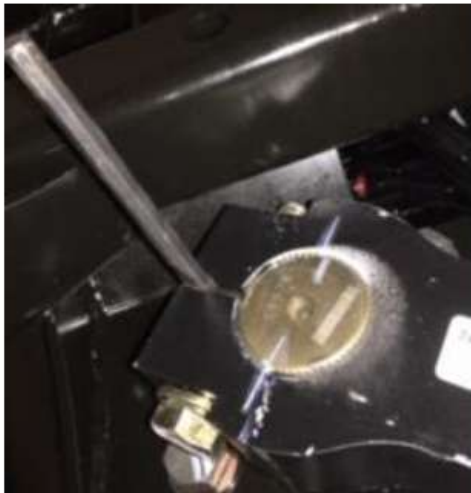
| 7 | Using small chisel, spread pitman arm end | |

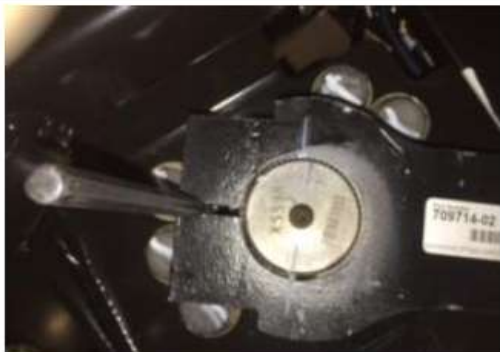
| 8 | Remove pinch bolt from pitman arm | |

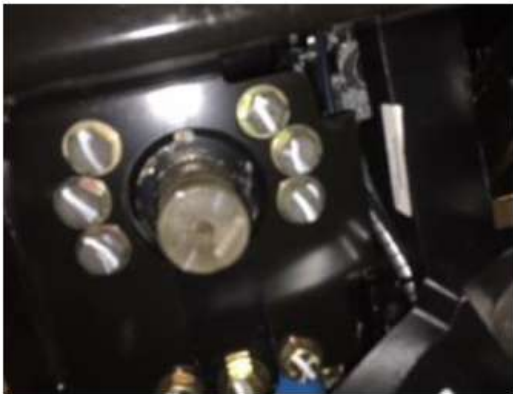
| 9 | Lower pitman arm and position pitman arm to where it's parallel with the relay rod | |

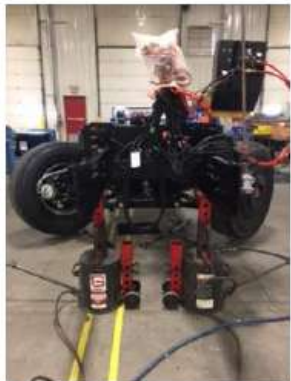
| 10 | Steer wheels all the way to the right and switch sides | |

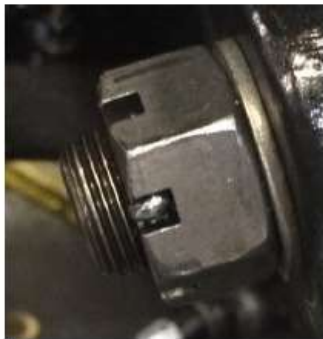
| 12 | Remove the cotter pin from the ball joint stud.<br><br>Remove the castle nut from the ball joint stud, and retain for re-install.<br><br><b><i>Ensure that all washers found under castle nuts are re-installed in their original position</i></b> | |

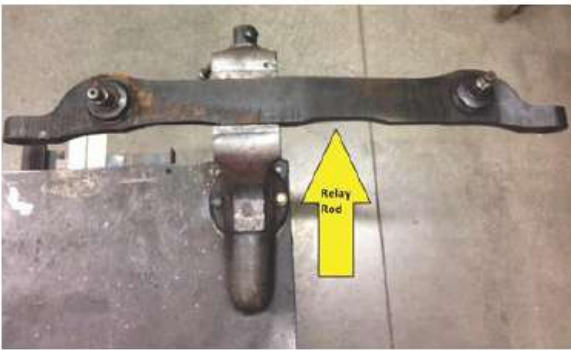
| 13 | Place relay rod assembly in vice as shown.<br><br>Remove pitman arms from the ball joints, using sacrificial nuts. | |

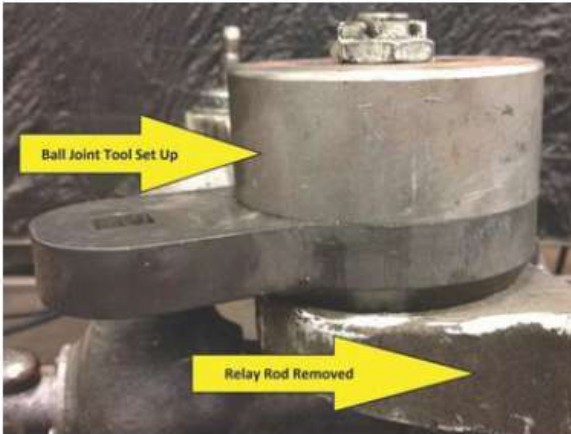
| 14 | <p>Using 50 mm ball joint tool and castle nut, place over ball joint (Use caution do not tear boot)</p> <p>Run castle nut down, leaving castle nut slightly loose ("DO NOT RUN DOWN TIGHT")</p> <p>Note: Tool 708116-03 is used with castle nut to hold tool 708116-06 loosely on the ball joints. Be sure that tooling set up is not binding when loosening, castle nut should come off freely after ball joint is loose.</p> | |

3. Improperly torquing the castle nut when using the ball joint tools (This can result in improper torque application.)
  - a. For removal, nut should be tightened until tool is almost seated, with no gaps above or below

- i. Nut should never be more than hand tight.
  - b. For installation, run the ball joint down until the flange touches, then put the ball joint tool in place.

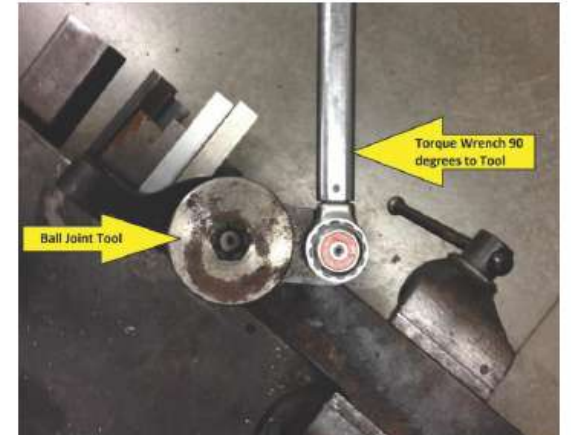
| 15 | <p>Using torque wrench (Set at 500 ft.lb) place in ball joint tool and apply 500 ft.lb of breakaway torque to the ball joint.</p> <p>Repeat this for the other ball joint.</p> | |

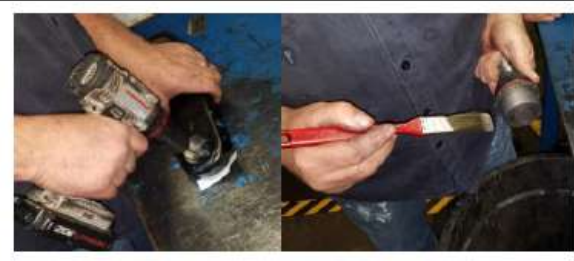
| 16 | <p>If ball joint moves (Breaks loose) before reaching required torque (500 lbf-ft), remove ball joint from pitman arm and clean external thread on ball joint and internal thread on pitman arm using a wire wheel. Clean threads with denatured alcohol.</p> | |

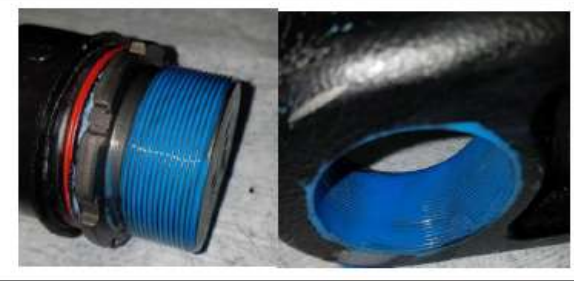
| 17 | <p>Ensure threads are clean and dry.</p> <p>Ensure that the Loctite242 is not expired.</p> <p>Using Loctite, 242 apply generously to the external threads of both ball joints and internal threads of the relay rod.</p> <p>(Ensure that all threads are covered)</p> | |

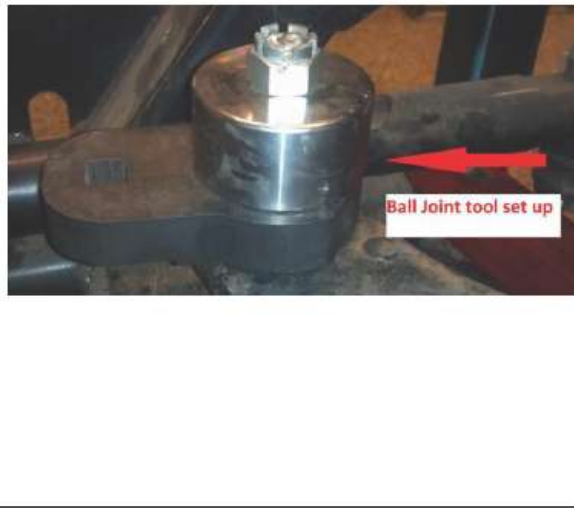
| 18 | <p>Install ball joint with Loctite 242 applied, into the relay rod. Screw in by hand, until properly seated.</p> <p>Using 50 mm ball joint tool and castle nut, placed over ball joint (Use caution do not tear boot), torque the ball joint to 325-375 lbf-ft. Be sure that tooling set up is not binding when tightening.</p> <p>Castle nut should come off freely after ball joint is torqued.</p> <p>Ensure that the ball joint is fully seated into the relay rod.</p> <p>Repeat for opposite side.</p> | |
