**MODEL:** Karma Revero

**TITLE:** Driver seat harness inspection

**PURPOSE:** This document will be used as a reference guide to inspect the driver seat under seat harness for proper installation

**CC-17-86-09**

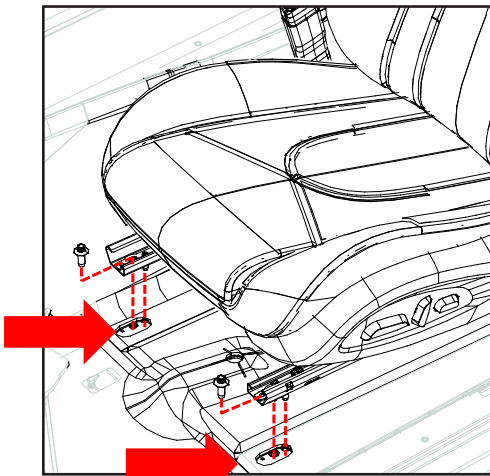
fig. 1a

1) Loosen the front and rear driver seat mounts, install torque  $50\text{Nm} \pm 5.0\text{ Nm}$  (fig. 1a, 1b) apply thread-locker to the bolts (such as Loctite 242 or equivalent fig.1c).
