Technical Journal

Keyless Drive receiver issues (short remote control range, key messages)

REF NO: TJ 27316.7.1	ISSUING DEPARTMENT: Technical Service	CAR MARKET: United States and Canada	
PARTNER: 3 US 7510 Volvo Car USA		ISSUE DATE: 2017-08-21	STATUS DATE: 2017-08-29
FUNC GROUP: 3669	FUNC DESC: Miscellaneous	Page 1 of 6

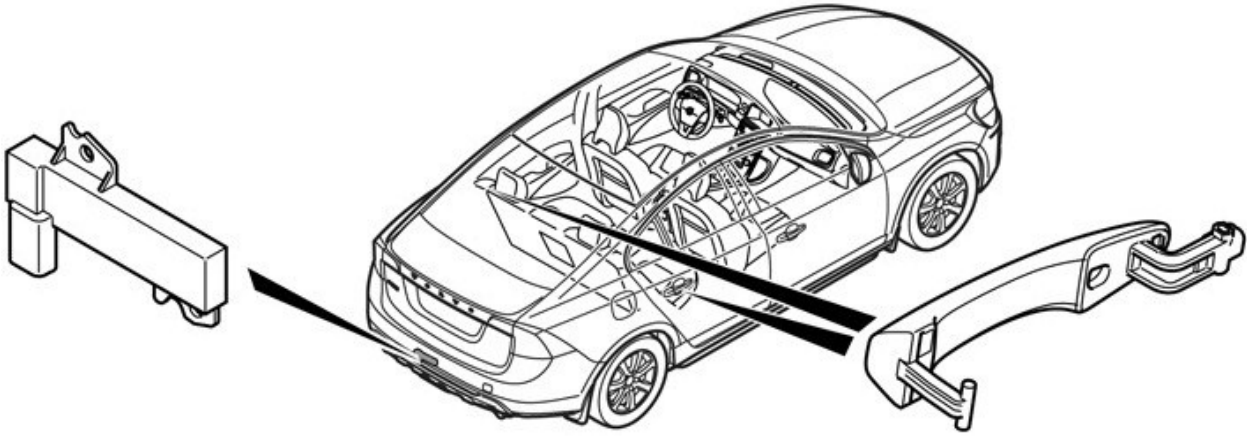
Test the function with both remote controls at all 3 external antennas (right, left and rear).

If both remote controls have short range at more than one antenna, the fault is likely in the remote receiver.

If the range is short with only one remote control or at only one external antenna the fault is probably not in the remote receiver. Fault trace accordingly.

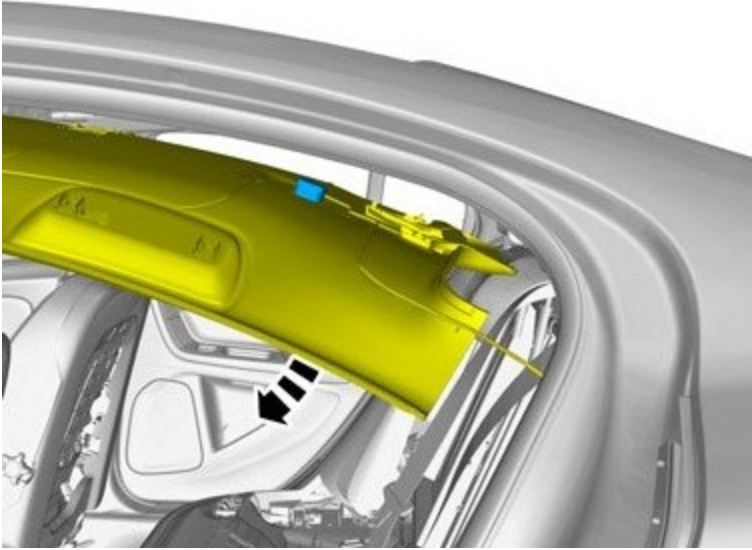
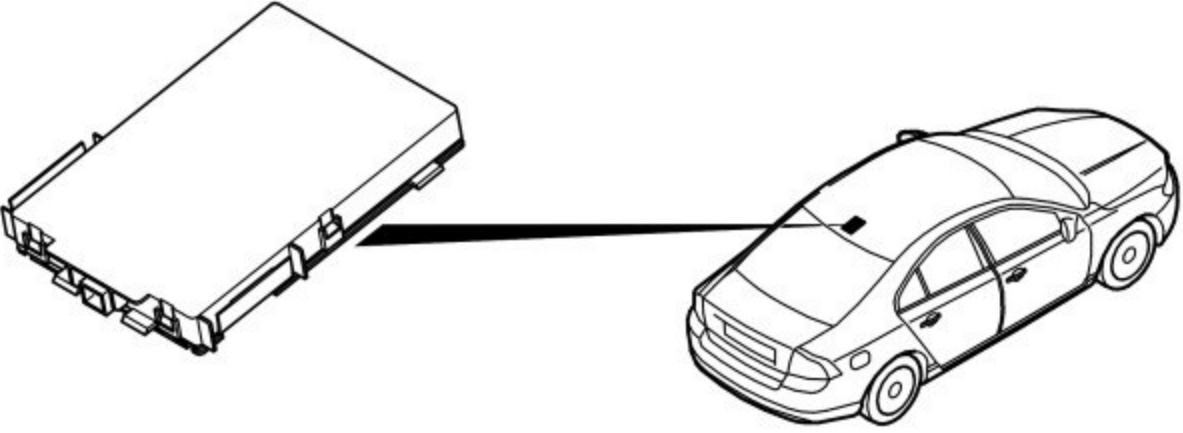
Keyless Drive remote receiver description:

The component is located on top of the headliner directly above the rear seat and is referred to as:

- '4/119 TRX' in the wiring diagram
- 'Receiver 30682115' in the VIDA parts catalogue
- 'Receiver lock system keyless entry RKE' in the VIDA repair instructions and Design and Function

Test if the symptom occurs with both remote controls. If so, then the fault is likely in the remote receiver. If the symptom occurs with only one remote control, the fault is likely in the remote control.
