Reference	SSM67377
Models	Range Rover Sport / L494
Title	L494 Range Rover Sport - Visual Appearance of Front Suspension Body Mounts
Category	Body
Last modified	08-Mar-2017 00:00:00
Symptom	111000 Body Panel(s)/Unibody
Attachments	1Right Hand strut mount.jpg (1Right Hand strut mount.jpg)

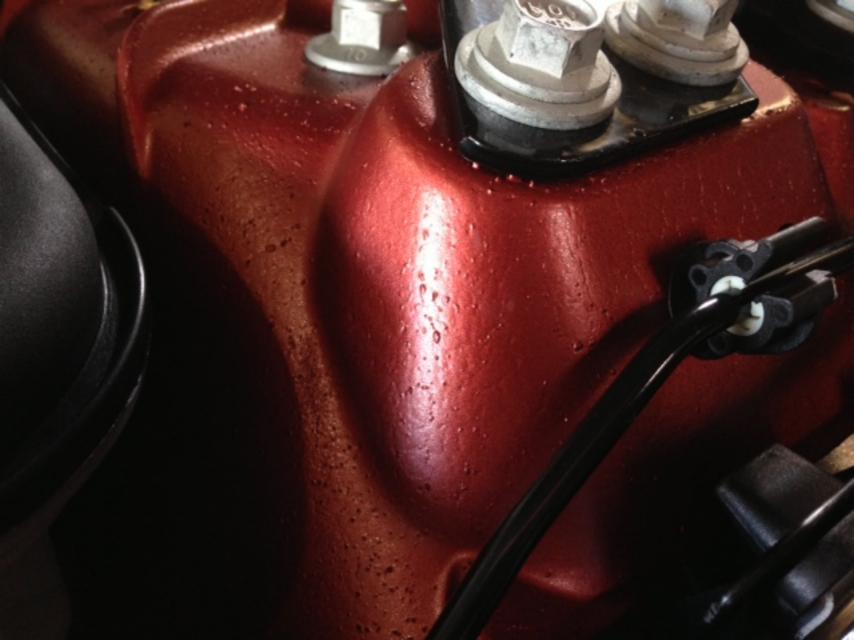
On L494 Range Rover Sport reports that the Right Hand Underbonnet Front Suspension Body Mount differs in visual external appearance compared to the left hand side.

The Right Hand side has a less smooth finish compared to the left hand Side, this is simply a cosmetic issue and the Integrity of the Suspension Body Mount is not affected.

No repair or replacement is necessary, this communication is for information only and the Suspension Body Mount meets JLR Engineering standards. A photograph of the Right hand Front Suspension Body Mount is attached for identification.
