05734 Version 4

Front Brake Noise and/or Front Brake Judder

Supersedes 16-002, dated April 27, 2016, to revise the information highlighted in **yellow**.

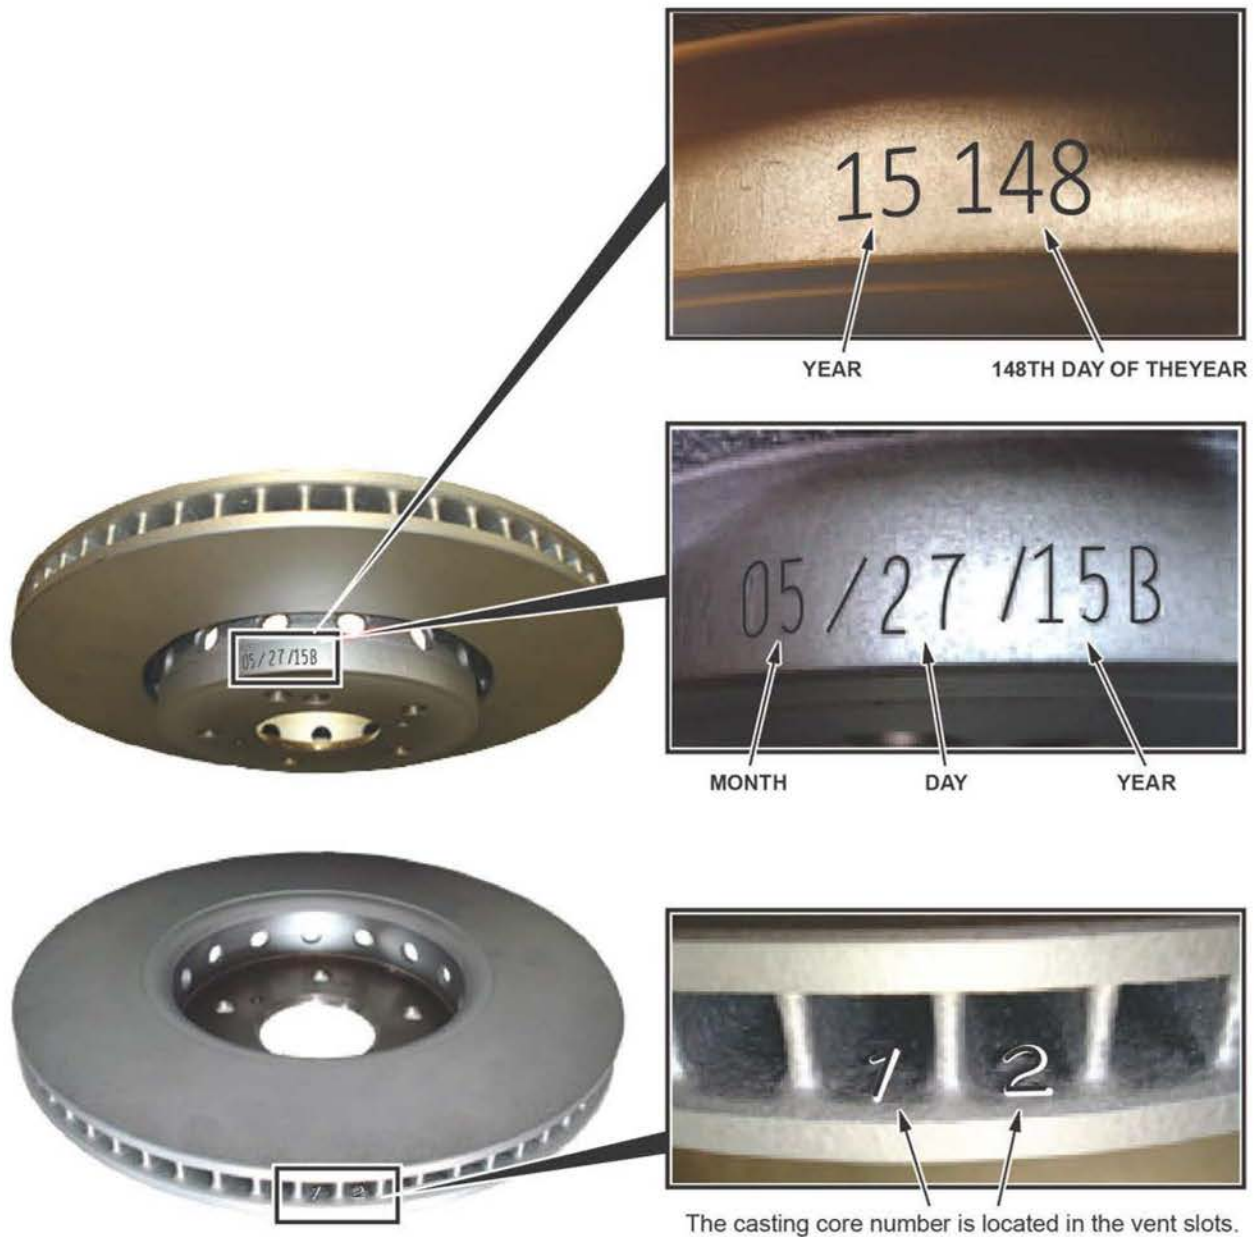
1. Inspect the supplier's manufacturing date code on new service brake discs to confirm they are from the newest mold. Wheel hub date stamping must be May 27, 2015, or later, by either conventional date format (MM/DD/YY) or Julian date format (YYDDD). The Julian date must be 15148 or later. The casting core number in the vent slots must be 11 or greater. If the new service parts do not meet these criteria, do not install them. Re-order a new set.

Julian date shows what number the day is of the year. May 27, 2015 is the 148th day of the year. As a Julian date, it will show as 15148.

2. With the vehicle on a lift, remove both front wheels.
3. Replace both front brake discs and brake pads. Refer to the service information.
4. Reinstall all removed parts in the reverse order of removal.
