08190 Version 8

**Warranty Extension: MIL Comes On with DTCs P0301 thru P0304**Supersedes 13-078, dated May 18, 2016, to revise the information highlighted in **yellow**.**AFFECTED VEHICLES**

Year	Model	Trim	VIN Range
2008–12	Accord	All V6 A/T	Check the iN VIN Status for Eligibility.

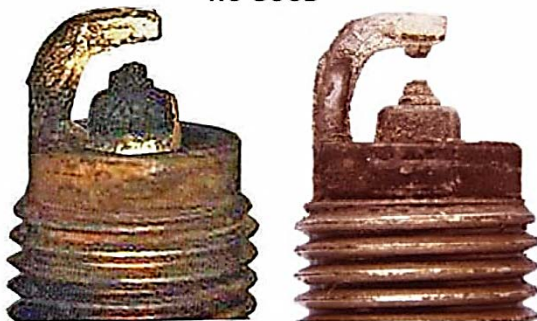
2. Remove and check the spark plug(s) on the affected cylinders (example: if P0301 is stored, check the spark plug on cylinder No. 1).

**GOOD**

**NO GOOD**

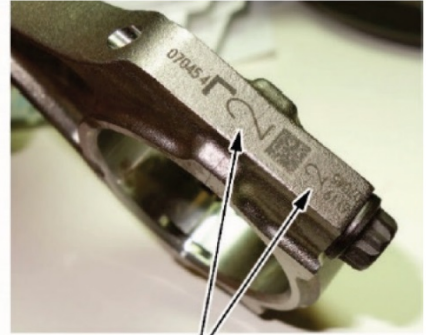
These are manufacturing marks, and do not indicate the cylinder number.

- Before removing the rod caps, use a grease pencil or suitable marking pen to mark each cap and its corresponding connecting rod with the cylinder number it came from.
- Do not confuse the existing marking on the side of the connecting rod and rod cap with a cylinder number. They are just manufacturing marks referring to the size of the big end of the rod.
- Installing a rod cap incorrectly will result in engine knock and/or engine failure. Remove and mark one rod assembly at a time to make sure it is assembled correctly.
- When torquing the rod cap bolts, refer to the service information for details.
- Click [HERE](#) to go to the *Tech2Tech*® video "Tips When Working with Fracture Rods".

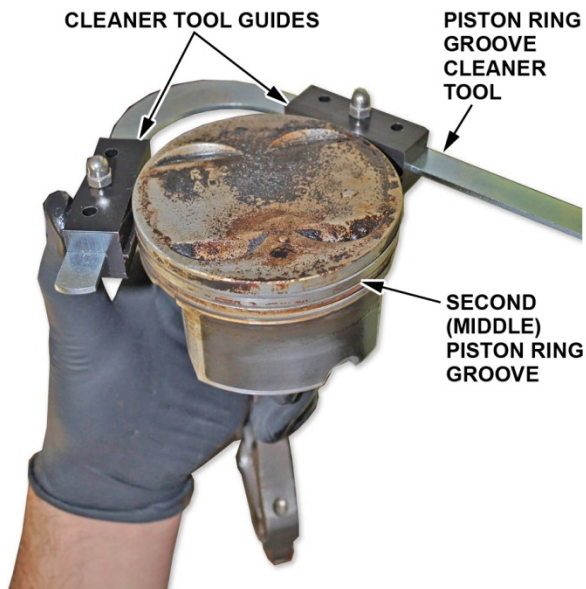
3. While holding the piston upright in your left hand, take the piston ring groove cleaner tool in your right hand and line up the cleaner tool guides with the second (middle) piston ring groove.

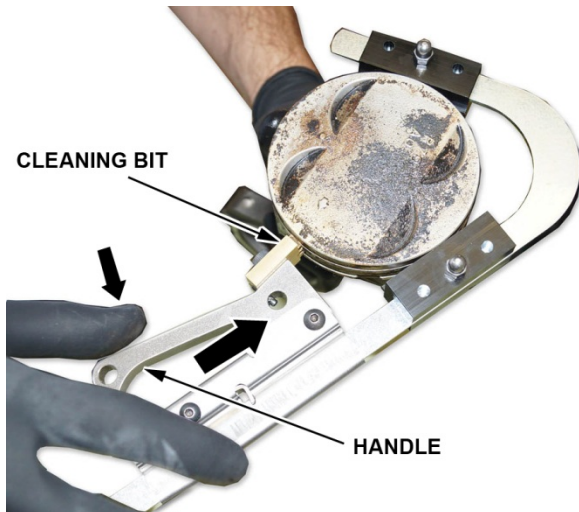
4. Press the handle on the piston ring groove cleaner tool and slide the cleaning bit onto the appropriate piston ring grooves.

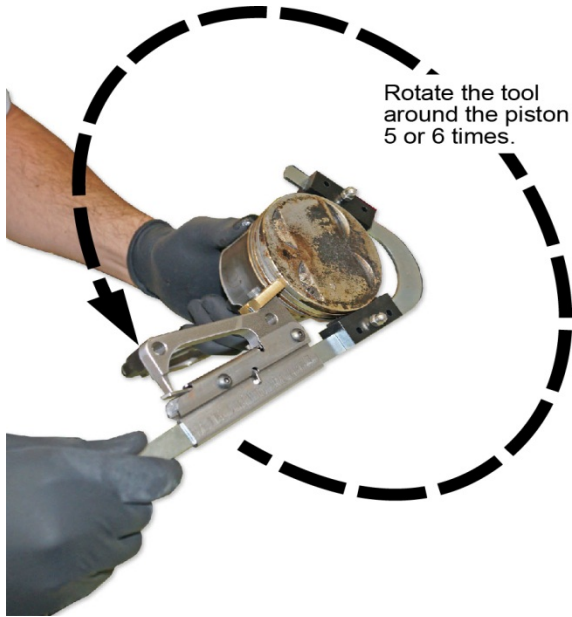
6. Hold the piston steady and rotate the tool counterclockwise five to six times to remove any carbon deposits in the piston ring grooves. **Do not** rotate the tool clockwise.

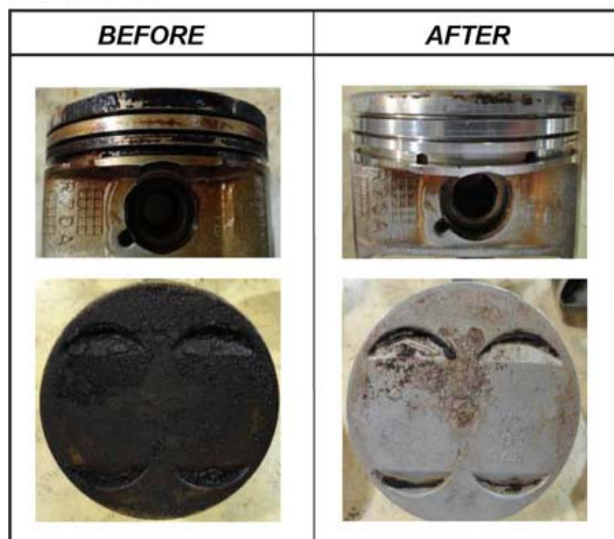
**54K PISTON**

NOTE: Below are some examples of before and after pictures. Depending on mileage and running conditions, the pistons will achieve different levels of cleanliness.
