**Document ID:** IK0100045

**Title:** LT Loose Ground Cable

This document will guide the user through detecting and repairing a loose ground terminal.

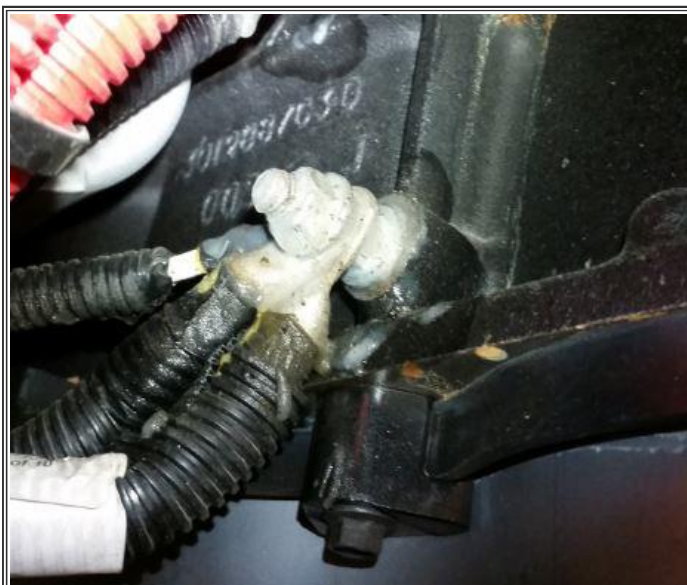
**Figure 1: Ground cable connection**

1. Bring vehicle into shop and park on a flat surface.
2. Shift transmission into park or neutral, set parking brake, and install wheel chocks.
3. Locate the ground cable connection on the side of the engine block, See Figure 1.

4. Grasp cable and try to rotate the cable.
5. If the cable rotates, disassemble all ground connections and clean.
6. Reinstall and apply dielectric grease and torque to 43Nm (31.7 ft-lbs).
7. Once complete, remove wheel chocks.
