08122 Version 7

Warranty Extension: MIL Comes On with DTCs P0301 Thru P0304

Supersedes 13-079, dated May 18, 2016, to revise the information highlighted in **yellow**.

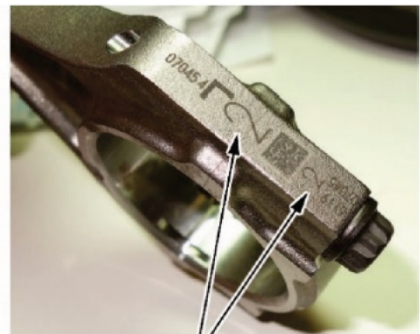
These are manufacturing marks, and do not indicate the cylinder number.

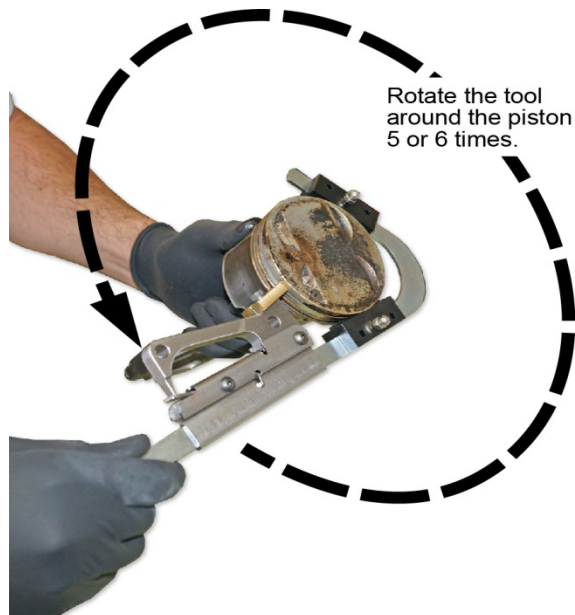
6. Hold the piston steady and rotate the tool counterclockwise five to six times to remove any carbon deposits in the piston ring grooves. **Do not** rotate the tool clockwise.

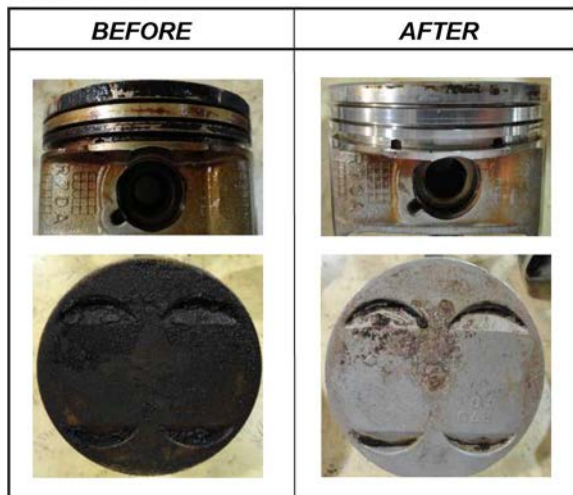
54K PISTON

NOTE: Below are some examples of before and after pictures. Depending on mileage and running conditions, the pistons will achieve different levels of cleanliness.
