07959 Version 12

## Warranty Extension: MIL Comes On With DTCs P0301 thru P0304

Year	Model	Trim	VIN Range
2011–13	Odyssey	ALL	Check the iN VIN Status for Eligibility

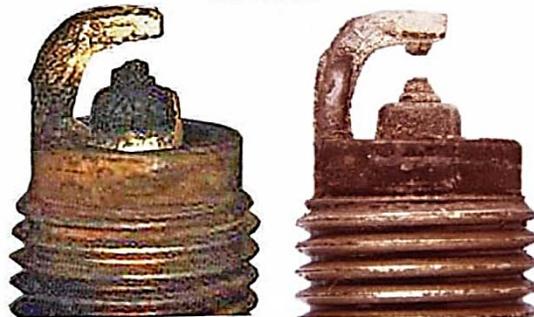
2. Remove and check the spark plug(s) on the affected cylinders (example: if P0301 is stored, check the spark plug on cylinder No. 1).

*Are the spark plug(s) fouled?*

**GOOD**

**NO GOOD**

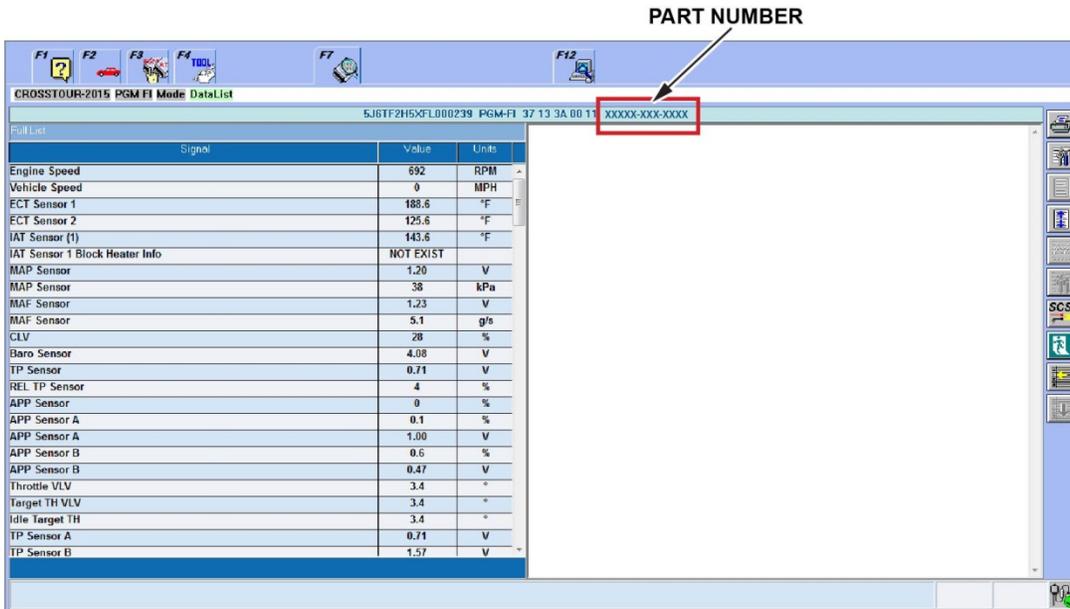
3. For 2011 Odyssey only: Check the PCM software version P/N located above the **PGM FI Data List**.

Year/Model	Program ID (or later)	Program P/N (or later)
2011 Odyssey (5-speed A/T)*	V0A560	37805-RV0-A56
2011 Odyssey (5-speed A/T)**	V0A240	37805-RV0-A24
2011 Odyssey (6-speed A/T)*	V0A760	37805-RV0-A76
2011 Odyssey (6-speed A/T)** (VIN before 5FNRL5...CB056992)	V04250	37805-RV0-425
2011 Odyssey (6-speed A/T)** (VIN including 5FNRL5...CB056992 and after)	V0A360	37805-RV0-A36
2012–13 Odyssey (ALL)	Software Updated from Factory

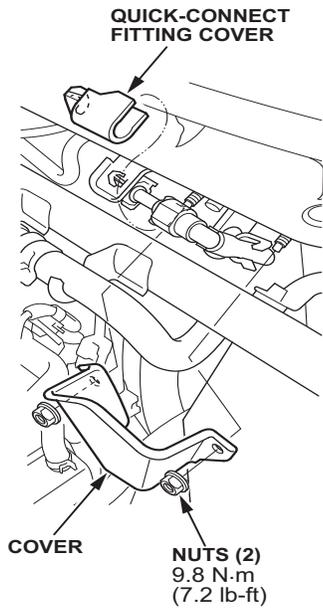
4. Disconnect the fuel feed hose line at the bulkhead.

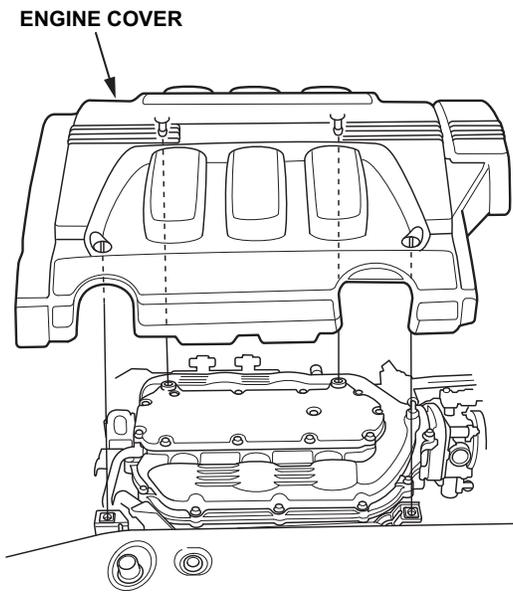
5. Remove the engine cover.

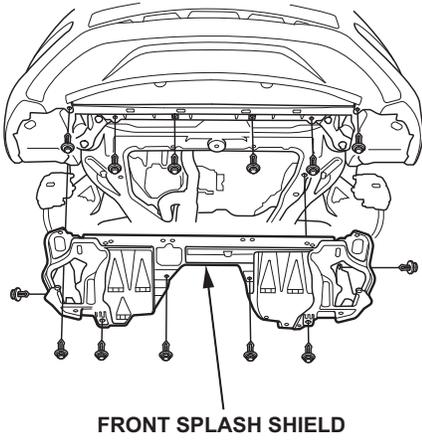
- 6. Remove the radiator cap.
- 7. Raise the vehicle.
- 8. Remove the front splash shield.

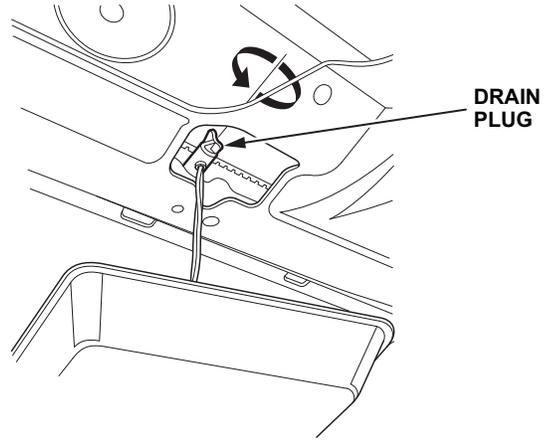
- 9. Drain the engine oil.
- 10. Loosen the drain plug on the radiator, and drain the coolant.

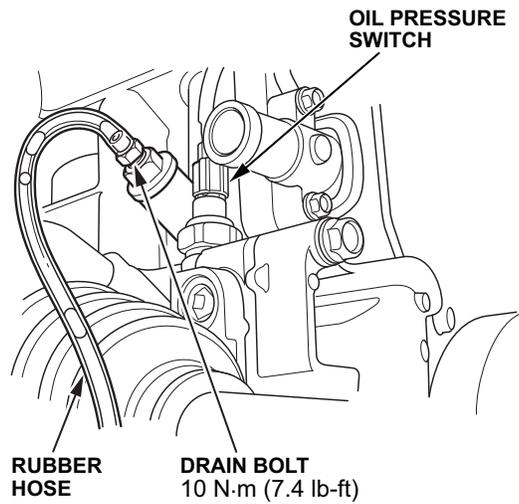
- 11. Install a 5/16th inner diameter rubber hose on the drain bolt located at the rear of the engine block, loosen the drain bolt, and drain all remaining coolant. Then disconnect the oil pressure switch connector.

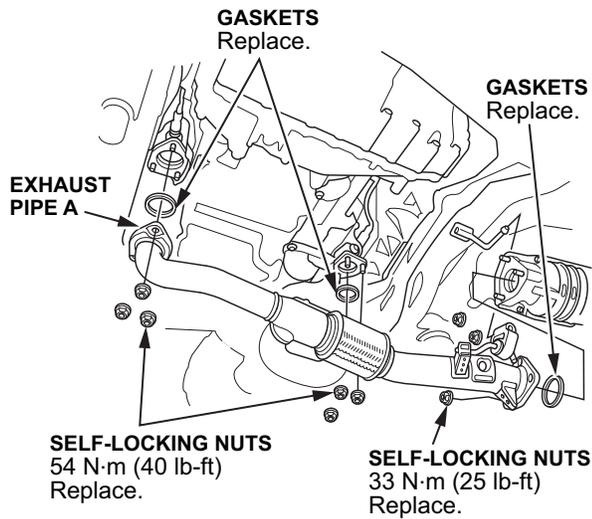
- Remove exhaust pipe A.

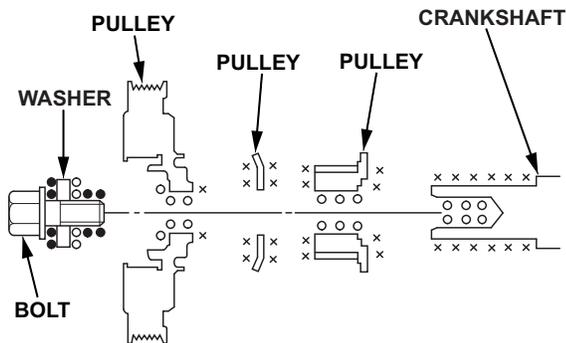
- Depending on the diagnosis, remove the appropriate WU-TWC support bracket bolts.
- Remove the EGR lower pipe nuts.
- Remove the crankshaft pulley bolt but not the pulley.

NOTE: Make sure to apply new oil to the bolt flange and threads before reinstallation.

X : Remove any oil

O : Clean

● : Lubricate with new engine oil

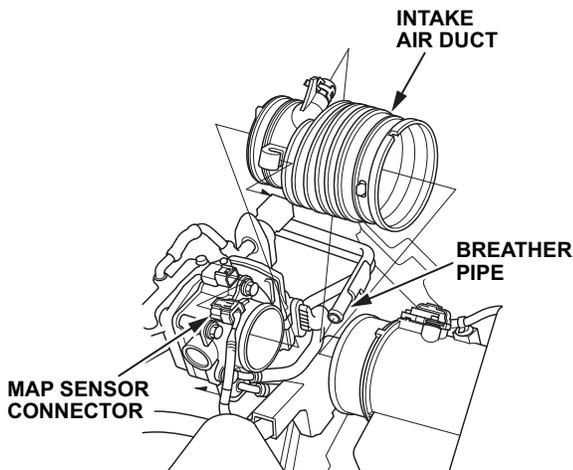
- Lower the vehicle.
- Disconnect the MAP sensor connector and the breather pipe, then remove the intake air duct.

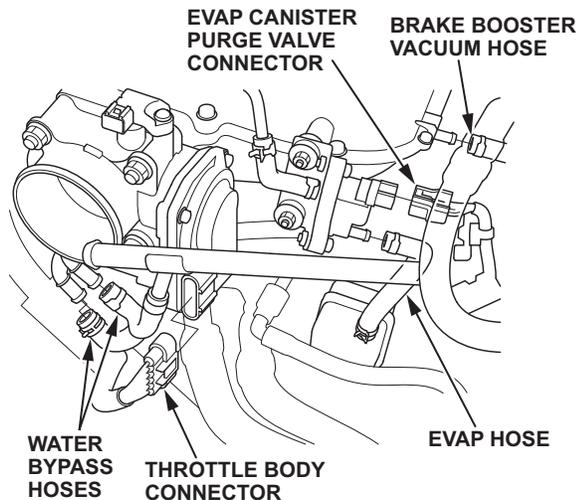
18. Disconnect the throttle body connector, the EVAP canister purge valve connector, the EVAP hose, the brake booster vacuum hose, and the vacuum hose.
19. Disconnect and plug the water bypass hoses.

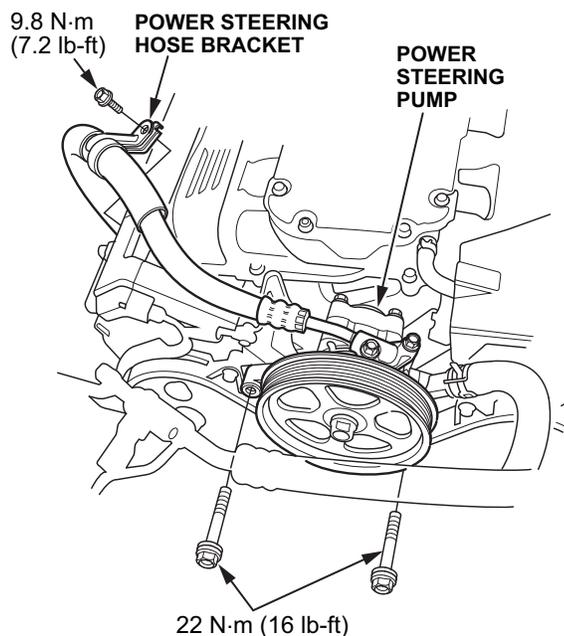
20. Remove the drive belt.
21. Remove the drive belt auto-tensioner.
22. Remove the power steering pump bolts, the power steering bracket then secure the power steering pump out of the way.

NOTE: Do not remove any of the hoses.

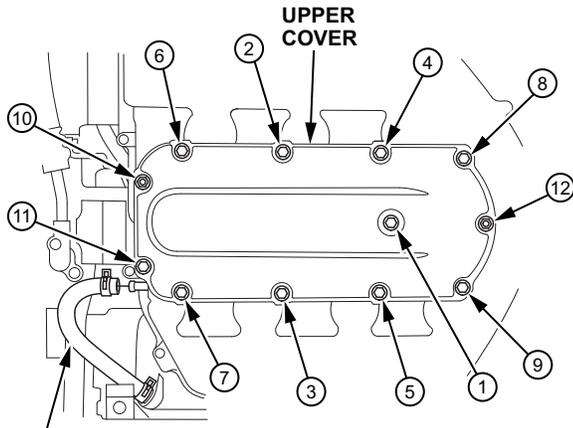
28. Remove the engine intake upper cover and PCV hose.

**SPECIFIED TORQUE**

6 x 1.0 mm

12 N·m (8.7 lb-ft)

**PCV HOSE**

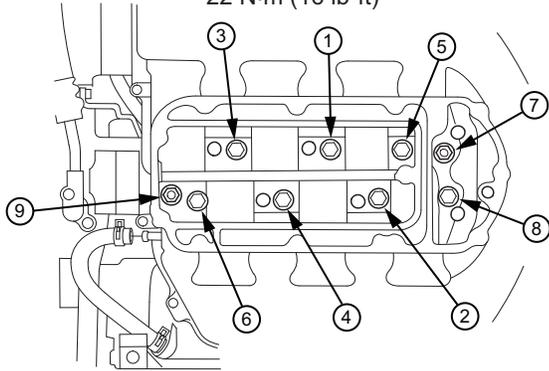
29. Remove the intake manifold bolts and nuts in three steps, then remove the intake manifold.

**SPECIFIED TORQUE**

22 N·m (16 lb-ft)

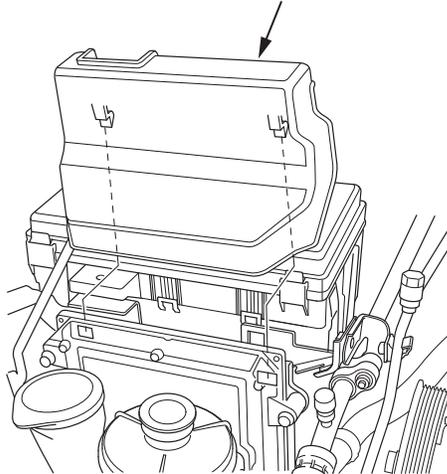
30. Remove the PCM cover.

**KEIHIN SHOWN:**

**PCM COVER**

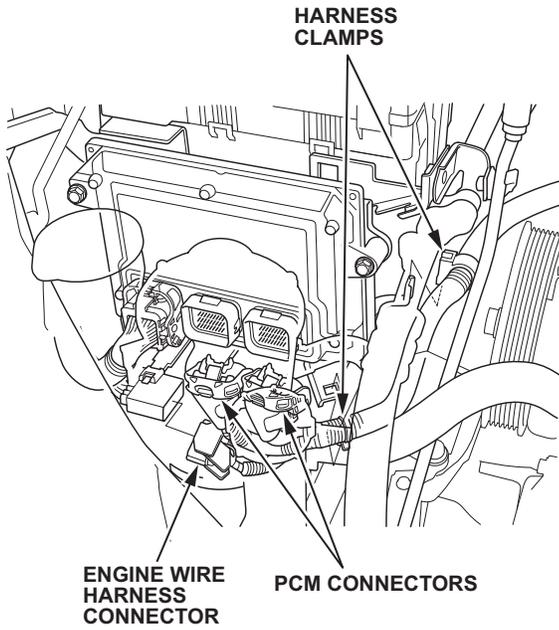
31. Remove the PCM connectors and harness clip. Remove the battery cables from the underhood fuse box.

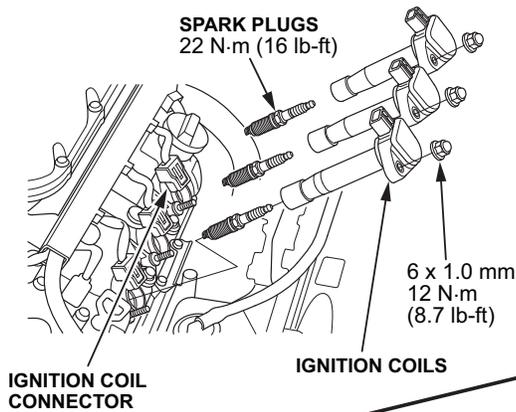
**FRONT**

32. Remove the appropriate Ignition coils based on the diagnosis.

NOTE: Depending on the diagnosis, you will either have to remove the rear bank ignition coils or both ignition coil banks.

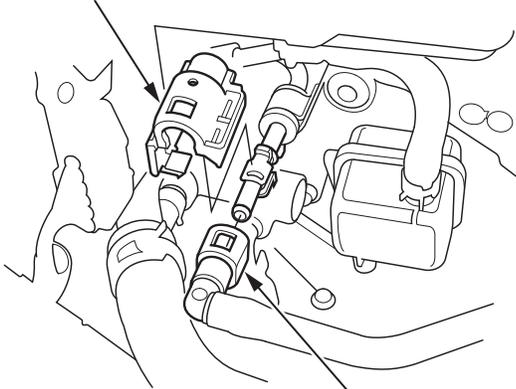
34. Remove the quick-connect fitting cover, then disconnect the fuel feed hose.

**QUICK-CONNECT  
FITTING COVER**

**FUEL FEED HOSE**

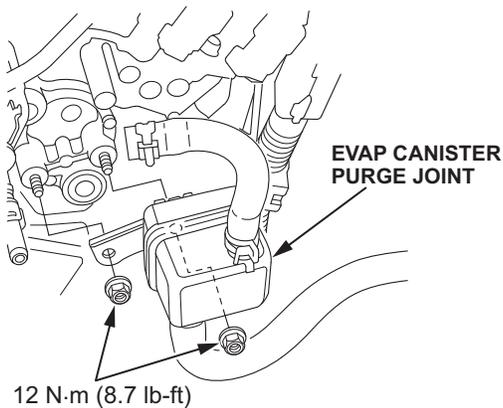
35. Remove the EVAP canister purge joint with the bracket.

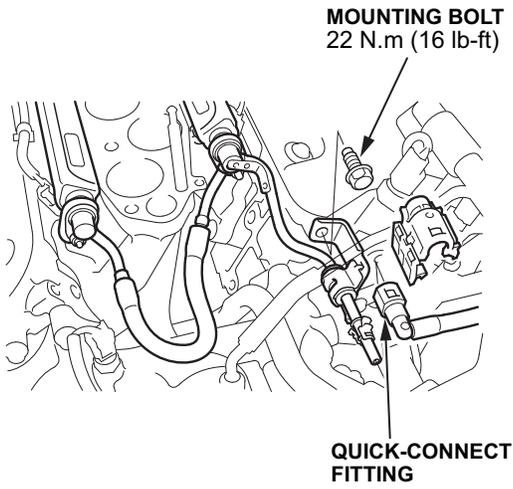
36. Remove the fuel rail connecting joint hose.

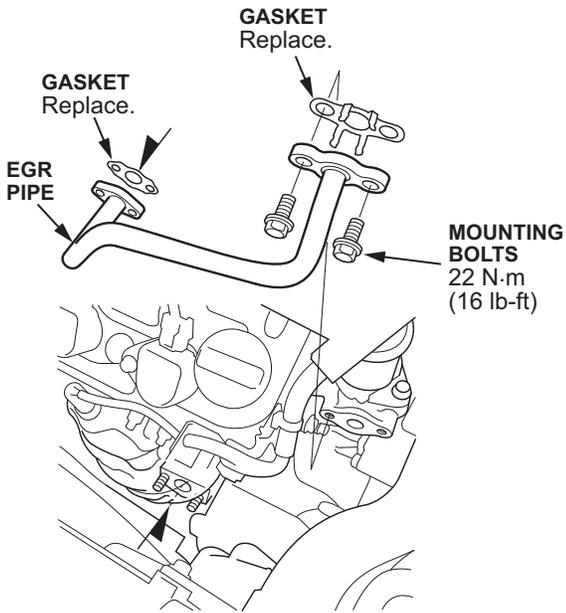
37. Remove the EGR pipe mounting bolts, then remove the EGR pipe.

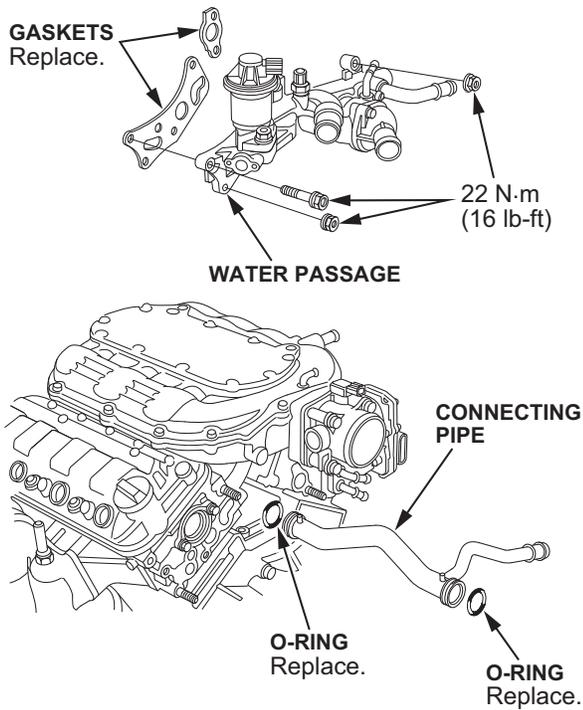
38. Separate the water passage from the heads.

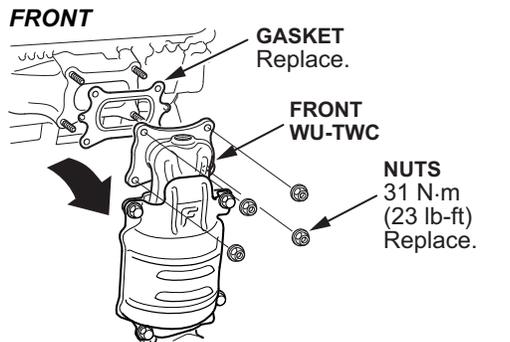
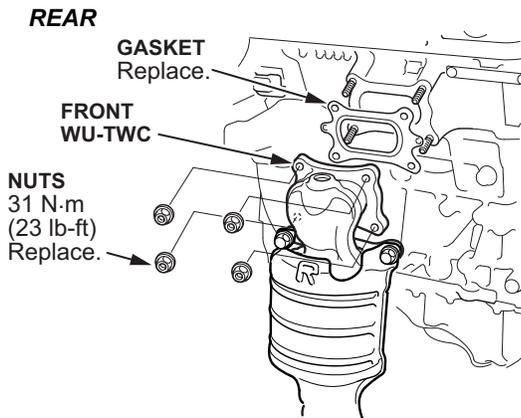
39. Remove the appropriate WU-TWC depending on diagnosis.

**NOTE:** Set the WU-TWC aside and cover the opening with shop towels to prevent coolant from entering.

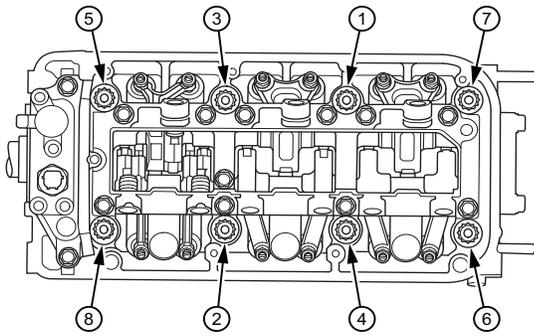
**FRONT**

40. Remove the appropriate head with the injector base attached.

NOTE: Depending on diagnosis, you will remove the rear bank head or both heads.

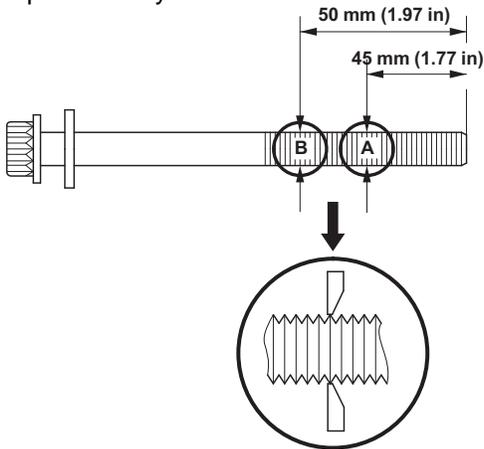
41. Measure the head bolts to determine if they need replacement. If either diameter is less than **11.3 mm (0.445 in)**, replace the cylinder head bolt.

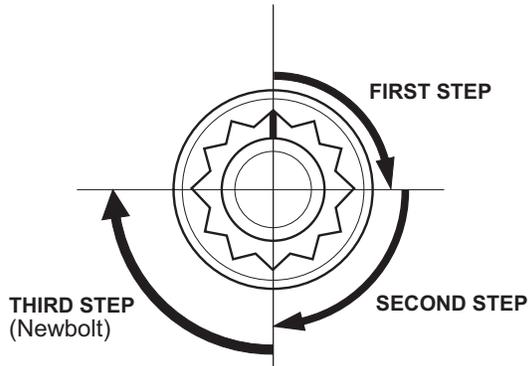
NOTE: Below are the head bolt torque specifications for reinstallation.

- First step: torque the cylinder bolts in sequence to **29 N·m (22 lb-ft)**.
- Second step: tighten in sequence an additional **90 degrees**.
- Third step: tighten in sequence an additional **90 degrees**.
- If the bolts are new, tighten an additional **90 degrees**.

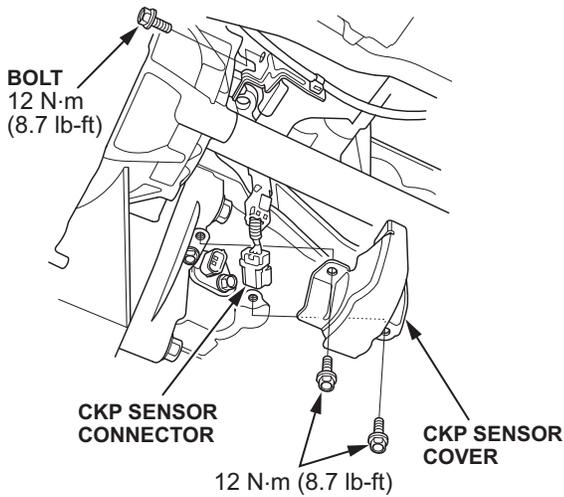
43. Remove the CKP sensor cover and bolts, then disconnect the CKP sensor connector.

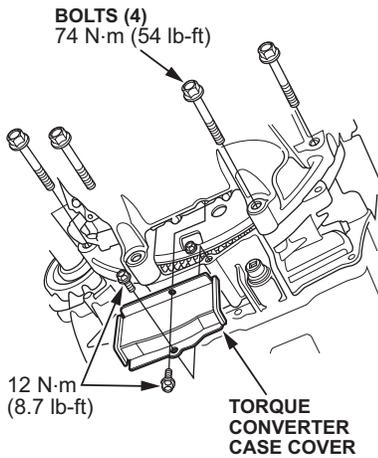
44. Remove the torque converter case cover and the four bolts securing the oil pan to the transmission.

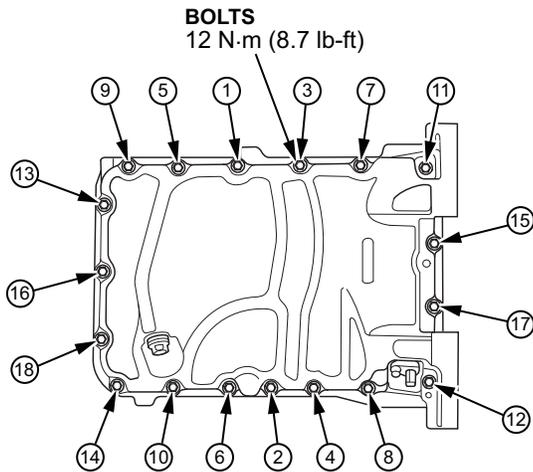
45. Remove all bolts securing the oil pan.

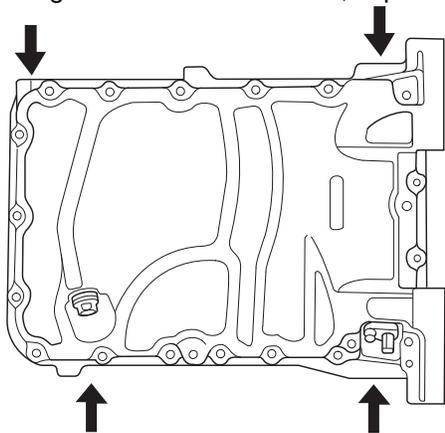
46. Using a flat blade screwdriver, separate the oil pan from the engine block in the areas shown.

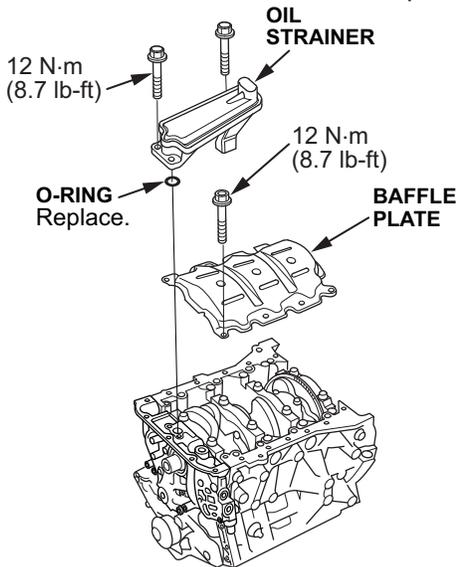
47. Remove the oil strainer and baffle plate.

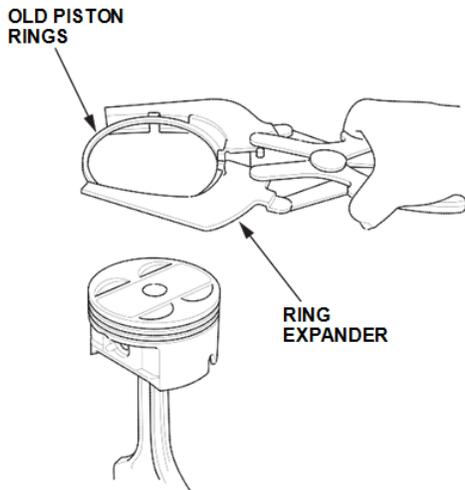
1. Remove the piston rings from the piston using a ring expander. Be careful not to damage the piston.

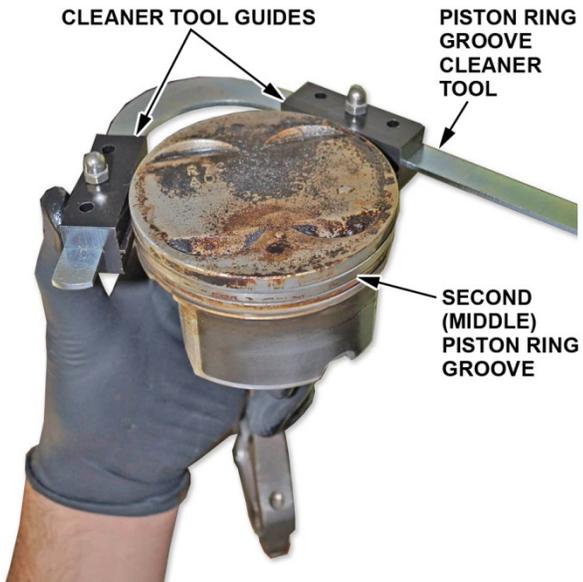
2. Spray the piston head and piston ring grooves thoroughly with Honda throttle plate cleaner.
3. While holding the piston upright in your left hand, take the piston ring groove cleaner tool in your right hand and line up the cleaner tool guides with the second (middle) piston ring groove.

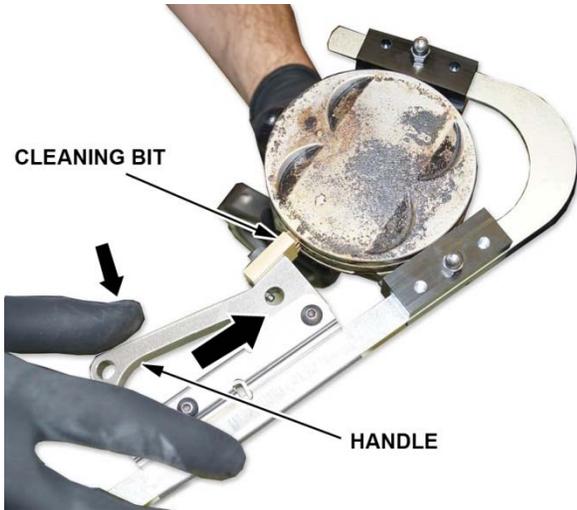
4. Press the handle on the piston ring groove cleaner tool and slide the cleaning bit onto the appropriate piston ring grooves.

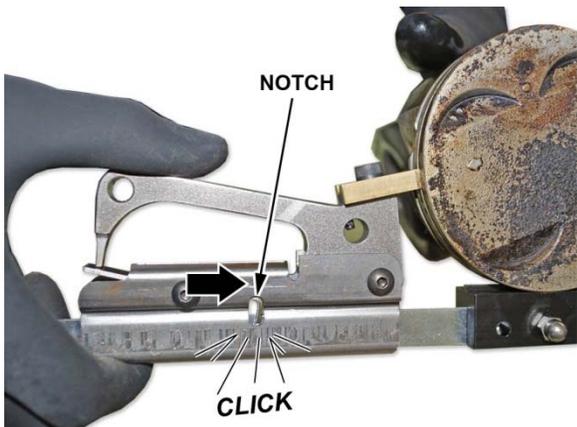
5. Once the cleaning bit is in the appropriate ring grooves of the piston, make sure the tool handle clicks in to place.  
NOTE: There is only one notch on the tool for the handle to engage.

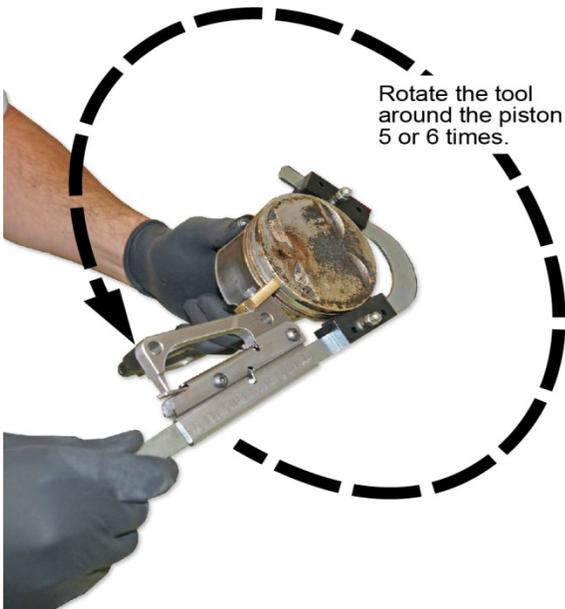
6. Hold the piston steady and rotate the tool counter-clockwise five to six times to remove any carbon deposits in the piston ring grooves. **Do not** rotate the tool clockwise.

NOTE: You can watch this procedure in the *Tech2Tech* segment "How to Clean Piston Ring Grooves".

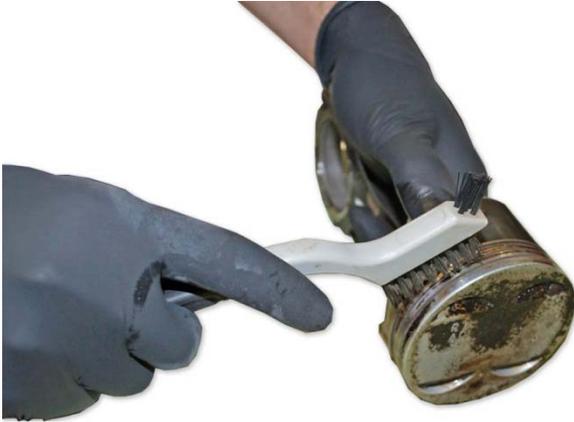
7. Remove the piston groove cleaning tool and clean off the carbon from the tool bit.
8. Finish cleaning the piston with throttle plate cleaner and the nylon brush. **Do not** use a steel wire brush.

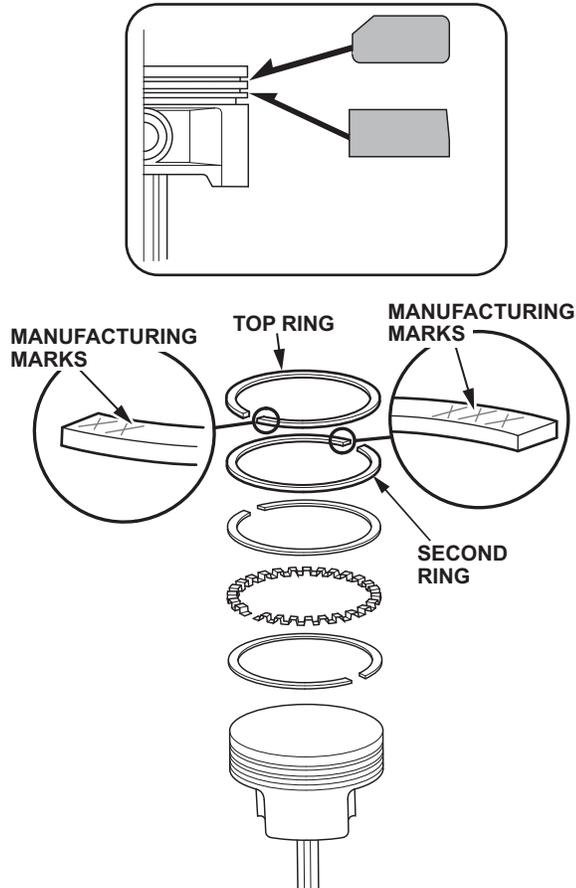
9. Install the piston rings as shown.

NOTE: The first (top) ring has a **1D** manufacturing mark and the second (middle) ring has an **SPR** manufacturing mark. The manufacturing marks must be facing upward.

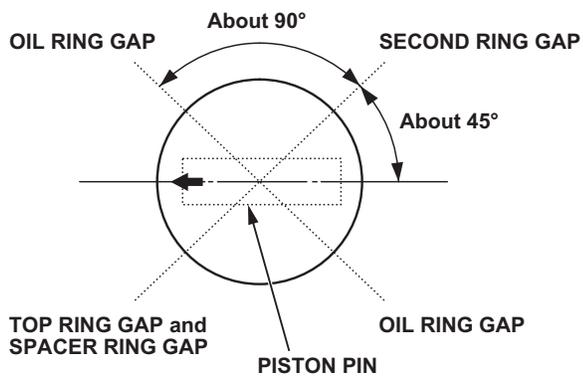
10. Position the ring end gaps as shown.

NOTE: If the ring gaps are not positioned correctly, excessive blowby may occur.

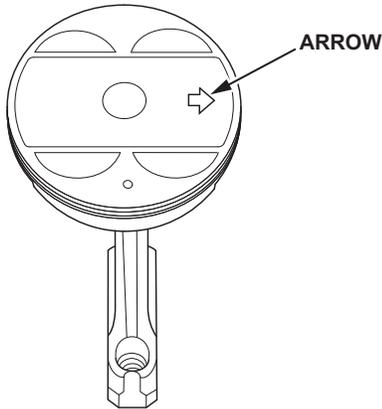
12. Install the piston/connecting rod assembly into the cylinder bore with the arrow on top of the piston facing the timing belt side of the engine.

NOTE: Be careful not to damage the cylinder wall when installing the piston.

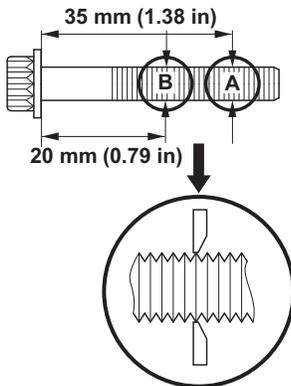
13. Measure the diameter of the connecting rod bolts to determine if they need replacement. Calculate the difference in diameter between point A and point B. It should not be more than **0–0.1 mm (0–0.004 in)**.

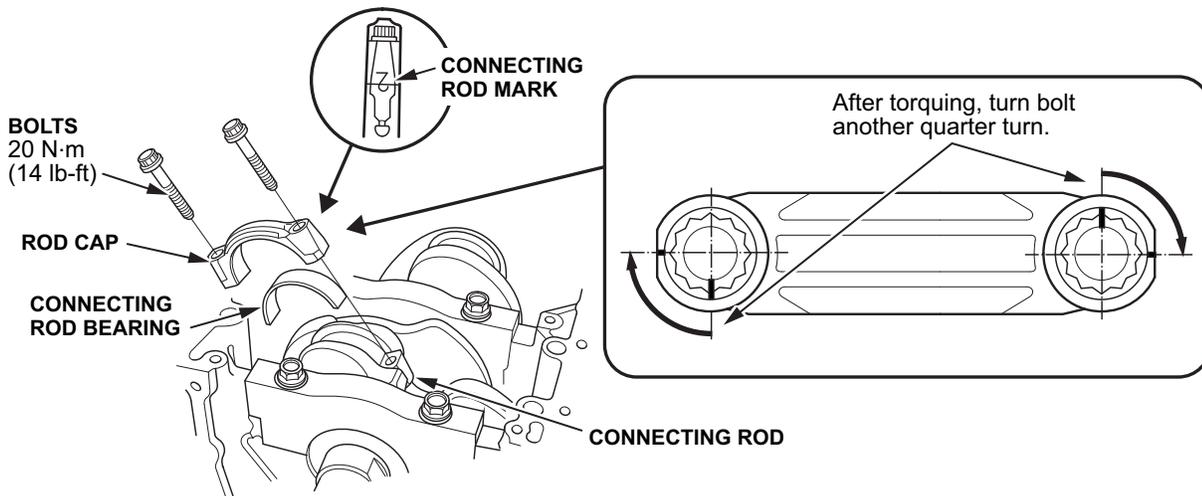
14. Apply new oil to the connecting rod bolt threads and flanges. Torque the bolts to **20 N·m (14 lb-ft)** then tighten the connecting rod bolts an additional **90 degrees**.
