CorroGuard Repair Procedure on a Support Gear Leg

October 2017
Great Dane L.P.

9-03-10232017

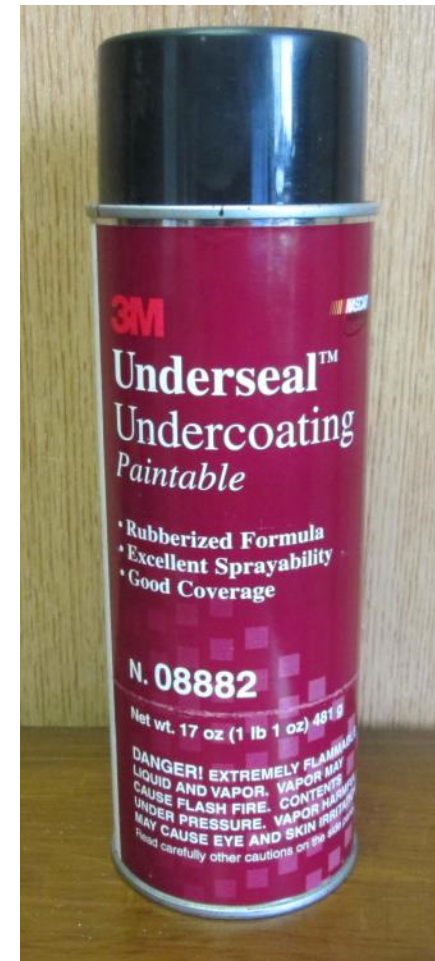
3M Underseal Undercoating

- Great Dane Part Number: MMM 08882
- 3M number: 08882
- Container Size: 20 oz.
- Paintable: Yes
- Rubberized Type: Yes
- Application Method: Aerosol Can
- Color: Black
- Volatile Organic Compound (VOC): 38% weight
- 1-2 cans needed per trailer.

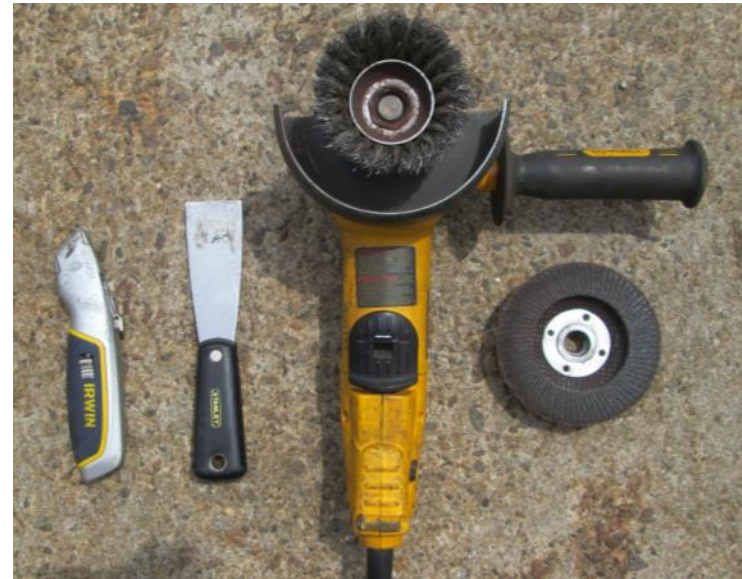
- Box cutter (utility knife)—with extra new blades.
- Putty Knife
- Wire brush power wheel.
- Sanding Disks.
- Masking tape (not shown)
- PPE as required (safety glasses, gloves, work boots, etc.)

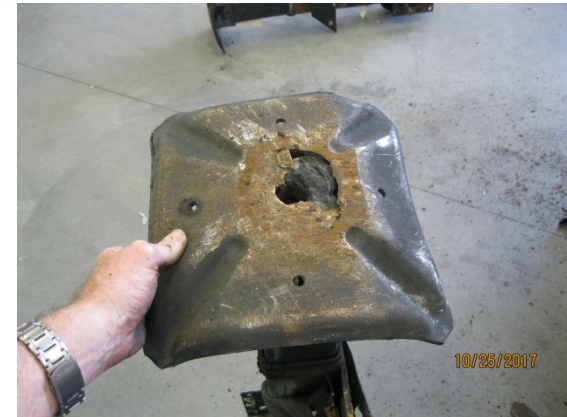
- *Inspect support gear legs for function. Correct any functional problems first before continuing with this repair. Leg replacement maybe required. Also check underside of sand shoe and replace if worn or badly bent.*

- Trim bulging, loose Corroguard with a sharp knife. Remove until the Corroguard remaining is firmly attached.
- Remove loose, flaking rust with a wire brush power wheel. Clean all loose debris, dirt, and dust from the repair area.
- Thoroughly apply a first coat of 3M Underseal 08882. Allow to cure for 20 minutes.
- Apply a 2nd coat of 3M Underseal 08882. Allow to cure before placing back into service.

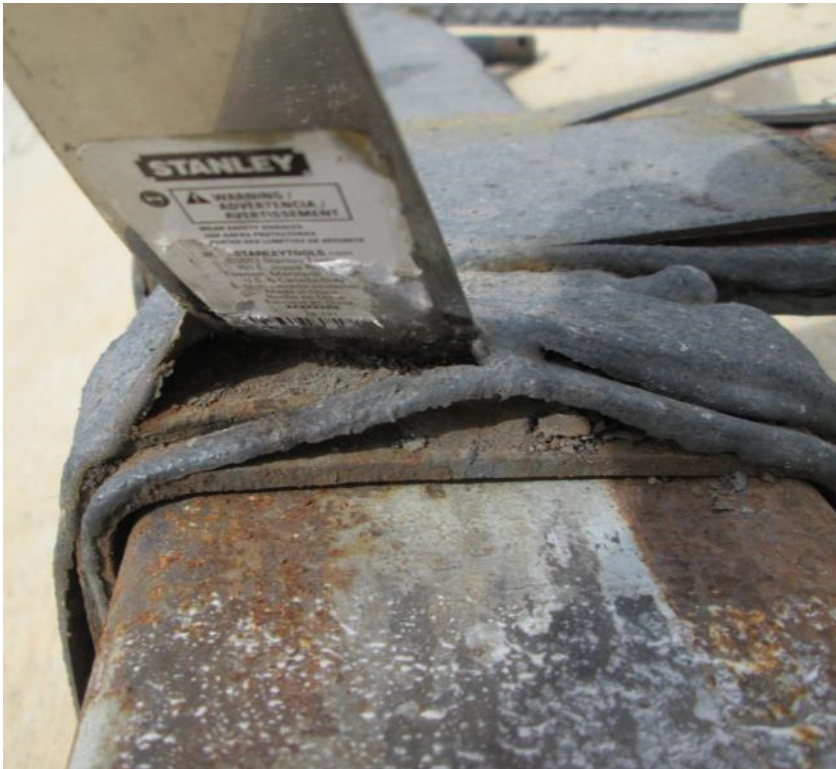
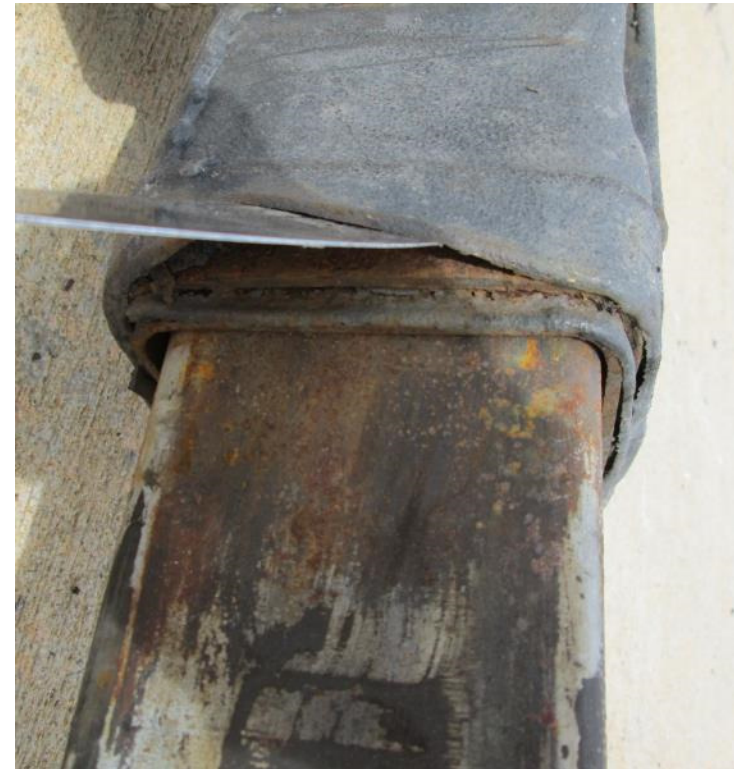
Identifying Loose CorroGuard

If CorroGuard is loose and can be lifted, repairs should be made. The photos below were taken from ground level looking up at the bottom of the upper telescoping leg.

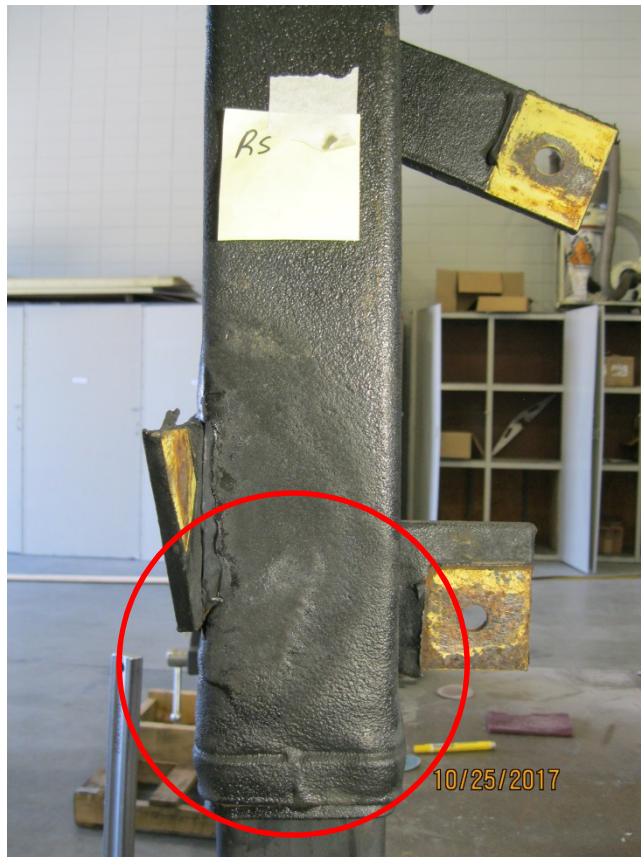
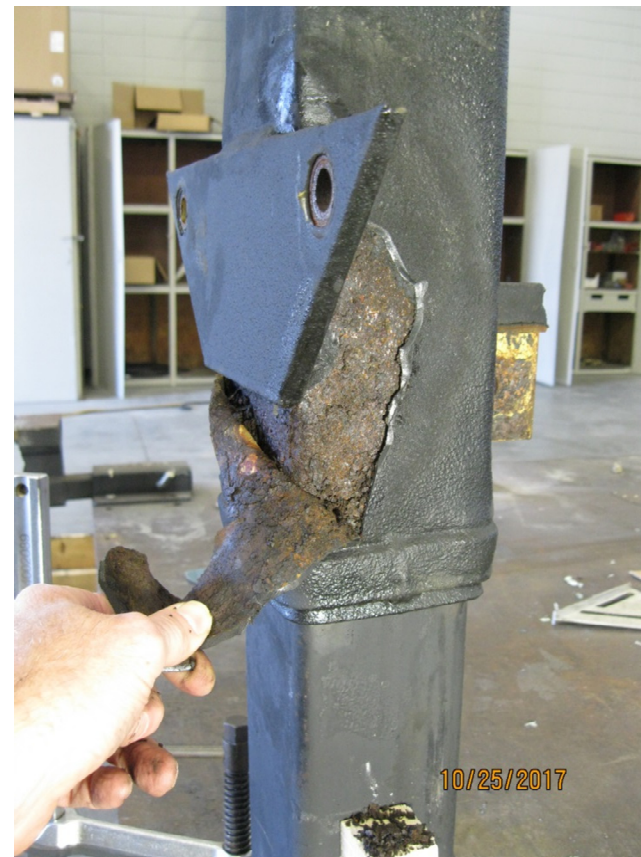
Identifying Bulging CorroGuard

If CorroGuard is bulged, it has broken loose from the parent metal and there is rust behind the Corroguard. The Corroguard must be cut away and repairs made. See the “Repair Procedure” slide that follows.

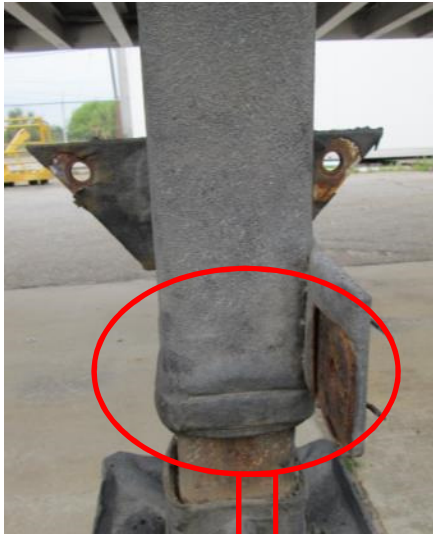
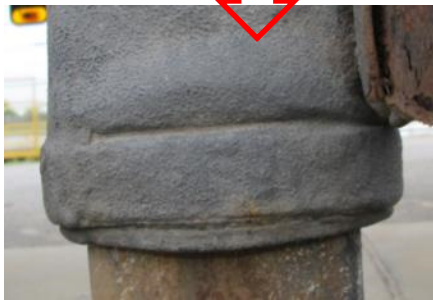
1. As Found.

(Complete leg removal from trailer is not necessary, but K-brace may require removal. If so first support trailer properly.)
