| | Field Repair Work Instruction No. <b>FRWI - 517</b> | Rev. NR | Page <b>1</b> of <b>2</b> |
| | Remove “Hopkins Electronic Taillight Converter Harness” from Chassis and Replace with Part # 04101971 | | |

| 1.0 | <div>Field Repair Work Instruction</div> <div>Replace “Hopkins” Electronic Taillight Converter Harness<br/>(1/2 hour labor allowance @ \$68/hr. + \$5 applicable shop supplies)</div> | | |

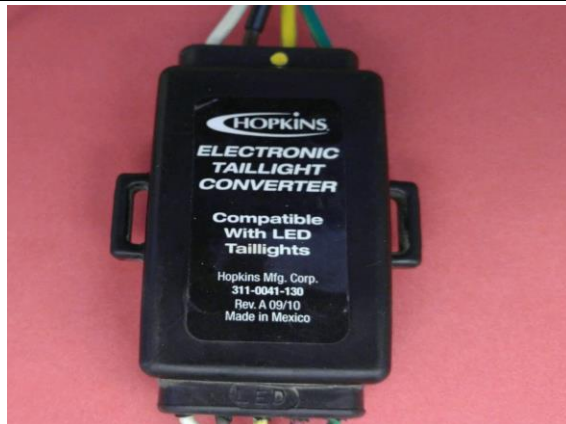
| 2.0 | <div>STEP 1: Upon Notification of a affected unit:</div> <div>Immediately Email <a href="mailto:MorganCampaign@morgancorp.com">MorganCampaign@morgancorp.com</a> for a replacement harness (Morgan Part # 04101971)<div>➤ Please allow for up to 2 business days to receive the replacement harness</div></div> | | |

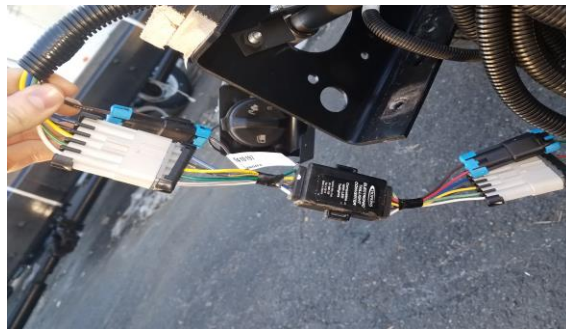
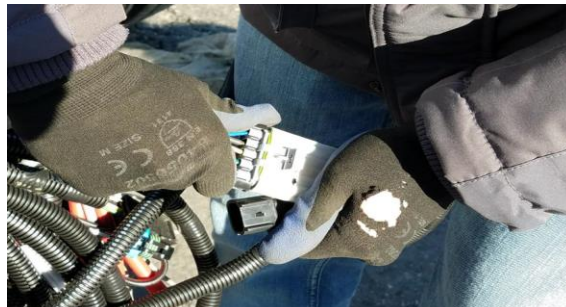
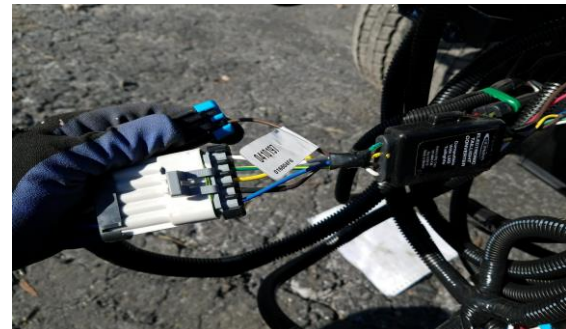
| 3.0 | <div>STEP 2: Removing and Replacing Harnesses</div> <div>Part A: Locating the converter Harness</div> <div>This part is a small black plastic module with “Hopkins Electronic Taillight Converter” marked on one side.</div> <div>Converter will be a plug n play harness, -identifiable with Metri-Pac connectors at both ends and will be located between the chassis cab and the taillight harness (typically found inside Chassis Frame rail at rear).</div> <div>Part B: Replace Converter harness with Morgan supplied harness</div> <div>Disconnect Metri-Pac connectors at each end to remove converter harness from vehicle</div> <div>Reconnect Metri-Pac connectors and tug on each connection to ensure a secured fit**</div> <div>Re-secure harness with wire ties to original location</div> <div>Confirm that Lights are operational and compliant to FMVSS-108.</div> | | |
