GROUP Body	MODEL 2017-2018MY Niro (DE P/HEV) Sportage (QL) Forte (YDm) 2016-2019MY Sorento (UMa) 2018MY Rio (SC)
	NUMBER PS551	DATE March 2018

RATTLE NOISE FROM REAR OF THE VEHICLE

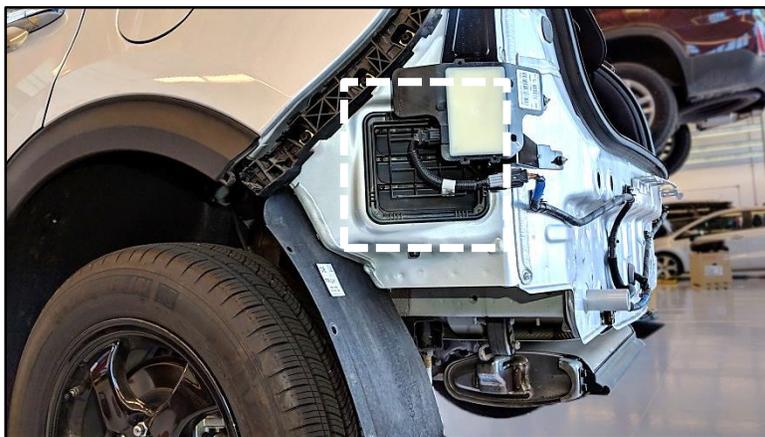
The noise is coming from the rear air extractors. These plastic air extractors are located at the left and right rear of the vehicle behind the rear bumper and are designed to vent the cabin and to release pressure. Do not replace or modify these air extractors, as they are functioning as designed.

Niro (DE) sample image for reference

Unnecessary replacements of the air extractors may be subject to chargeback.
