# Technical Service Bulletin

## 93C7 UPDATE – Software Update for Battery Regulation (NVLW)

February 15, 2018

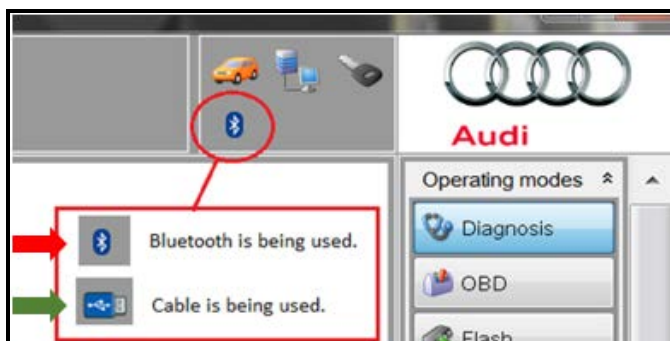
4. Attach the scan tool to the vehicle using an USB cable.
5. Confirm that the scan tool is communicating with the diagnostic head by USB <Green Arrow>. If the Bluetooth symbol is shown <Red Arrow> then disconnect the diagnostic head from the vehicle and then reattach the USB cable to the diagnostic head and then reattach to the vehicle.
