**Solution K20965159**

| <b>Title (customer effect)</b> | Fuel Tank Vent Filter Ices / Freezes Up In Cold Weather; Possible Low Fuel Pressure And Loss Of Prime; Vacuum (Rush, Hiss Of Air) Observed When Fuel Tank Cap Is Loosened |

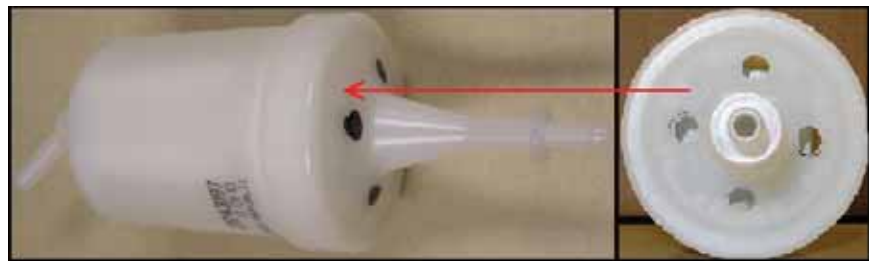
| <b>Cause</b> | Under certain conditions in cold weather operation, excessive accumulation of ice may cause restriction or blockage of the fuel tank vent lines. |

Fuel tank vent filter freeze-up most commonly occurs when a chassis is working in extreme cold conditions with temperatures below 0 °F (-18 °C). It may be necessary to increase the surface area contacted by air when it first enters the filter housing and allow for additional drainage.

For units displaying excessive ice build-up in the fuel tank vent filters, the following modification should be made to the vent filter housing:

- Four holes should be drilled at 90° intervals in the lower filter housing as shown below.
  - The holes should be 0.25" (6 mm) in diameter.
