April 7, 2018

08704 Version 5

## Product Update: MDX 9-Speed Transmission Warmer

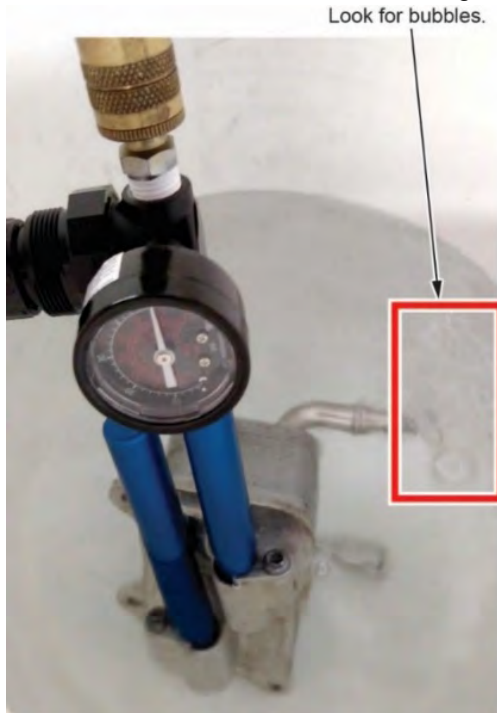
14. Check the transmission warmer for leaks by submerging the warmer completely under the water and watching for bubbles.

NOTE: Some bubbles are normal when the transmission warmer is first submerged and will come to a stop. If there is a leak, there will be a steady stream of bubbles coming from the transmission warmer.

- If there are no bubbles coming from the warmer, continue with the warmer replacement. Go to step 15.
- If there are bubbles, take photos (see Photos) and check to see if the vehicle also overheated by checking the client responses on the RO.
  - If the transmission warmer leaks, but the engine **did not overheat**, go to [REPAIR PROCEDURE B](#).
  - If the transmission warmer leaks, and the engine **overheated**, go to [REPAIR PROCEDURE C](#).

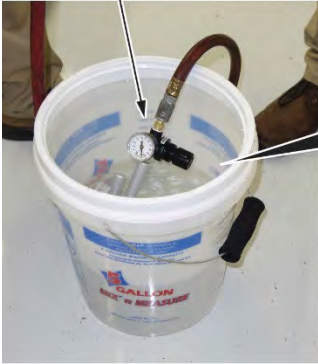
ATF WARMER PRESSURE TEST

If there are bubbles because of a leaking transmission warmer, take photos of the bubbles during the pressure test, the transmission warmer serial number, and the VIN.

BUBBLES

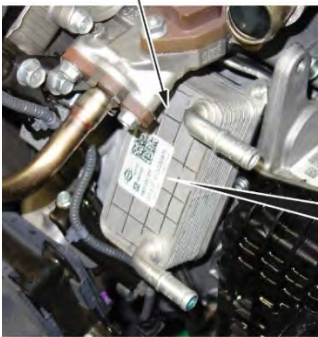
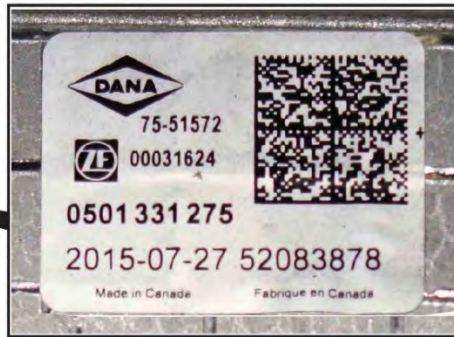
TRANSMISSION WARMER

- The transmission warmer serial number

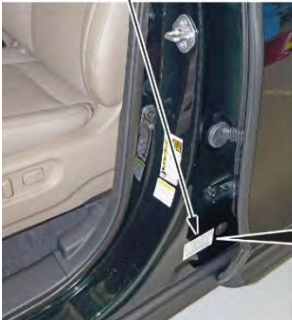
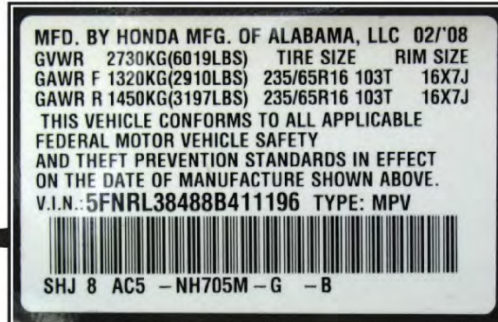
VIN LABEL

- VIN

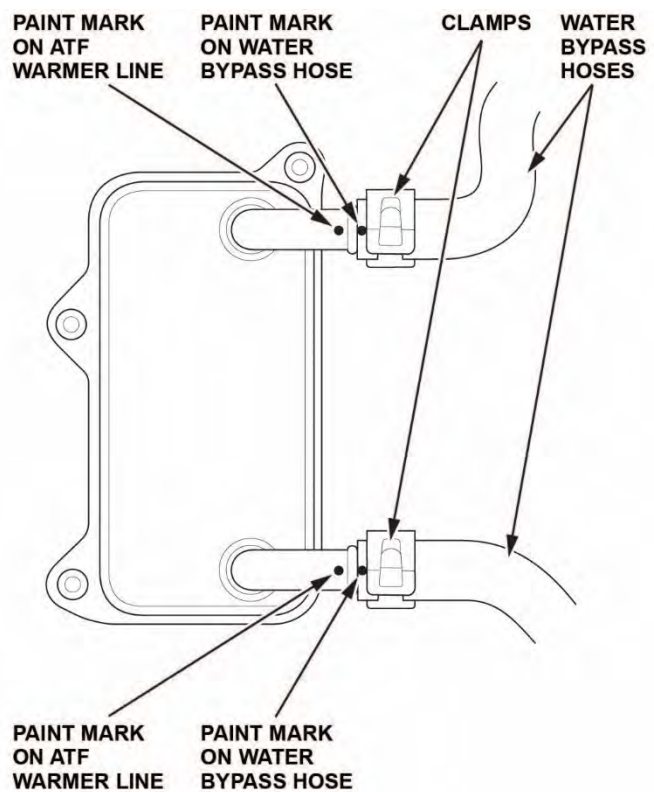
22. Connect the water bypass hoses. Make sure you align the paint marks on the ATF warmer lines with the paint marks on the water bypass hoses as shown. Secure the water bypass hoses with the clamps.

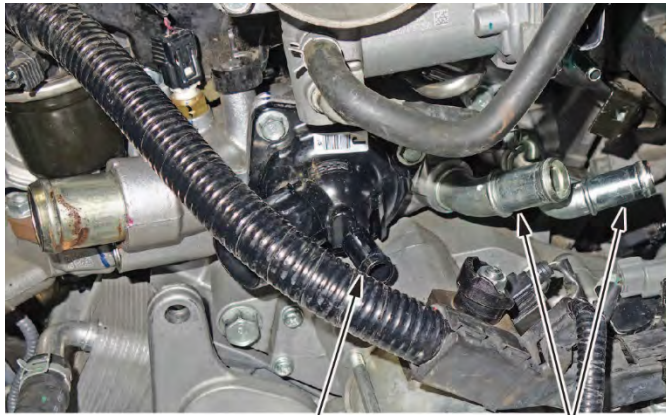
9. Using the three colored plugs from the flush kit, cap off both heater hoses and the ATF transmission warmer line as shown.

ATF TRANSMISSION  
WARMER LINE

HEATER HOSES

YELLOW PLUG  
(ATF WARMER LINE)

RED PLUG  
(HEATER  
HOSE)

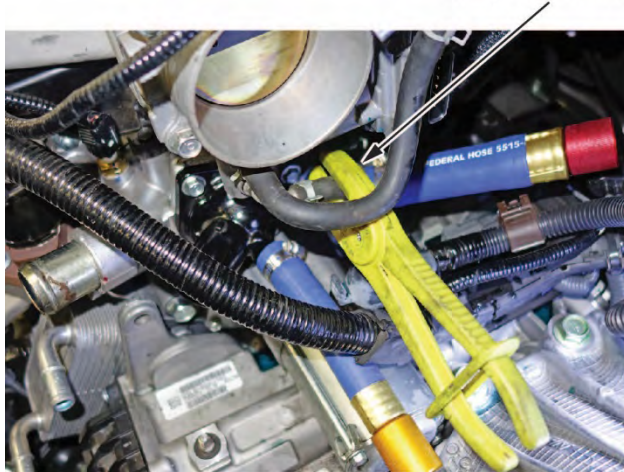
10. Using commercially-available clamps, clamp the throttle body coolant lines as shown.

Clamp both of the throttle body coolant lines.

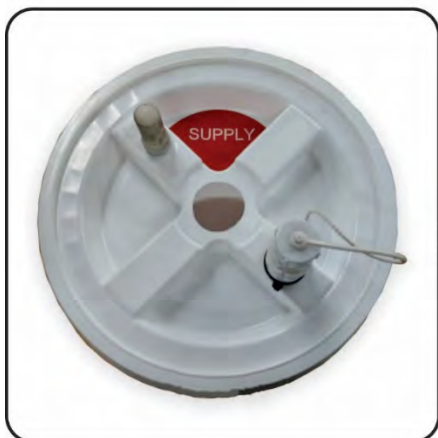
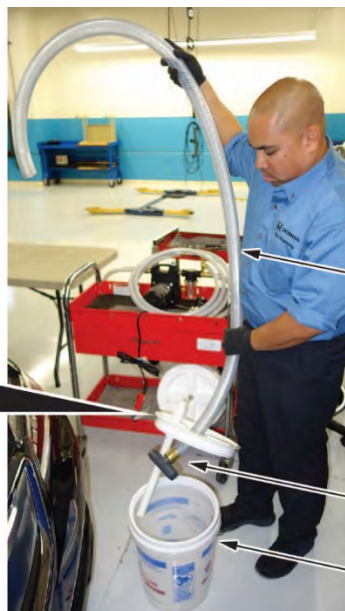
ENGINE RETURN HOSE

11. Remove the lid from the SUPPLY bucket, and install the large (1.5 in.) return hose with the T-fitting through the hole in the lid as shown.

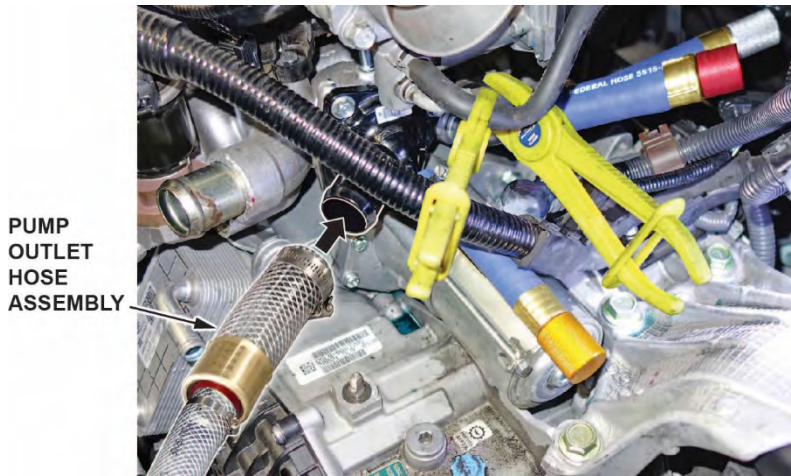
13. Install the pump outlet hose to the thermostat housing.

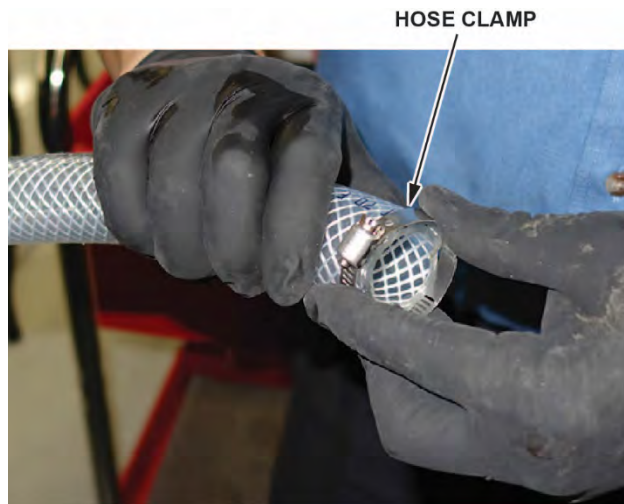
14. Install the return hose to the water passage as shown, then fill the bucket with 4.5 gallons of fresh water, and install the lid.

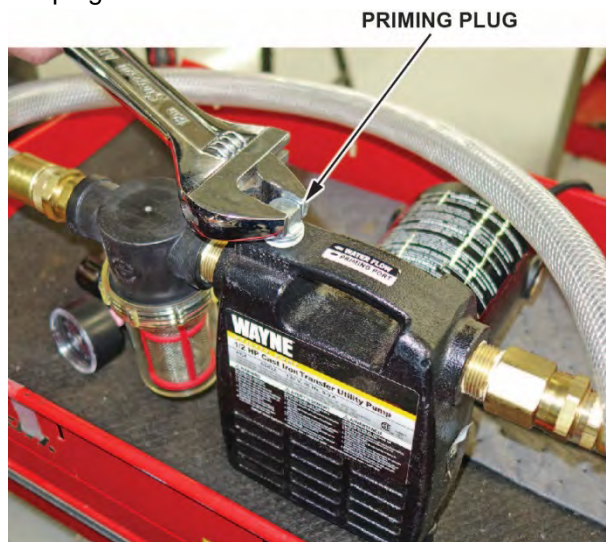
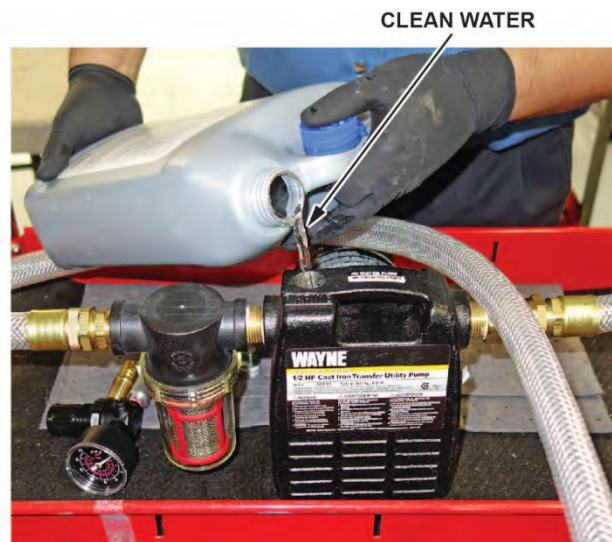
NOTE: If this is the first time using the pump, remove the priming plug, fill the pump with clean water, then reinstall the plug.

16. Turn on the pump, and let it run for 10 minutes.
17. After 10 minutes, turn the pump off and dump all the contents of the SUPPLY bucket into the waste coolant container. Wipe off any oil residue from the bucket, refill the bucket with water, then repeat the flush 4 more times (50 minutes total time flushing with water).

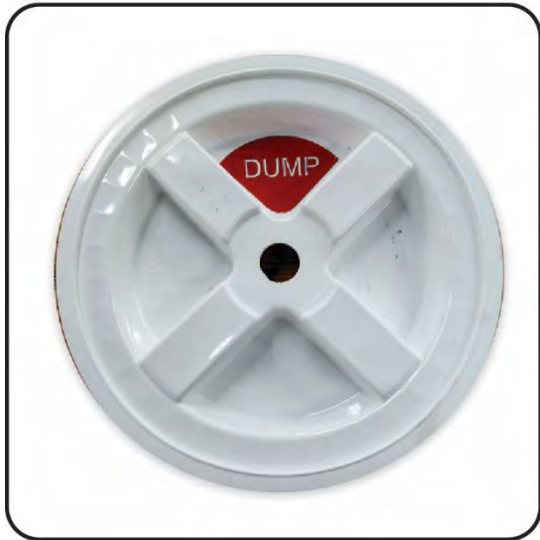
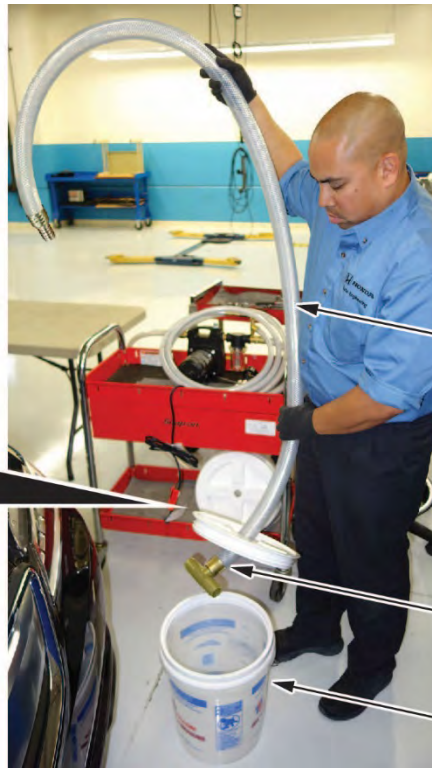
HEATER CORE RETURN HOSE

23. Install the heater core return hose through the DUMP bucket lid.

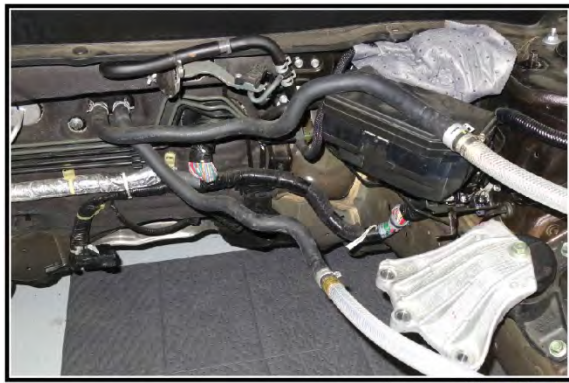
**SUPPLY BUCKET**  
Fill with water and  
run the pump until  
bucket is empty.

6. Fill the SUPPLY bucket with water, and run the pump until the SUPPLY bucket is empty.

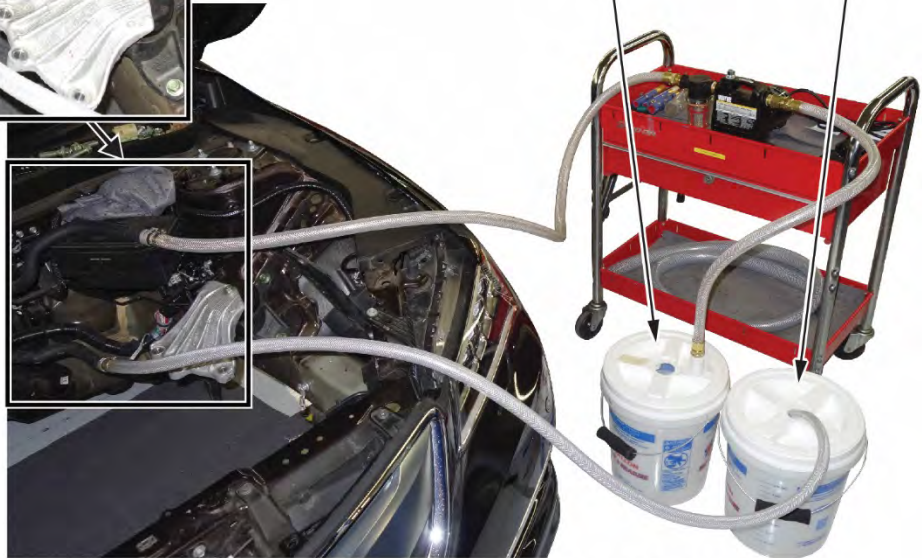
FLUSH 4 TIMES TOTAL.

**DUMP BUCKET**  
Empty into waste  
coolant container.

7. Empty the DUMP bucket into the waste coolant container.  
8. Repeat the flush 3 more times.  
9. Remove the pump and return hose from the vehicle.

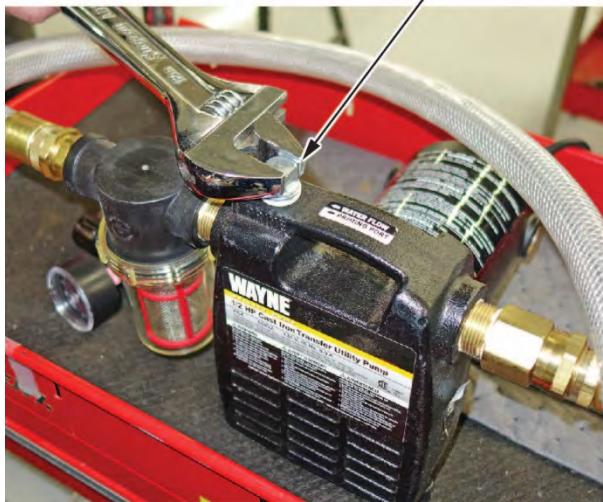
**PRIMING PLUG**

NOTE: If this is the first time using the pump, remove the priming plug, and fill the pump with clean water, then reinstall the plug.
