Service Bulletin

18-012

Capless Fuel Shutter Set (Mis-Fuel Inhibit Device) Is Frozen

Year	Model	Trim	VIN Range
2016-17	Civic	4-door	ALL
2016-18	Civic	2-door	ALL

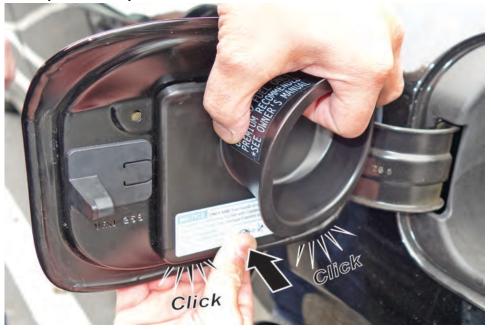
3. Press the bottom of the fuel lid cover to the fuel door until both locking tabs click. This indicates the fuel lid cover is securely and correctly installed.

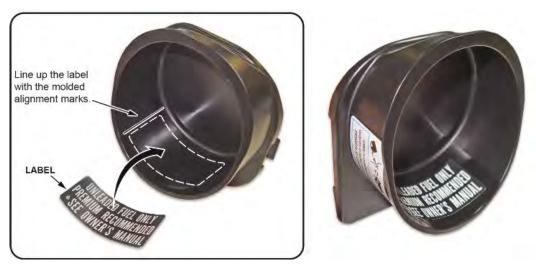
1. **On Si models only:** Apply the fuel lid label to the new fuel lid cover as shown.

Make sure the new fuel lid cover is clean and grease-free, especially on the surface where the label will be applied.

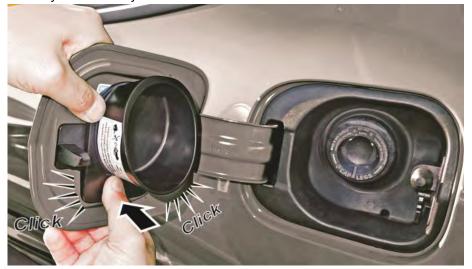
3. Press the left of the fuel lid cover to the fuel door until both locking tabs click. This indicates the fuel lid cover is securely and correctly installed.
