**April 21, 2018**

Version 3

## Capless Fuel Shutter Set (Mis-Fuel Inhibit Device) Leaks When Refueling Vehicle

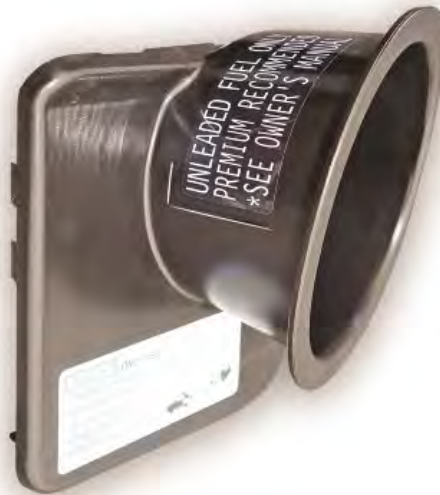
1. **On Si models only:** Apply the fuel lid label to the new fuel lid cover as shown.

Make sure the new fuel lid cover is clean and grease-free, especially on the surface where the label will be applied.

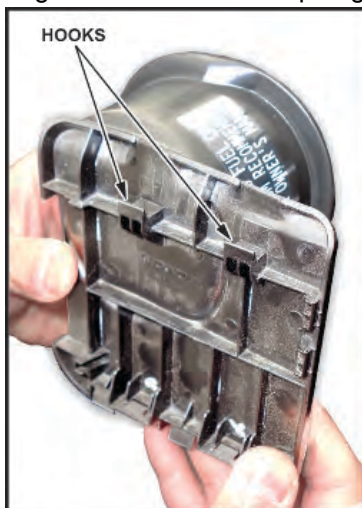
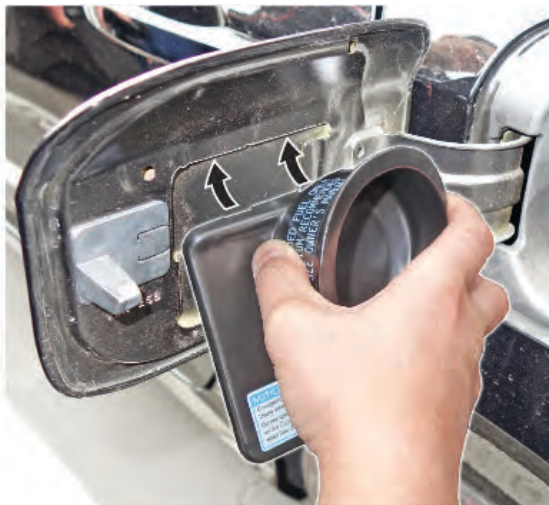
2. Align the hooks on the top edge of the fuel lid cover to the fuel door.

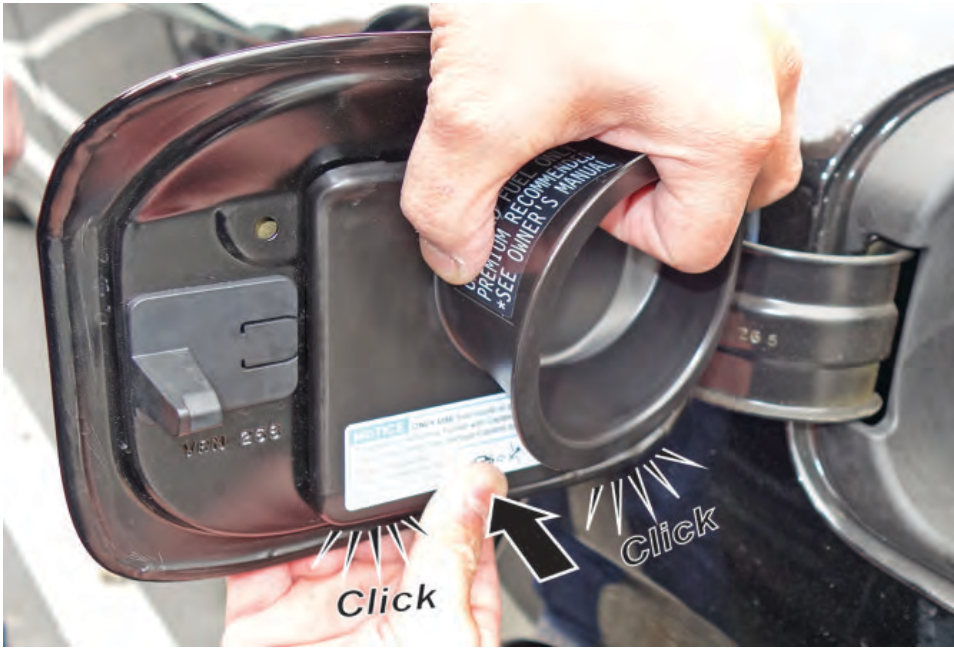
3. Press the bottom of the fuel lid cover to the fuel door until both locking tabs click. This indicates the fuel lid cover is securely and correctly installed.

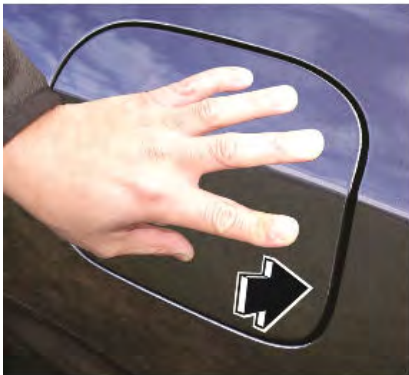
4. Make sure the fuel door closes and latches without contact or interference from the mis-fuel inhibit device and surrounding area. The gap between the door and the surrounding quarter panel should remain consistent.

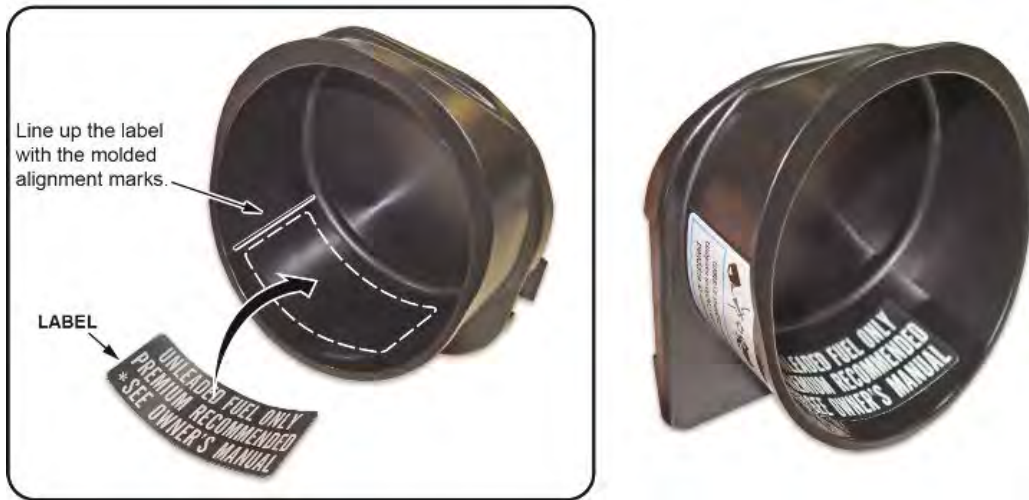
1. **On Si models only:** Apply the fuel lid label to the new fuel lid cover as shown.

Make sure the new fuel lid cover is clean and grease-free, especially on the surface where the label will be applied.

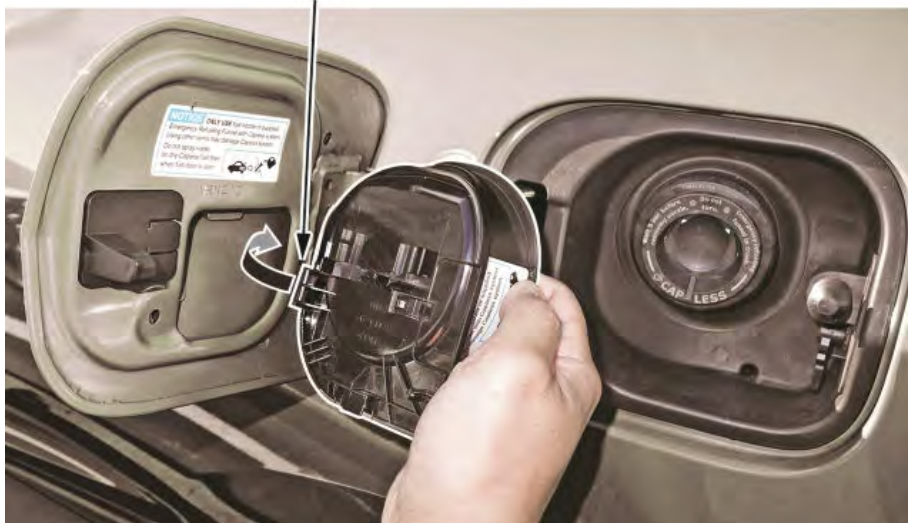
2. Align the hook on the right side edge of the fuel lid cover to the fuel door.  
**HOOK**

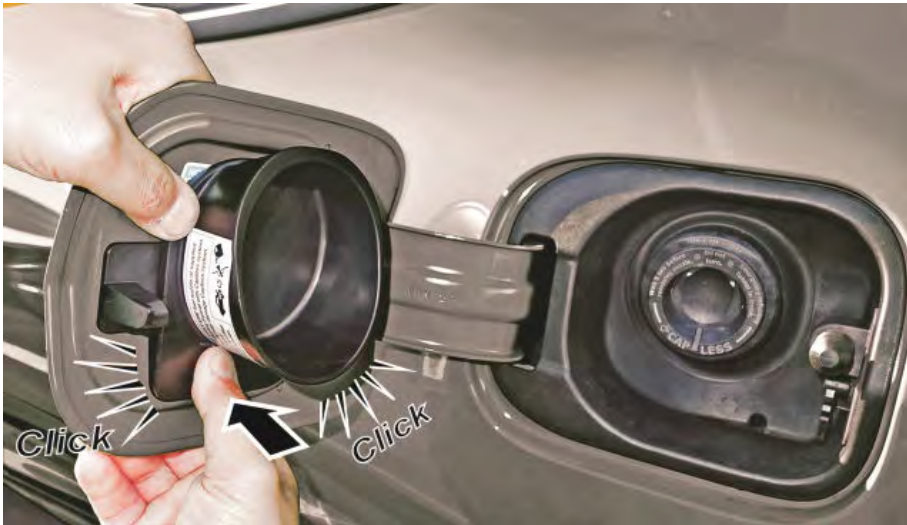
3. Press the left of the fuel lid cover to the fuel door until both locking tabs click. This indicates the fuel lid cover is securely and correctly installed.

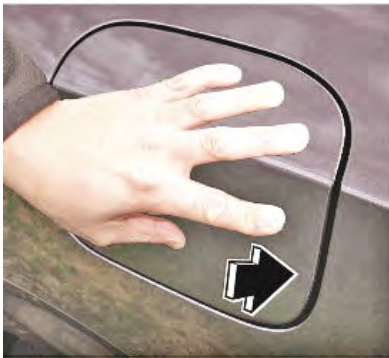
4. Make sure the fuel door closes and latches without contact or interference from the mis-fuel inhibit device and surrounding area. The gap between the door and the surrounding quarter panel should remain consistent.
