# Service Campaign Bulletin

Campaign No. 2018010005, February 2018

SUBJECT: **Model 906, Model Year 2017**  
**Emissions ECU SW Update**

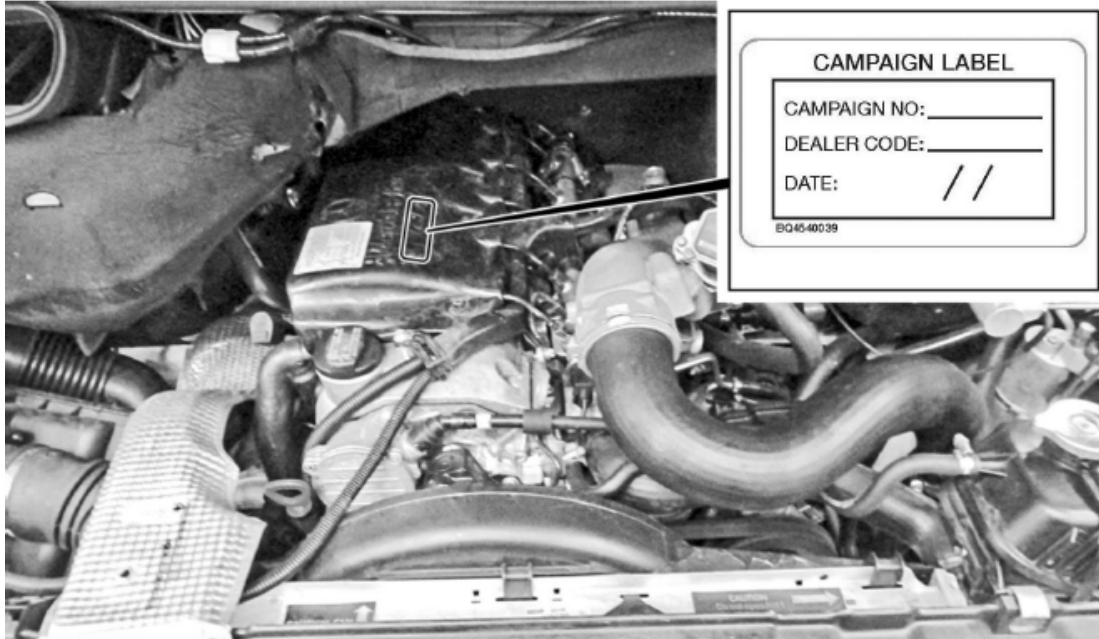
**Figure 1**

Apply Proof of Correction Label (BQ 4 54 0039) to area identified in Figure 2. Fill in Campaign number: 2018010005, your dealer code, and the date of the repair, using a black permanent marker.

**i** Note: Clean engine's bonding surface prior to affixing label.
