## Technical Information Bulletin

**02-140**

T680 Washer Reservoir Leak

3/23/2018

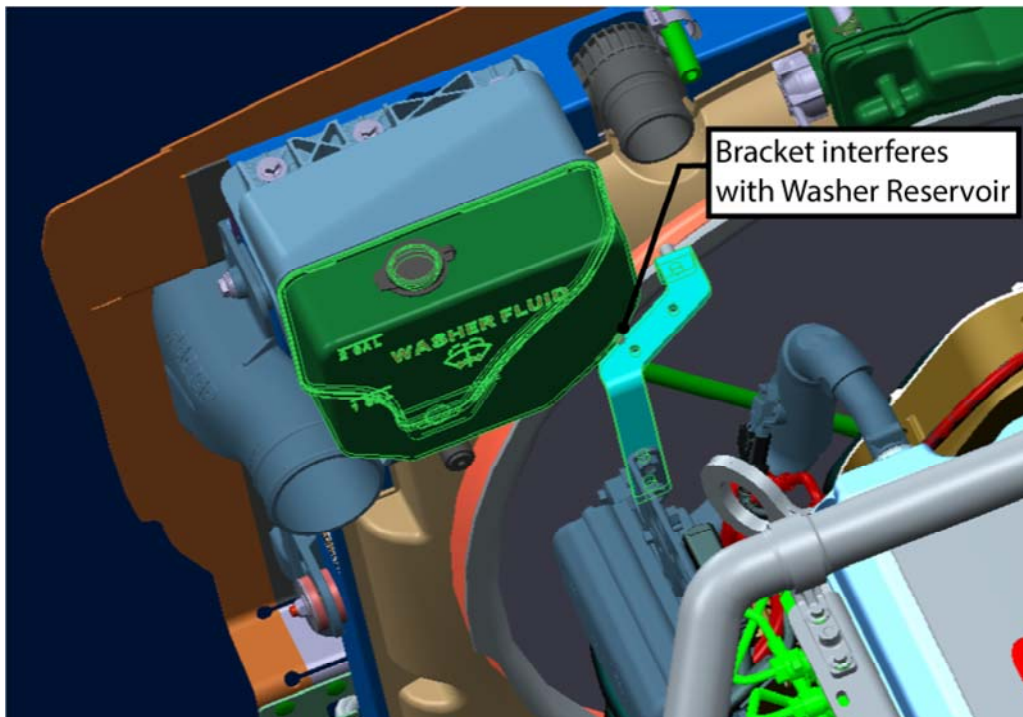
The top drivers-side fan ring support bracket may rub through the washer reservoir, causing a leak.

1. Confirm that the washer reservoir has a leak caused by the top drivers-side fan ring support bracket rubbing on the reservoir.

2. Remove the washer reservoir.
3. Remove the top drivers-side fan ring bracket.
4. Install the updated fan ring bracket.
5. Install the new washer reservoir.
6. Confirm there is at least 1 in. (25 mm) clearance between the bracket and the reservoir.
