April 26, 2018

08946 Version 5

High Pressure Fuel Pump Chirps

HONDA

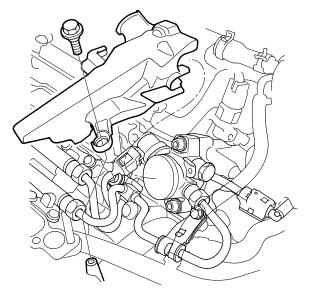
- 1. Relieve the fuel pressure. Due to the high pressure, see service information.
- 2. Set the No. 1 piston at top dead center (DTC). See service information.
- 3. Remove the intake manifold and intake manifold base. See service information.
- 4. Remove the high pressure fuel pump cover.

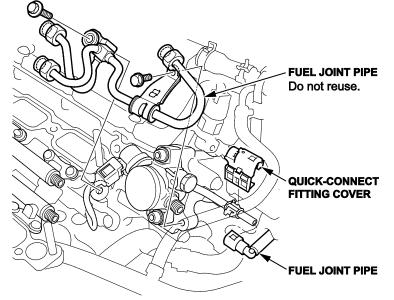
5. Remove the quick-connect fitting cover.

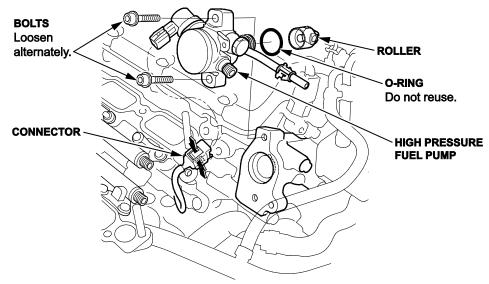
- 6. Disconnect the quick connect fitting.
- 7. Remove the fuel joint pipe.
- 8. Disconnect the high pressure fuel pump connector.

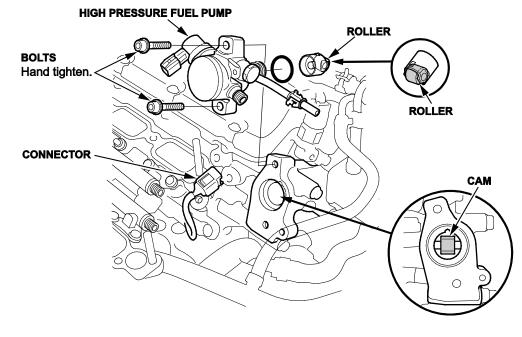
17. Coat the roller, O-ring, cam and around the bore of the lifter with clean engine oil.

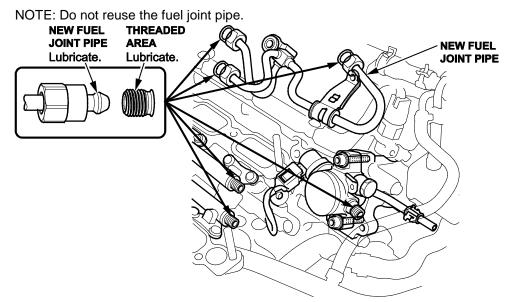
19. Lubricate the top of the new fuel joint pipe and the threaded area of the fuel rails and the high pressure fuel pump with polyethylene glycol included in the new fuel joint pipe kit.

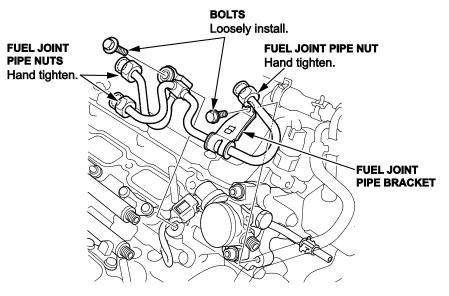
20. Tighten the fuel joint pipe nuts by hand until the end of the joint pipe is seated on the fuel rails and high pressure fuel pump.

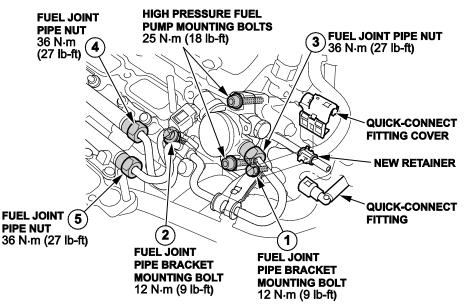
- 21. Set the fuel joint pipe bracket on the cylinder head and loosely install the bolts
- 22. Tighten the high pressure fuel pump mounting bolts to the specified torque.

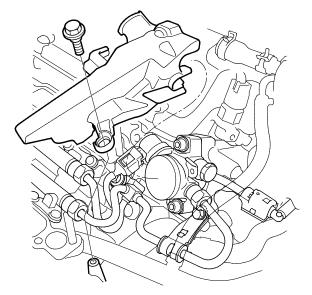
23. Tighten the fuel joint pipe bracket mounting bolts and the fuel joint pipe nuts to the specified torque in the numbered sequence shown.

- A crowfoot-type special tool increases the torque applied by the torque wrench. Refer to Torque Specifications for details on how to recalculate the torque wrench setting.
- Failure to tighten the fuel joint pipe nuts to the proper torque will cause a fuel leak.
- 24. Connect the quick-connect fitting and install the quick-connect fitting cover.
- 25. Set the power mode to ON, but do not start the engine. After the fuel pump runs for about two seconds, the fuel line will be pressurized. Repeat this two or three times, then check for fuel leakage.
- 26. Install the high pressure fuel pump cover and torque it to **12 N·m (9 lb-ft)**.
