08973 Version 9

Warranty Extension: MIL Comes On with DTCs P0301 thru P0304

AFFECTED VEHICLES

Year	Model	Trim	VIN Range
2008–12	Accord	All V6 A/T	Check the iN VIN Status for Eligibility.

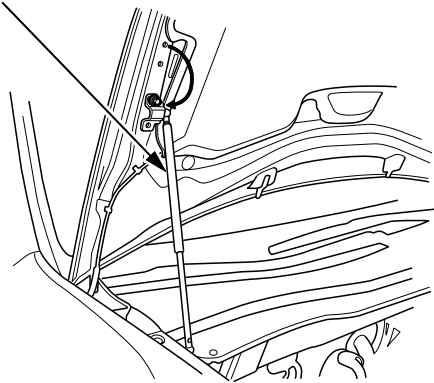
HOOD SUPPORT STRUT

- Use fender covers to avoid damaging painted surfaces.
 - To avoid damaging any wires and terminals, unplug the circuit connectors carefully while holding the connector portion.
 - Mark all the circuits and hoses to avoid misconnection. Make sure they do not contact other circuit wiring, hoses, or interfere with other parts.
1. Using both hood support struts, prop up the hood in a wide-open position.

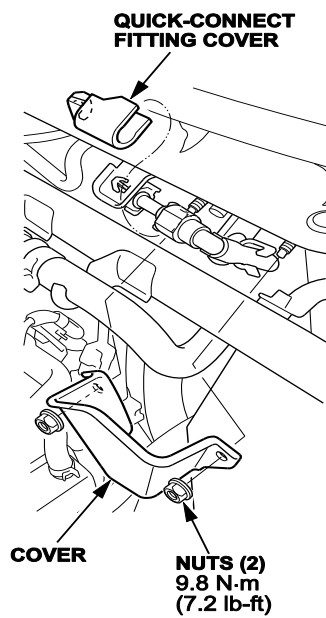
6. Disconnect the fuel feed hose line at the bulkhead.

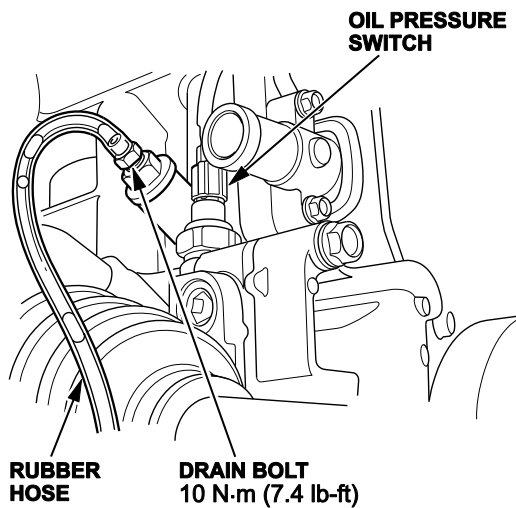
13. Install a 5/16th inner diameter rubber hose on the drain bolt at the rear of the engine block, loosen the drain bolt, and drain all remaining coolant. Then, disconnect the oil pressure switch connector.

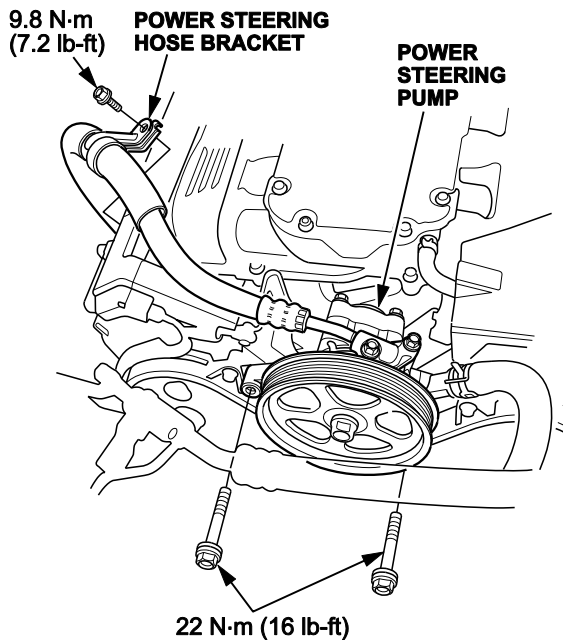
22. Remove the drive belt.
23. Remove the drive belt auto-tensioner.
24. Remove the power steering pump bolts, the power steering bracket then secure the power steering pump out of the way.
NOTE: Do not remove any of the hoses.

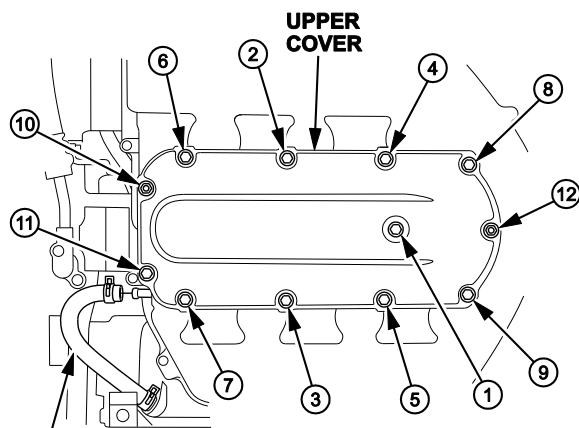
PCV HOSE

30. Remove the engine intake upper cover bolts and nuts. Then remove the cover and the PCV hose.

SPECIFIED TORQUE

6 x 1.0 mm

12 N·m (8.7 lb-ft)

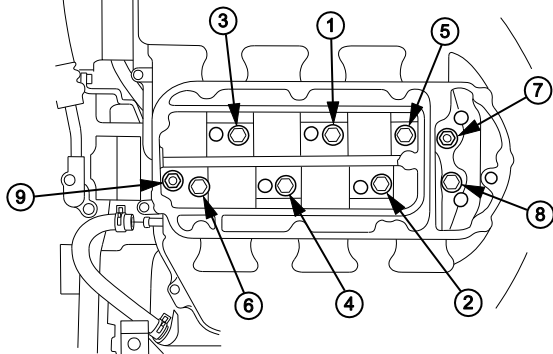
31. Remove the intake manifold bolts and nuts in three steps, then remove the intake manifold.

SPECIFIED TORQUE

22 N·m (16 lb-ft)

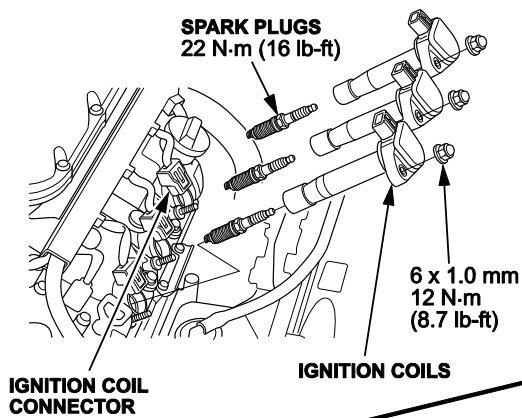
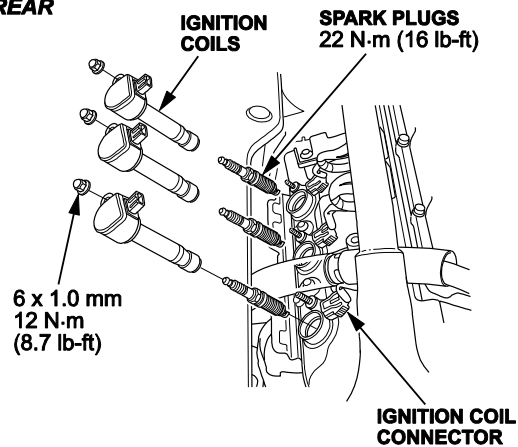
34. Remove the appropriate Ignition coils based on the diagnosis.
NOTE: Depending on the diagnosis, you will either have to remove the rear bank ignition coils or both ignition coil banks.

FRONT

REAR

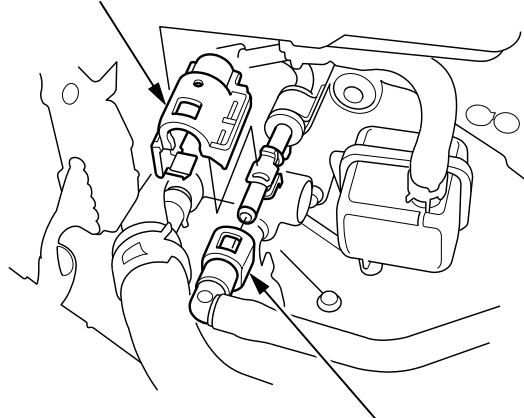
**QUICK-CONNECT
FITTING COVER**

36. Remove the quick-connect fitting cover, then disconnect the fuel feed hose.

FUEL FEED HOSE

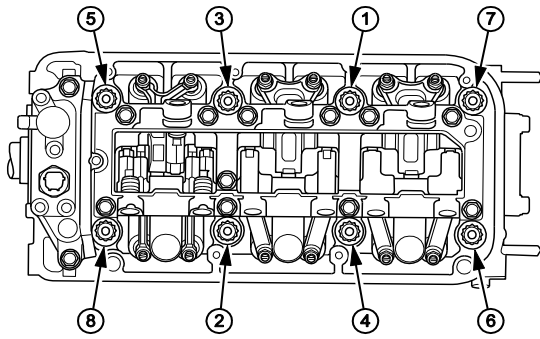
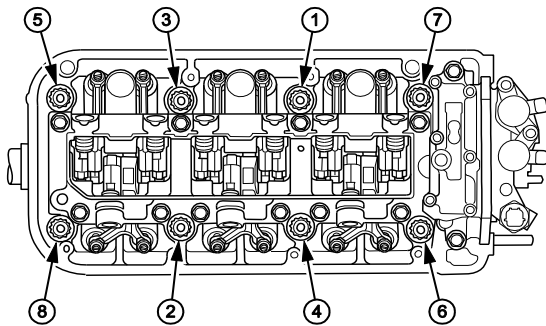
42. Remove the appropriate head with the injector base attached.

NOTE: Depending on diagnosis, you will remove the rear bank head or both heads.

FRONT

REAR

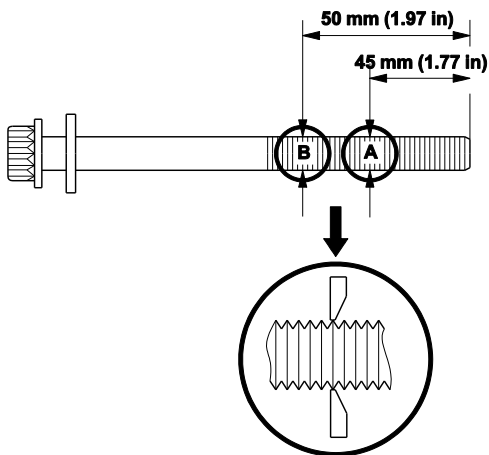
43. Measure the head bolts to determine if they need replacement. If either diameter is less than **11.3 mm (0.445 in)**, replace the cylinder head bolt.

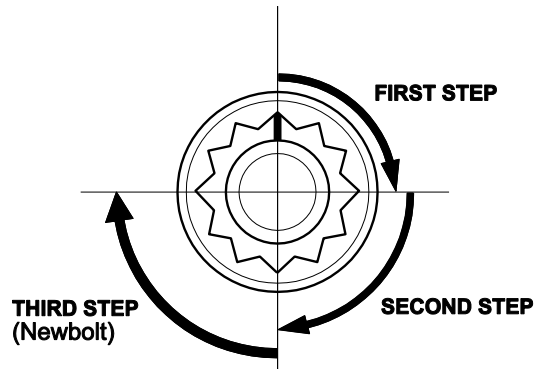
NOTE: Below are the head bolt torque specifications for reinstallation.

- First step: Torque the cylinder bolts in sequence to **29 N·m (22 lb-ft)**.
- Second step: Tighten in sequence an additional **90 degrees**.
- Third step: Tighten in sequence an additional **90 degrees**.
- If the bolts are new, tighten an additional **90 degrees**.

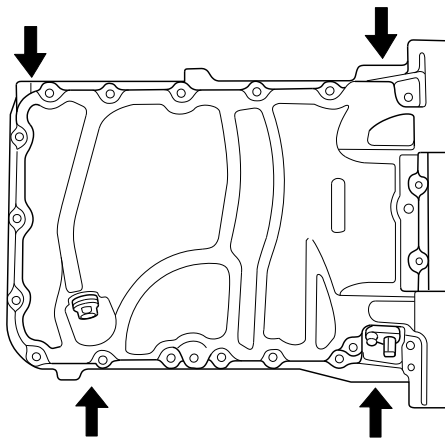
48. Using a flat-blade screwdriver, separate the oil pan from the engine block in the areas shown.

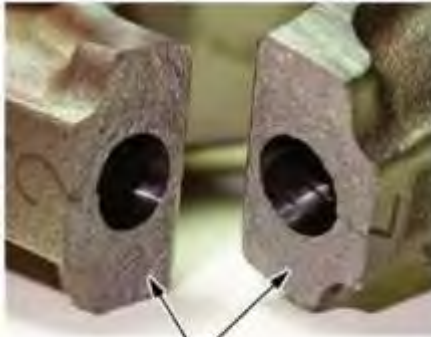
The uneven mating surfaces are uniquely matched and not interchangeable.

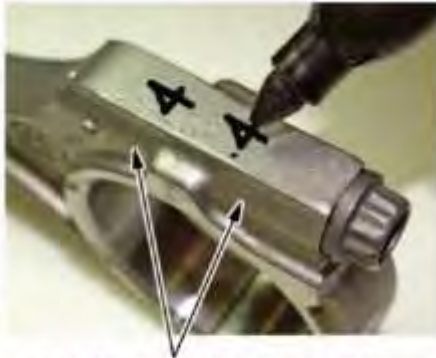
Mark the connecting rod and rod cap with the cylinder number.

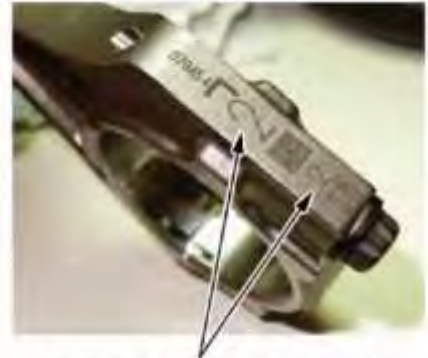
These are manufacturing marks, and do not indicate the cylinder number.

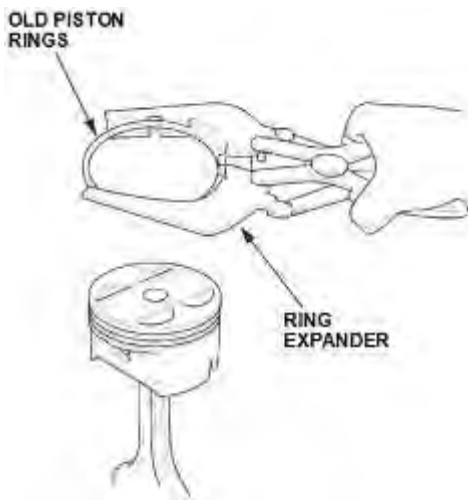
1. Remove the piston rings from the piston using a ring expander. Be careful not to damage the piston.

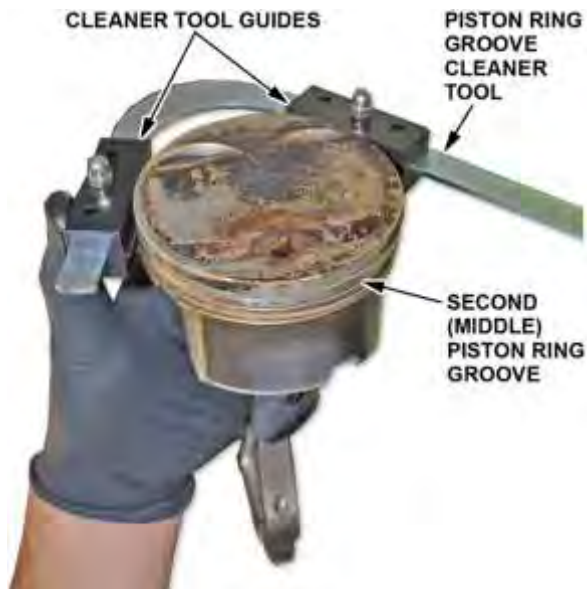
3. While holding the piston upright in your left hand, take the piston ring groove cleaner tool in your right hand and line up the cleaner tool guides with the second (middle) piston ring groove.

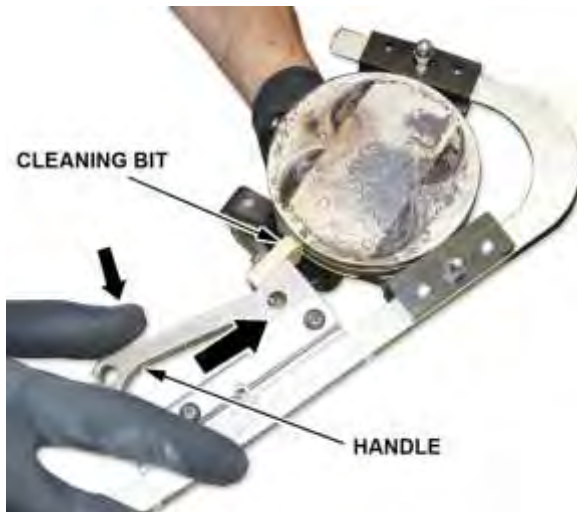
4. Press the handle on the piston ring groove cleaner tool and slide the cleaning bit onto the appropriate piston ring grooves.

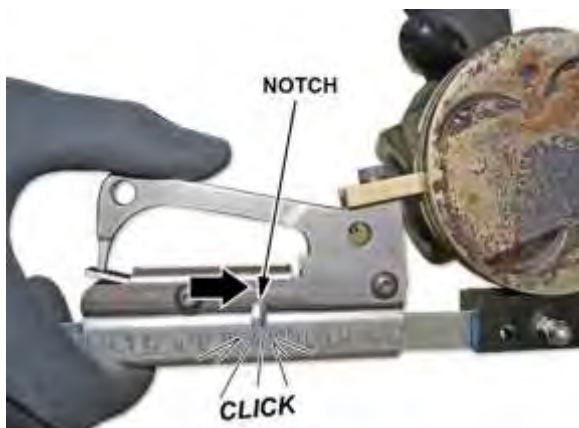
5. Once the cleaning bit is in the appropriate ring grooves of the piston, make sure the tool handle clicks into place.
NOTE: There is only one notch on the tool for the handle to engage.

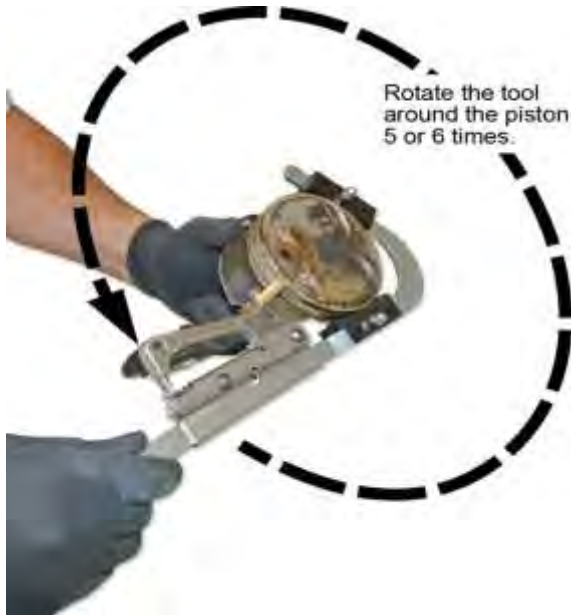
6. Hold the piston steady and rotate the tool counterclockwise five to six times to remove any carbon deposits in the piston ring grooves. **Do not** rotate the tool clockwise.

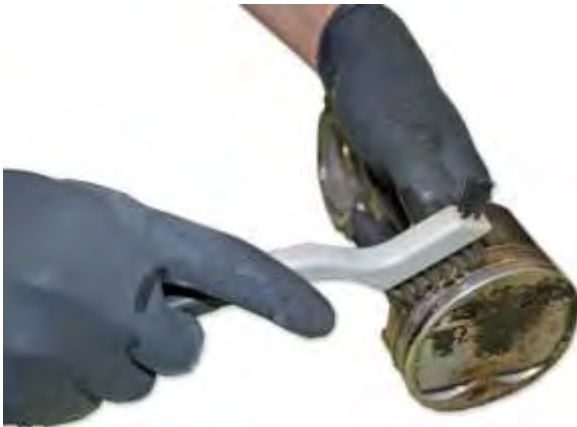
7. Remove the piston groove cleaning tool and clean off the carbon from the tool bit.
8. Finish cleaning the piston with throttle plate cleaner and the nylon brush. **Do not** use a steel wire brush.

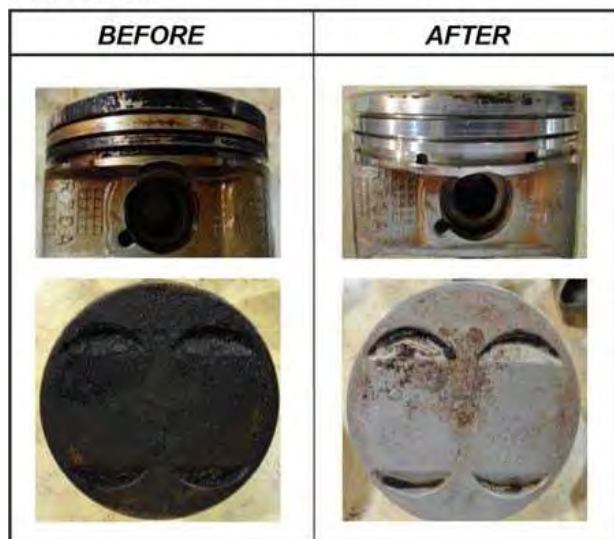
54K PISTON

NOTE: Below are some examples of before and after pictures. Depending on mileage and running conditions, the pistons will achieve different levels of cleanliness.

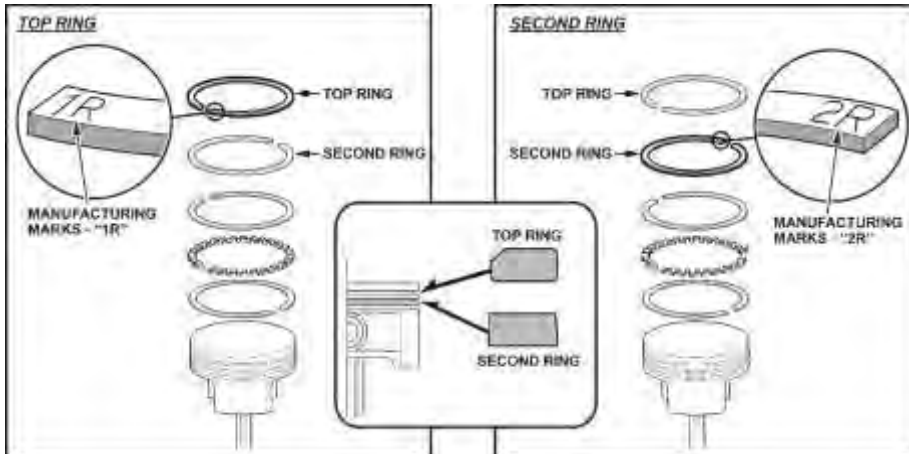
9. Install the piston rings as shown.

NOTE: The first (top) ring has a **1R** manufacturing mark and the second (middle) ring has a **2R** manufacturing mark. The manufacturing marks must be facing upward.

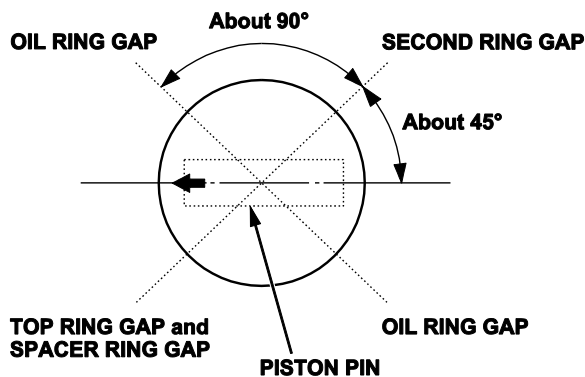
10. Position the ring end gaps as shown.

NOTE: If the ring gaps are not positioned correctly, excessive blowby may occur.

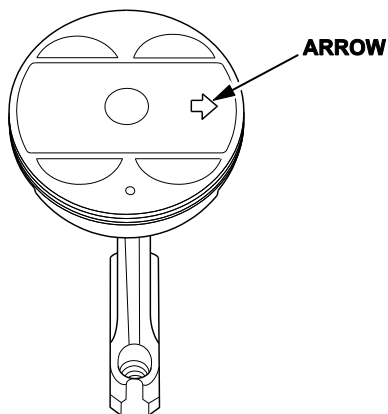
12. Install the piston/connecting rod assembly into the cylinder bore with the arrow on top of the piston facing the timing belt side of the engine.

NOTE: Be careful not to damage the cylinder wall when installing the piston.

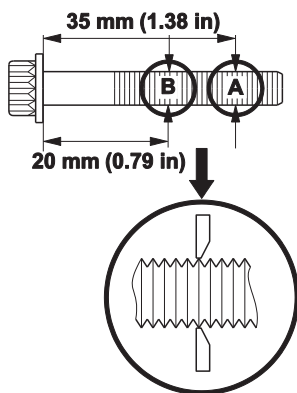
13. Measure the diameter of the connecting rod bolts to determine if they need replacement. Calculate the difference in diameter between point A and point B. It should not be more than **0–0.1 mm (0–0.004 in)**.

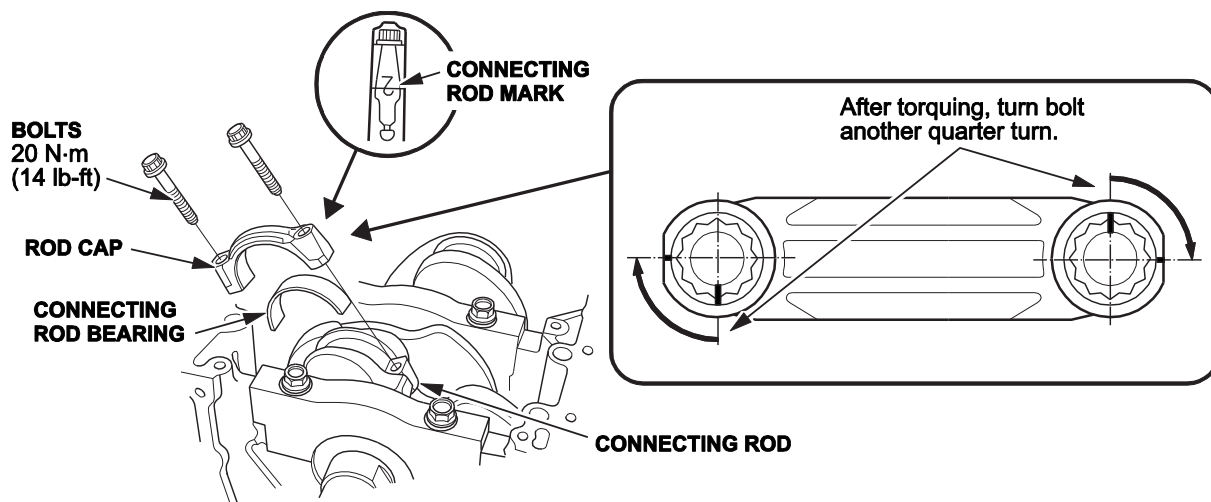
14. Apply new oil to the connecting rod bolt threads and flanges. Torque the bolts to **20 N•m (14 lb-ft)** then, tighten the connecting rod bolts an additional **90 degrees**.
