08975 Version 8

Warranty Extension: MIL Comes On with DTCs P0301 Thru P0304

AFFECTED VEHICLES

Year	Model	Trim	VIN Range
2010–12	Crosstour	ALL V6	Check the iN VIN Status for Eligibility.

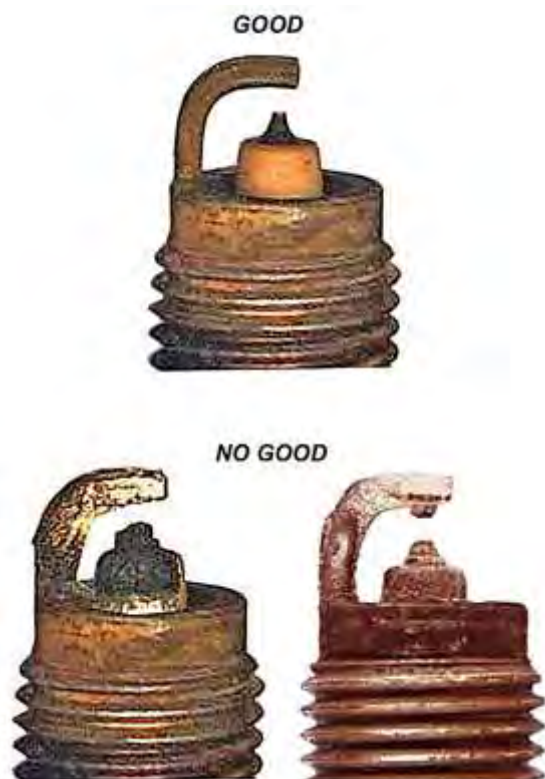
2. Remove and check the spark plug(s) on the affected cylinders (example: if P0301 is stored, check the spark plug on cylinder No. 1).

Are the spark plug(s) fouled?

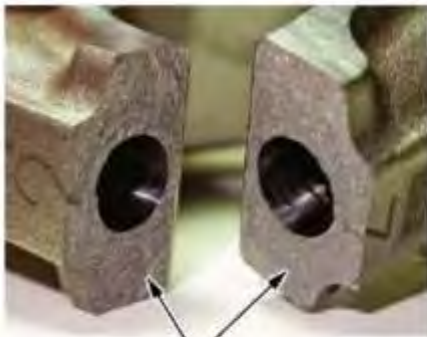
The uneven mating surfaces are uniquely matched and not interchangeable.

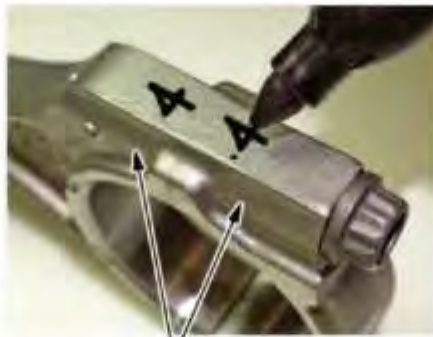
Mark the connecting rod and rod cap with the cylinder number.

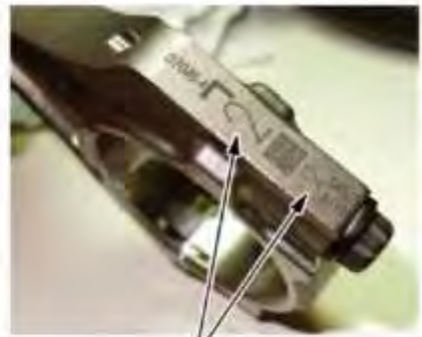
These are manufacturing marks, and do not indicate the cylinder number.

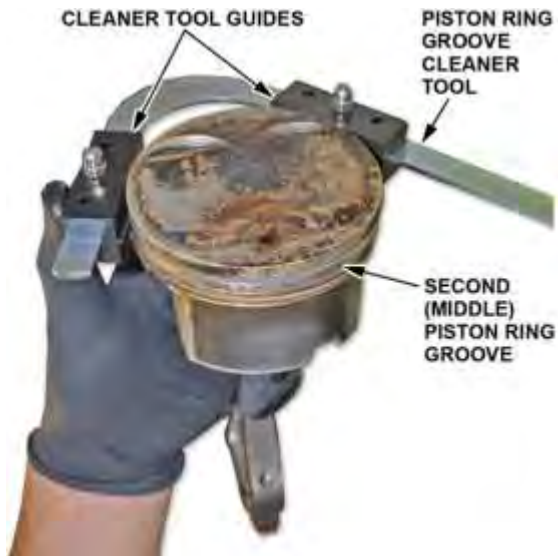
2. Spray the piston head and piston ring grooves thoroughly with Honda throttle plate cleaner.
3. While holding the piston upright in your left hand, take the piston ring groove cleaner tool in your right hand and line up the cleaner tool guides with the second (middle) piston ring groove.

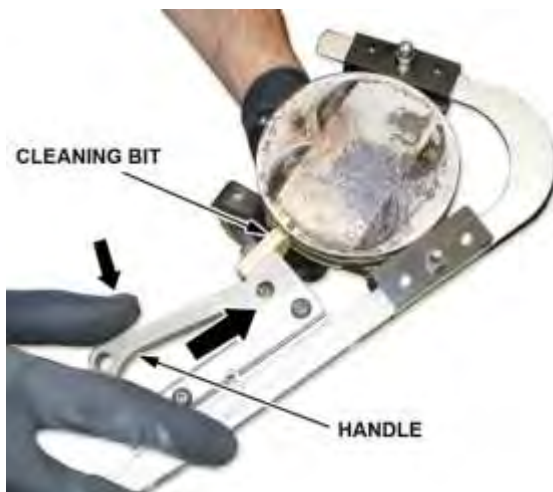
4. Press the handle on the piston ring groove cleaner tool and slide the cleaning bit onto the appropriate piston ring grooves.

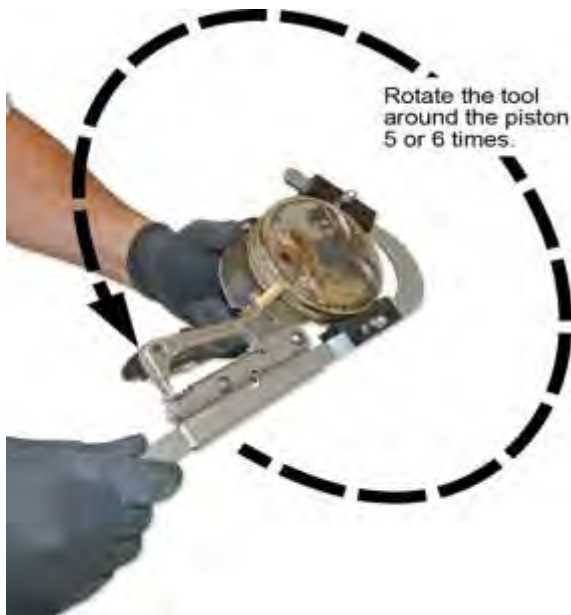
6. Hold the piston steady and rotate the tool counterclockwise five to six times to remove any carbon deposits in the piston ring grooves. **Do not** rotate the tool clockwise.

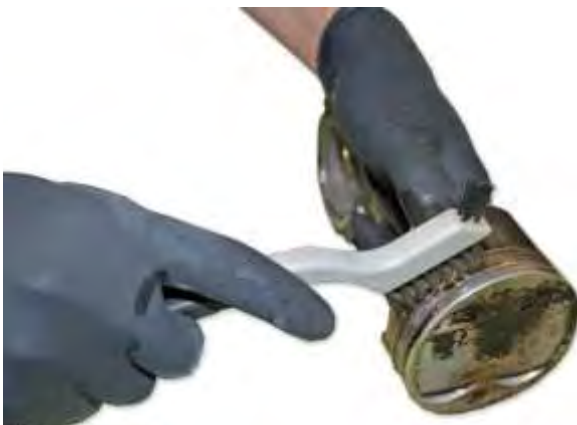
7. Remove the piston groove cleaning tool and clean off the carbon from the tool bit.
8. Finish cleaning the piston with throttle plate cleaner and the nylon brush. **Do not** use a steel wire brush.

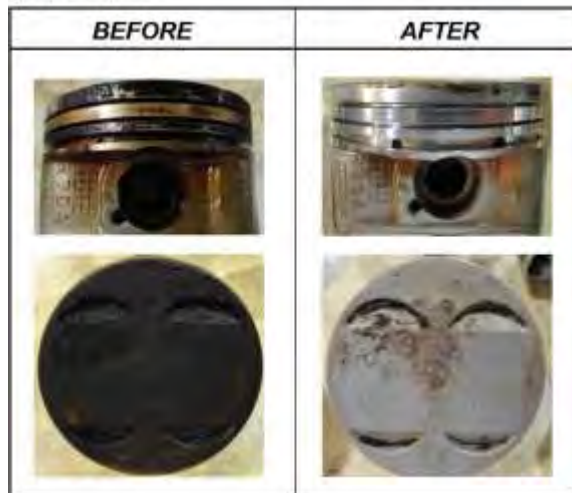
54K PISTON

NOTE: Below are some examples of before and after pictures. Depending on mileage and running conditions, the pistons will achieve different levels of cleanliness.
