GROUP ELE	MODEL 2014-2015MY Sorento (XMa) Forte (YD)
	NUMBER 145 (Rev 1, 4/06/2018)	DATE March 2018
TECHNICAL SERVICE BULLETIN		
SUBJECT: HEAD UNIT MISMATCH WITH MICROPHONE

HEAD UNIT MISMATCH WITH MICROPHONE

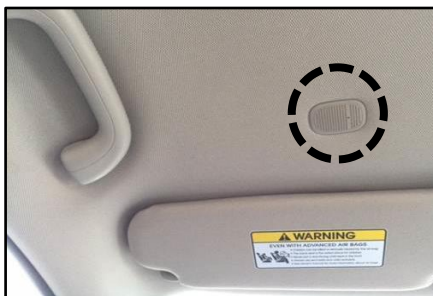
The difference in the microphone’s operating voltage can be identified by the outer appearance of the microphone. (Note: Both 3.3 Volt and 8 Volt head units may have an identical appearance.) **Identify the microphone type to order the proper head unit through Direct Exchange when this concern occurs, using the information below.**

The Hands Free Microphone (MIC) is located on the front driver side of the roof headliner. **NOTE: The 3.3V MIC has a linear or dotted style screen and the 8V MIC has a mesh style screen.** Determine the vehicle equipped MIC and reference the table below for the head unit exchange part number needed.
